Reinterpretation of the third sewn boat from the ancient port of Zaton in the vicinity of ancient Nin (*Aenona*), Croatia

Dušanka Romanović – Irena Radić Rossi – Katarina Batur

Keywords: sewn boat, port, *Aenona*, Zaton 3, boat structure

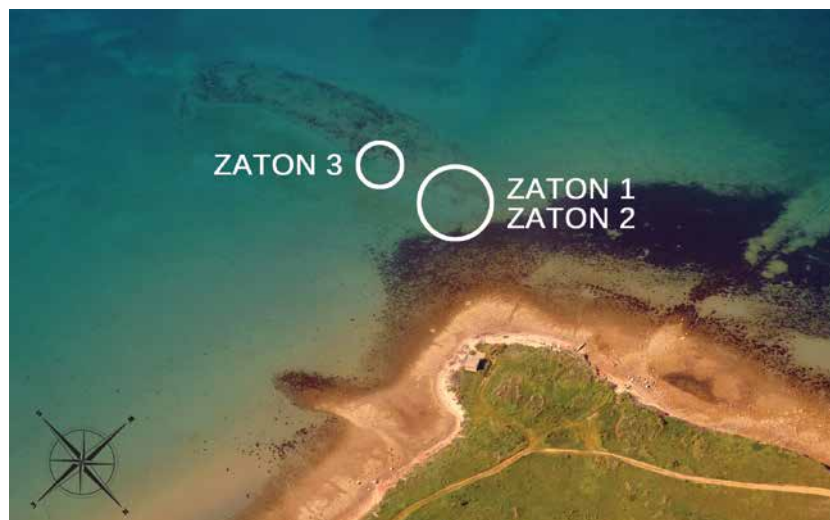
Fig. 2 Aerial photo from the north-east of Cape Kremenjača with position of the three sewn boats (photo: D. Grosman)

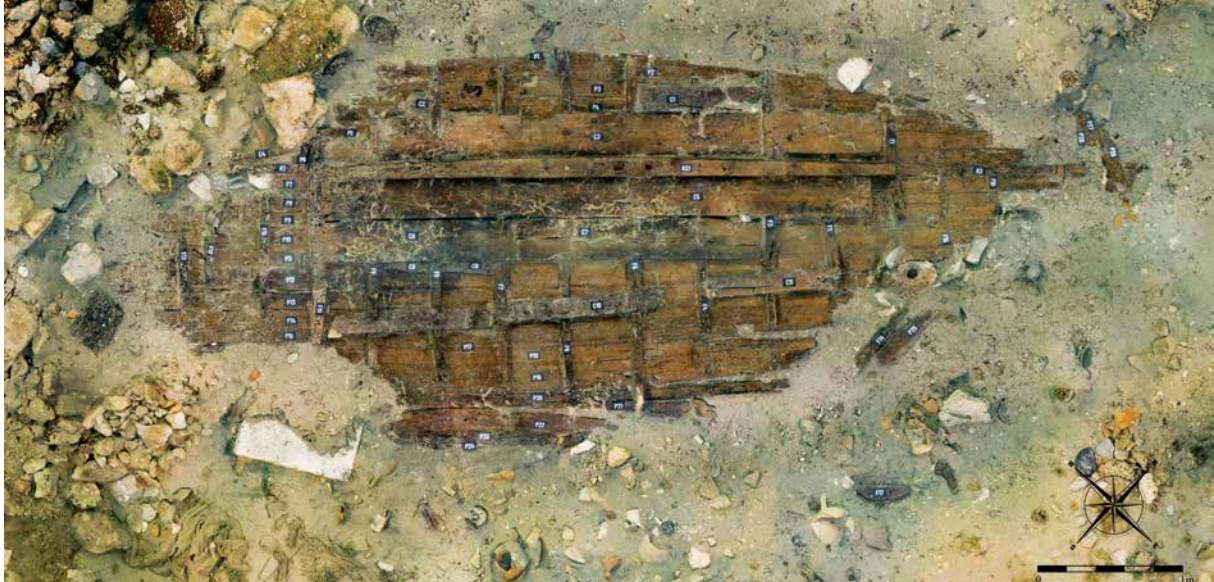
Fig. 3 Orthoimage of the first phase of Zaton 3 boat excavations in 2019: the inner carpentry (ceiling and keelson are still in place) (author: K. Yamafune)

The best researched of the three sewn boats from the Roman-period port in Zaton is the third boat (Fig. 3). Data about Zaton boats 1 and 2 is very scarce. Only a few reports on the underwater excavations were found in the archives, and many questions about Zaton 1 and 2 remain unsolved (Romanović 2021). The remains of this third boat are in better condition than the remains of the other two. The boat's structure was explored by sections in four campaigns from 2002 to 2007, but not entirely and it was not documented in detail. During the 2019 excavations, the entire preserved boat's structure with its periphery was cleaned up and documented, providing new data on its construction.

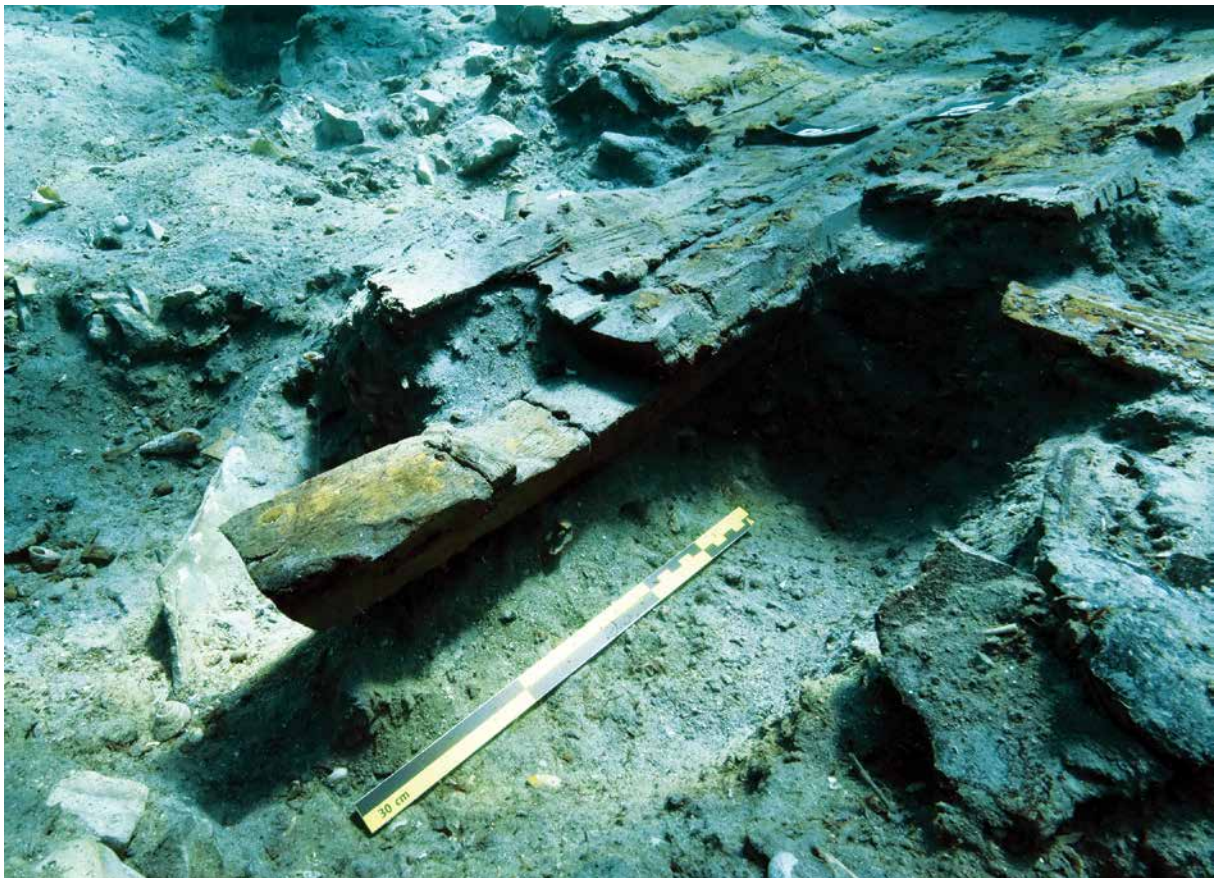
Fig. 5 Keel end with scarf for attaching the stem or transitional timber at the bow (photo: M. Martinčak)

The boat rests on its keel (K) that is preserved in length of 6.13 m. The total length of the keel and its original shape remain unknown. The eastern extremity is entirely preserved, while the western extremity was damaged heavily by degradation process. The eastern extremity (the bow) ends with a finely processed scarf for attaching the stem or transitional timber (Fig. 5). The cross-section of the keel is visible on the eastern side, where it is almost rectangular and chamfered. The oblique channels for the stitches were drilled perpendicular to the keel edges, along both sides of the upper part of the keel.

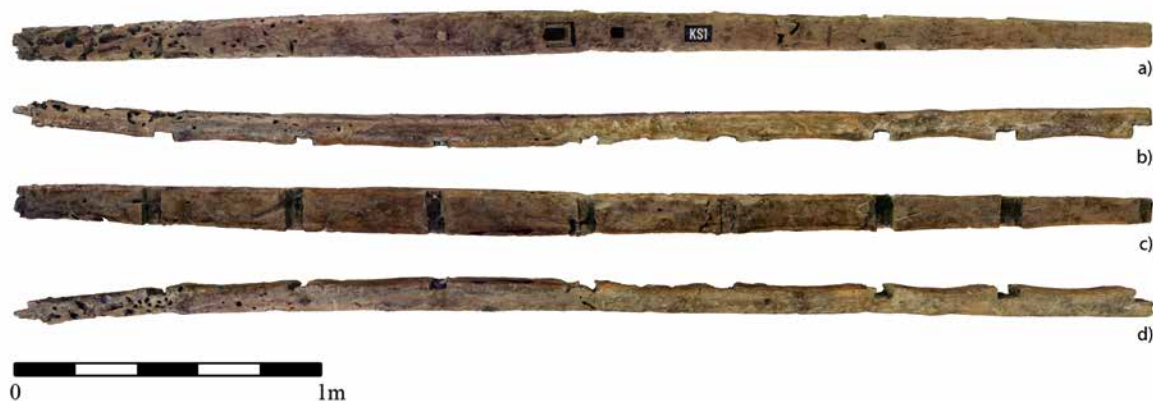
Fig. 6 Orthoimage of the four sides of the keelson: a) top view; b) view from the south-east; c) bottom view; d) view from the north-west (author: K. Yamafune)

A massive keelson (KS) placed above the keel and frames represents one of the longitudinal reinforcements of the boat structure. The 2019 excavation campaign established that the bow was oriented to the east. The preserved length of the keelson is 3.75 m. It extends from frame F1 at the bow to frame F10 at the stern, where it is quite damaged so its full length cannot be established. The dimensions of the keelson are 7.6 to 14.2 cm sided and 7.1 to 7.9 cm moulded, with the widest part in the central section of the boat. On the lower side of the keelson there are recesses for accommodating it on the frames, as well as slight arch-shaped indentations between the recesses which allow circulation of bilge water. On the upper side, on its central (and widest) section, there is the mast mortise (Fig. 6). The mast mortise is rectangular, and the north-east edge is cut obliquely to facilitate lowering of the mast towards the stern. The mast mortise is flanked by rectangular recesses on three sides, for hosting vertical planks to support the mast. To enable the final part of the third recording phase, the keelson was lifted and photogrammetrically recorded. On the upper side

of the keelson, at the position of frame F20, a trace of a nail that once joined it to the keel and frames is visible. After removing the keelson, on its lower side, at the position of frames F3, F20, and F21, traces of nails were observed, which were probably hammered in from the bottom of the keel, passing through the keel and entering the frames and keelson.
