Homemade? An early 16th century carvel ship found in Oslo harbour, Norway

Sarah Fawsitt – Marja-Liisa Petrelius Grue – Hilde Vangstad

Keywords: Dutch-Flush, Norway, 16th century, shipbuilding, Bispevika 8

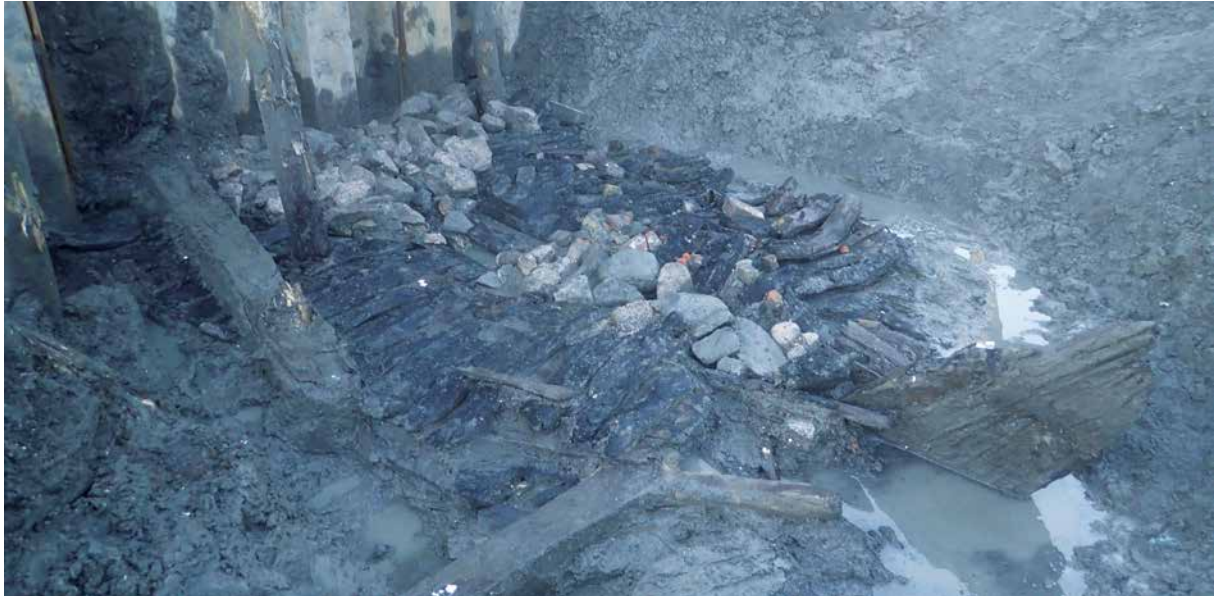
Fig. 1 What remained of Bispevika 8 had been damaged by fire, dredging, and the insertion of a cofferdam (photo: Norwegian Maritime Museum).

Only 6.4 × 5 m of Bispevika 8 was preserved, and those remains had been badly damaged by a fire. More than half of the hull's length was dredged away sometime in the 19th century (Fig. 1). Among the boat parts preserved were a rabbeted keel, a three-part stern post with stern knee, a keelson, 73 frames, parts of nine stakes, seven graving pieces, and small pieces of ceiling planks, as well as the foot of a bilge pump (Fig. 2). What remained of the Bispevika 8 keel was rabbeted, 34.9 cm sided and 26 cm moulded. This is a deeper keel than many of the Dutch-Flush ships, but it is not unique, with the later B&W 2 and B&W 5 Christianshavn vessels having a similar ratio of sided to moulded dimensions (Lemée 2006). The aft stem was made of three parts, securely fastened to the ship with treenails and iron bolts.

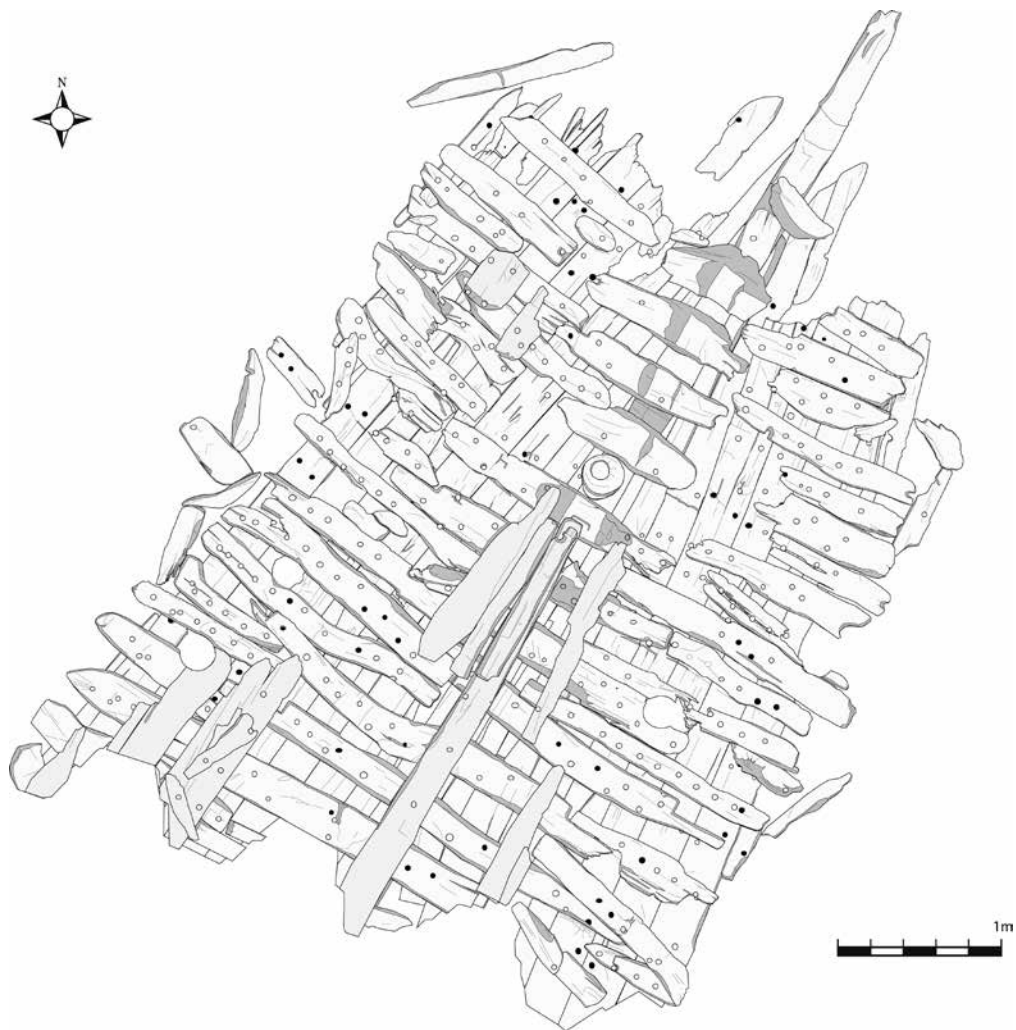
Fig. 2 The boat parts that did survive included a keel, a stern post with stern knee, a keelson, frames, strakes, graving pieces, ceiling planks as well as the foot of a bilge pump (photo: Norwegian Maritime Museum).

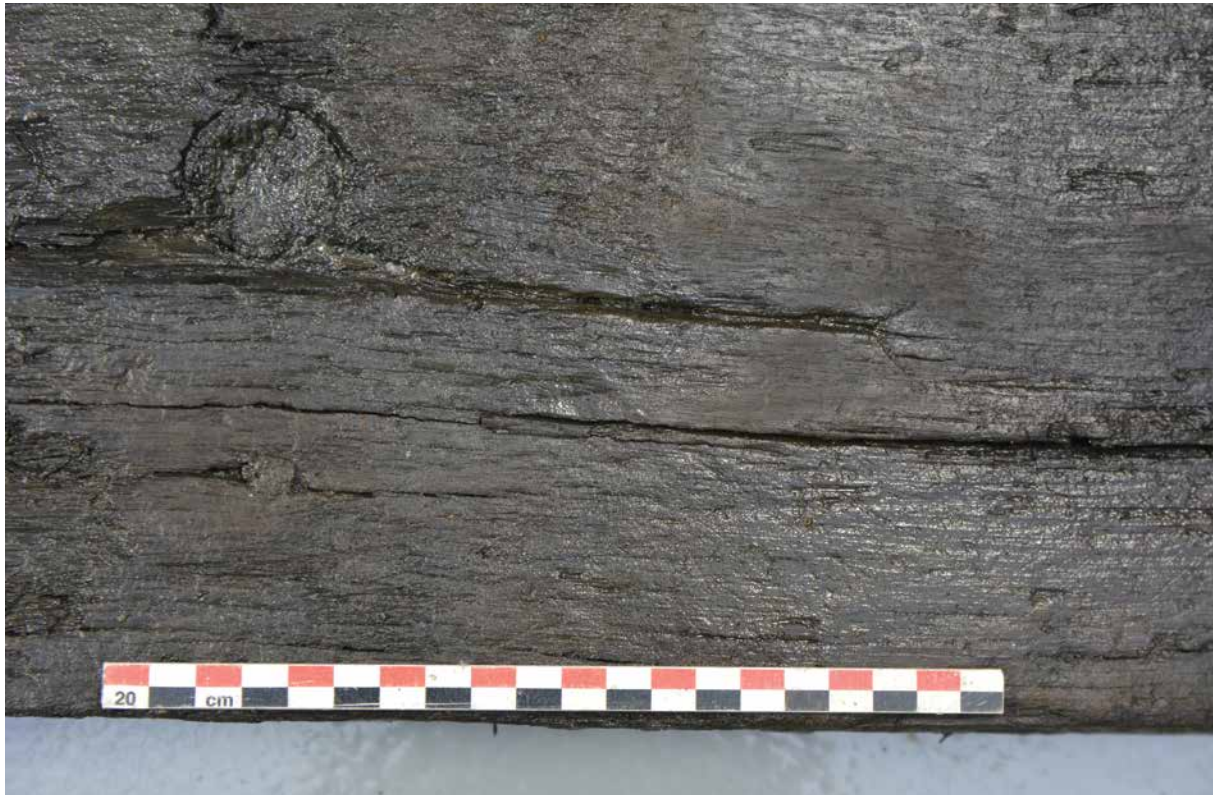
Fig. 3 One of the many spike-plugs found in the hull planking of Bispevika 8. Also visible in the picture is an arrow shaped stop-mark, used to stop the progression of a crack (photo: Norwegian Maritime Museum).

During the insertion and fastening of the frames in a Dutch-Flush ship construction, temporary cleats were used to hold the stakes together. When the cleats were removed, their nail holes were filled with small wooden plugs called spike-plugs. During the 1:1 documentation of the Bispevika 8's planks, spike-plugs were documented on the inside and outside of the hull planking, with evidence for cleats from the keel to the seventh stake, approaching the turn of the bilge.
