Waste disposal in the Netherlands as reflected in shipwrecks of the former Zuiderzee

Alice Overmeer – André van Holk

Keywords: 19th-century, pram, composition of cargo, waste disposal, the Netherlands, coal gas production

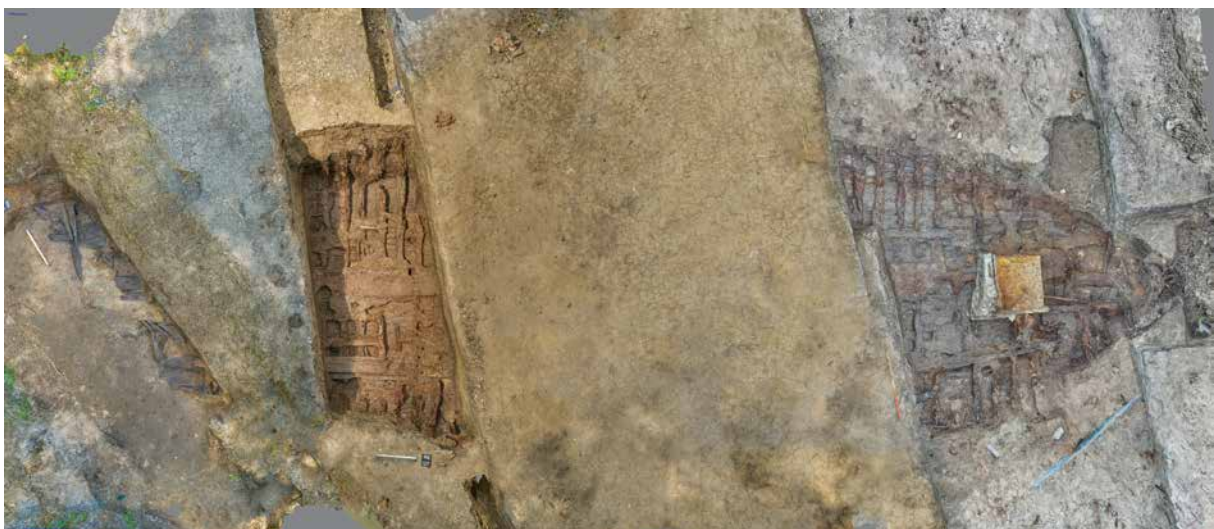
Fig. 2 Overview of the ZP 5/6 wreck, photogrammetry results (authors: T. van Damme, J. Opdebeeck, Cultural Heritage Agency – RCE)

Three trial trenches were planned, which in fact were extensions of the 1982 trenches, or placed adjacent to them. One was positioned at the stern, one amidships, and one at the forward end of the wreck (Fig. 2).

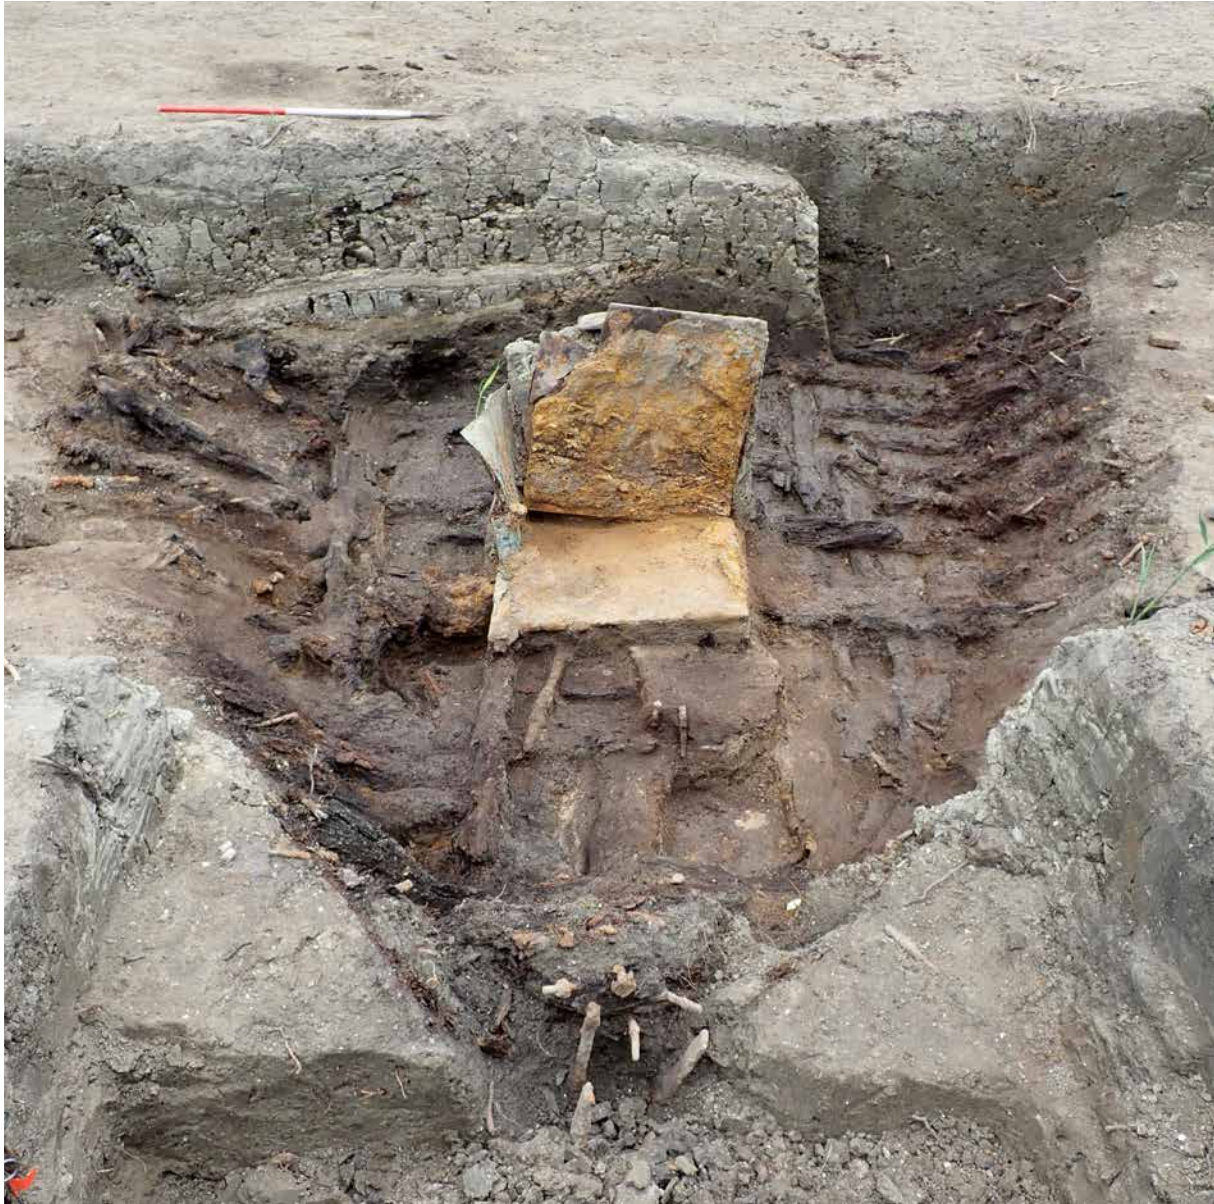
Fig. 3 Trench in the stern of the ship, with the hearth place in the centre (photo: Cultural Heritage Agency – RCE)

Based on the various layers and the find material in the ship, we can say that the internal space of the ship was divided into at least two, presumably three, different compartments. Aft in the ship was the cabin, which was used as kitchen and living quarters. It must have been a cramped room, not much larger than 3 × 3 m. In the centre of the cabin was a hearth place, consisting of a horizontal iron base plate of 75 × 63 × 1 cm and a vertical iron plate of 75 × 77 × 1 cm (Fig. 3). To either side of the hearth, vertical wooden boards were attached, covered with copper plates. A stove or furnace may have been placed on it, but it may also have been a fireplace, of which the wooden frame and chimney are missing. Many peat bricks were found next to it, in very bad condition.

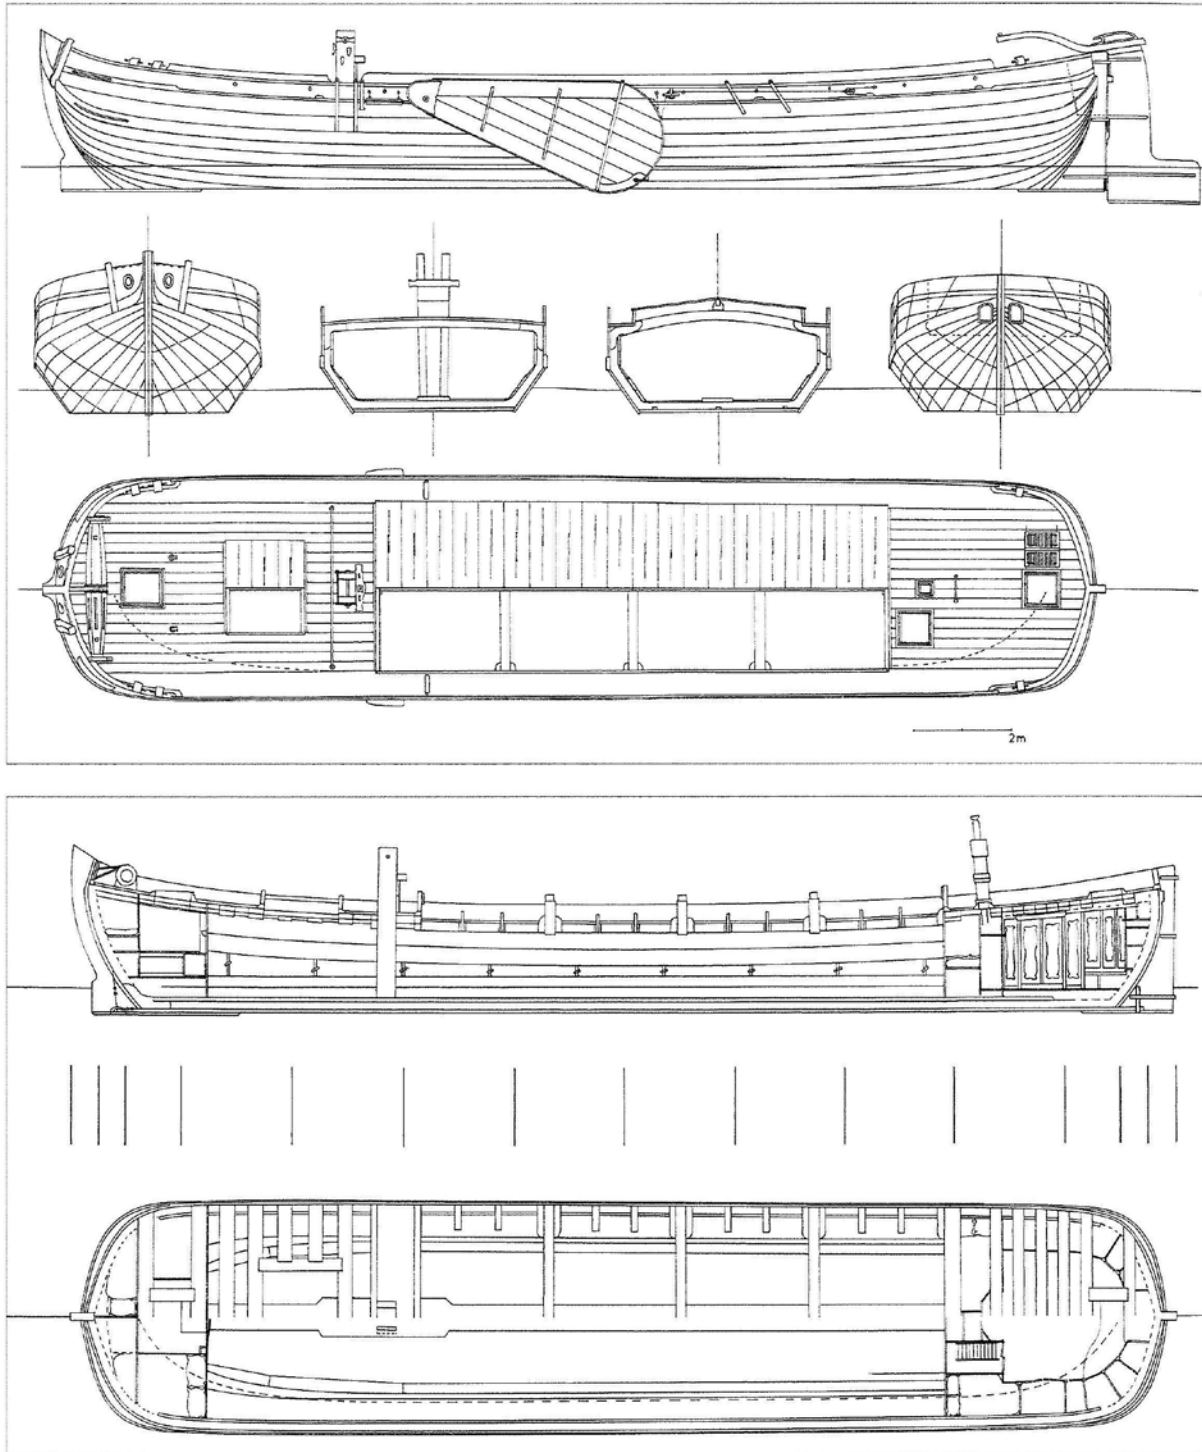
Fig. 4 Reconstruction plan of a large pram (drawing: Schutten 2004: Fig. 2.16)

The main characteristics – a lance-shaped bottom, a hard chine, a straight raking stern, its dimensions and the find material – all lead to the conclusion that wreck ZP 5/6 was a pram-like vessel from the last decades of the 19th century (Fig. 4). It probably had a length of over 18.5 m, a width of 4.15 m and a depth of about 1.5 m.

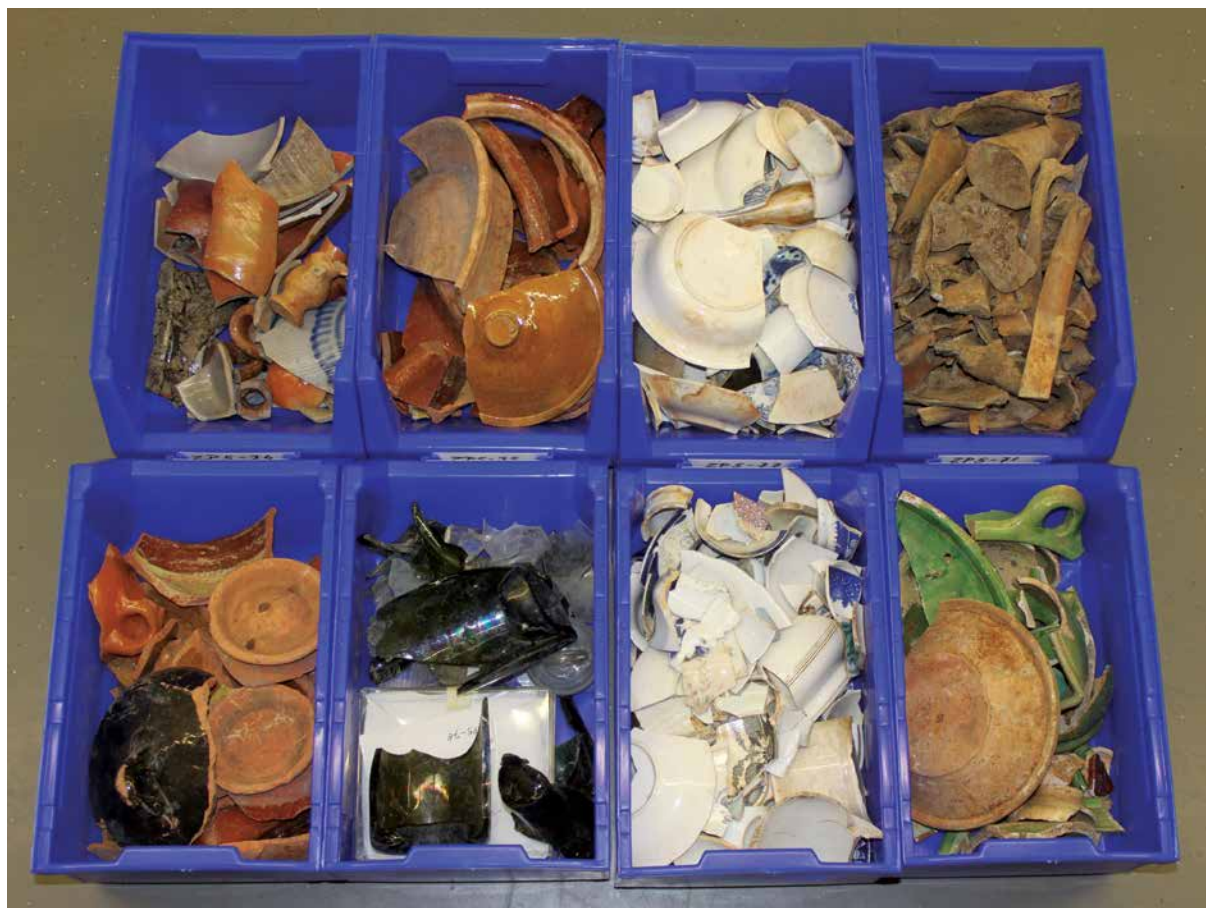
Fig. 5 Waste consisting of different kinds of broken ceramics from the cargo of ZP 5/6 (photo: A. van Holk)

The composition of the cargo of wreck ZP 5/6 is remarkable and raises some questions. In 1982 part of the cargo was salvaged. It was composed of a great variety of materials, which initially could visually be identified as the contents of a cesspit (Fig. 5). So, it was thought that the vessel transported city waste, consisting of street sweepings, the contents of cesspits, hearth-ashes, and household waste.

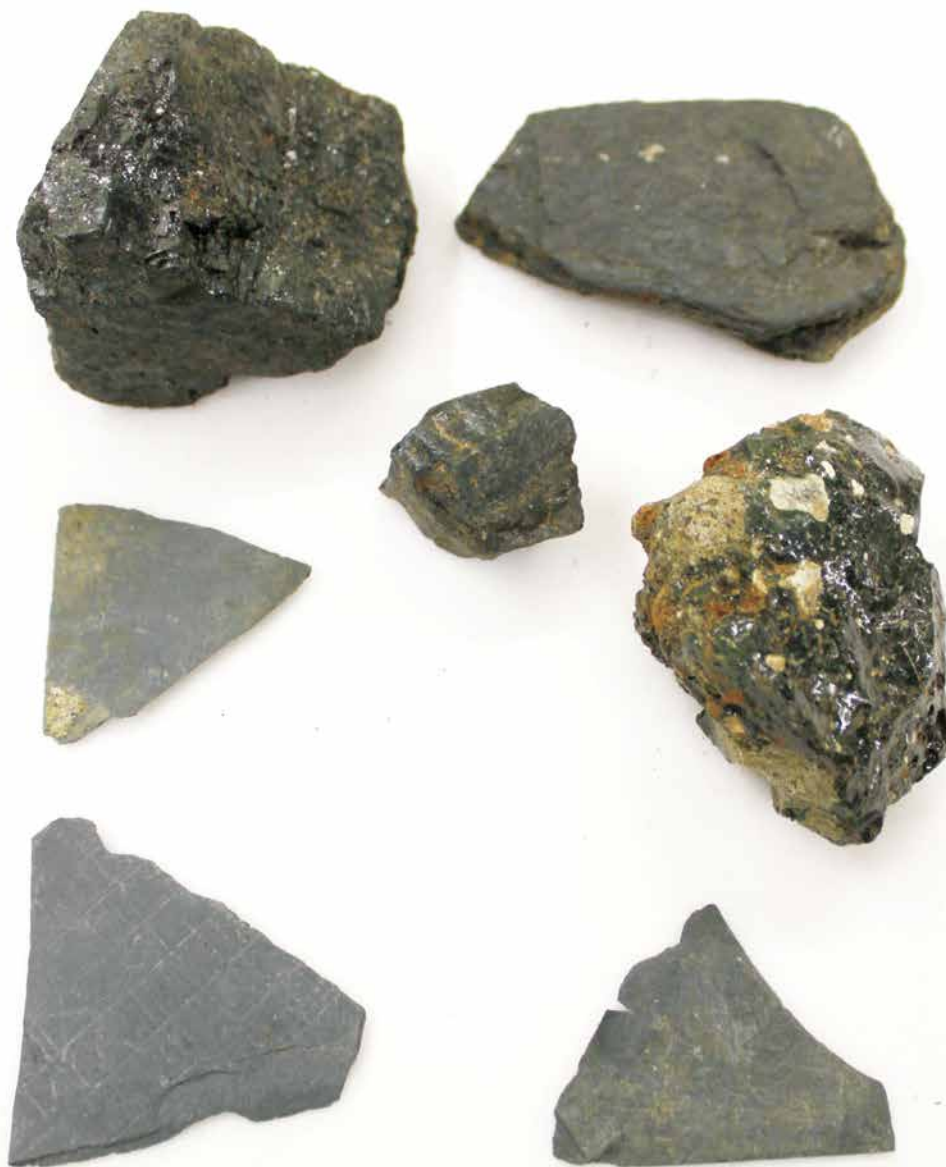
Fig. 6 Coal ashes and slag from the cargo of ZP 5/6, waste associated with gasworks and some pieces of slate (photo: A. van Holk)

If we consider the results of the XRF analysis and the sieving work, we could launch another hypothesis about the cargo. A significant part of the cargo consisted of slag material (from the combustion of coal and charcoal), heated natural stone, cokes, coal and charcoal (Fig. 6). All of these products are generated during the production of gas for light from coal in a gas factory (Van Os 2024).

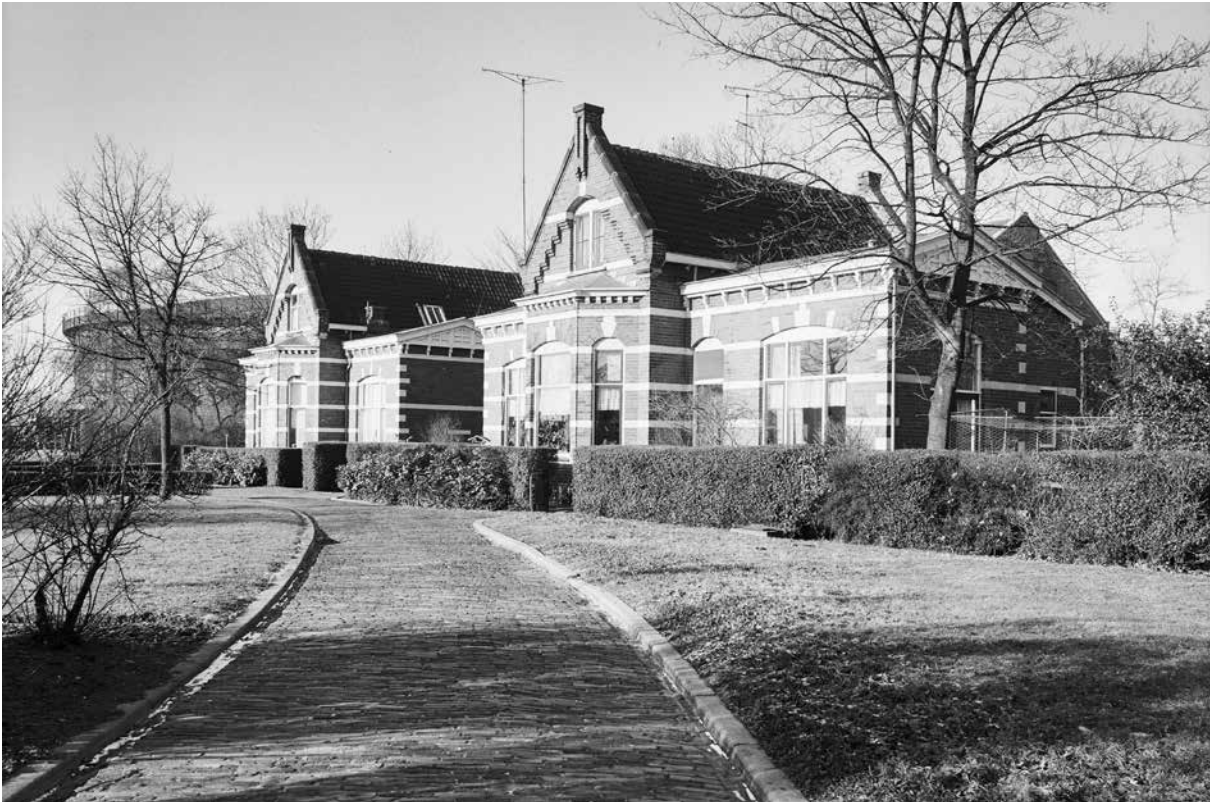
Fig. 7 Company house (to the right) next to a gas holder (to the left) at the Haarlemmerweg in Amsterdam (photo: Cultural Heritage Agency – RCE, Amersfoort/ 232.669)

The presence of the household waste can possibly be explained by the fact that the manager of a gas factory was obliged to live next to the factory, so he could immediately intervene in case of a dangerous situation (Fig. 7) (Waszink 1996: 77). In this case, it is possible that the waste of the manager's household got mixed up with the waste of the gas factory.
