An early 17th-century ‘half-carvel’ construction in the North Frisian Wadden Sea: The Japsand wreckage near Hallig Hooge, Germany

Daniel Zwick

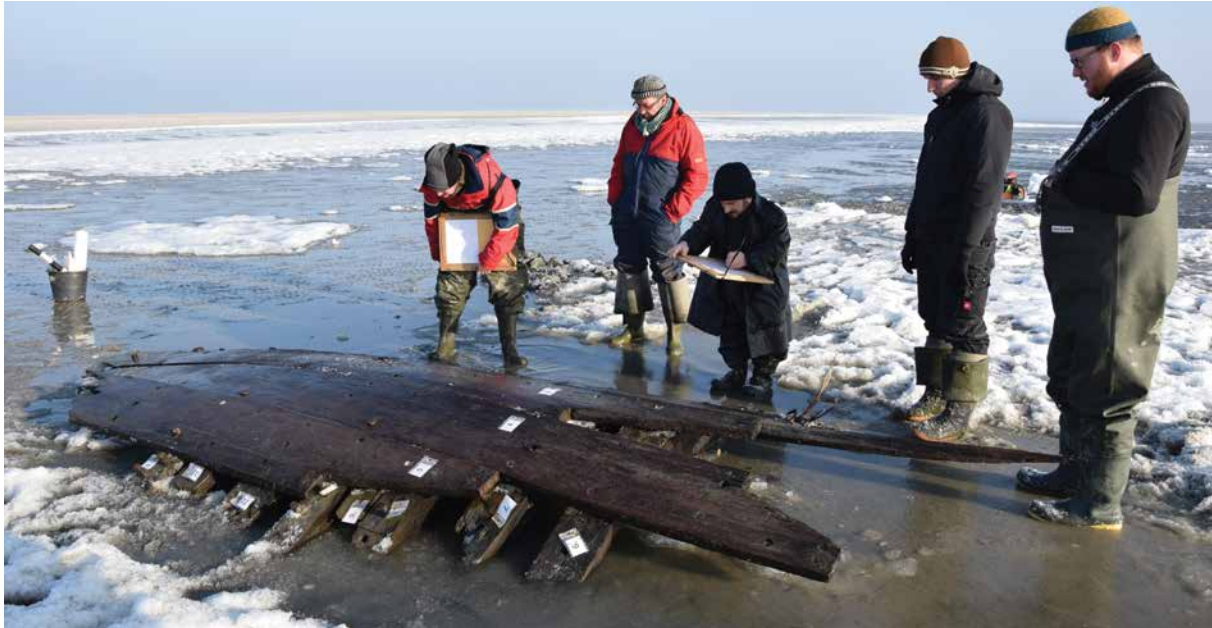
Fig. 2 The documentation of the first wreck fragment (WF1) in February 2017 (photo: ALSH)

Due to the short time window in which the survey had to take place, the wreck fragments could not be studied in greater detail and the exposed location of wreck fragment 1 (WF1) led to its loss shortly after the investigation. WF2 remained *in situ* and was gradually covered by sands again. It was detected through a multi-coil FD-EMI survey three years later, in which WF2 was used as test case to optimise this technology (*cf.* Wilken *et al.* 2022).

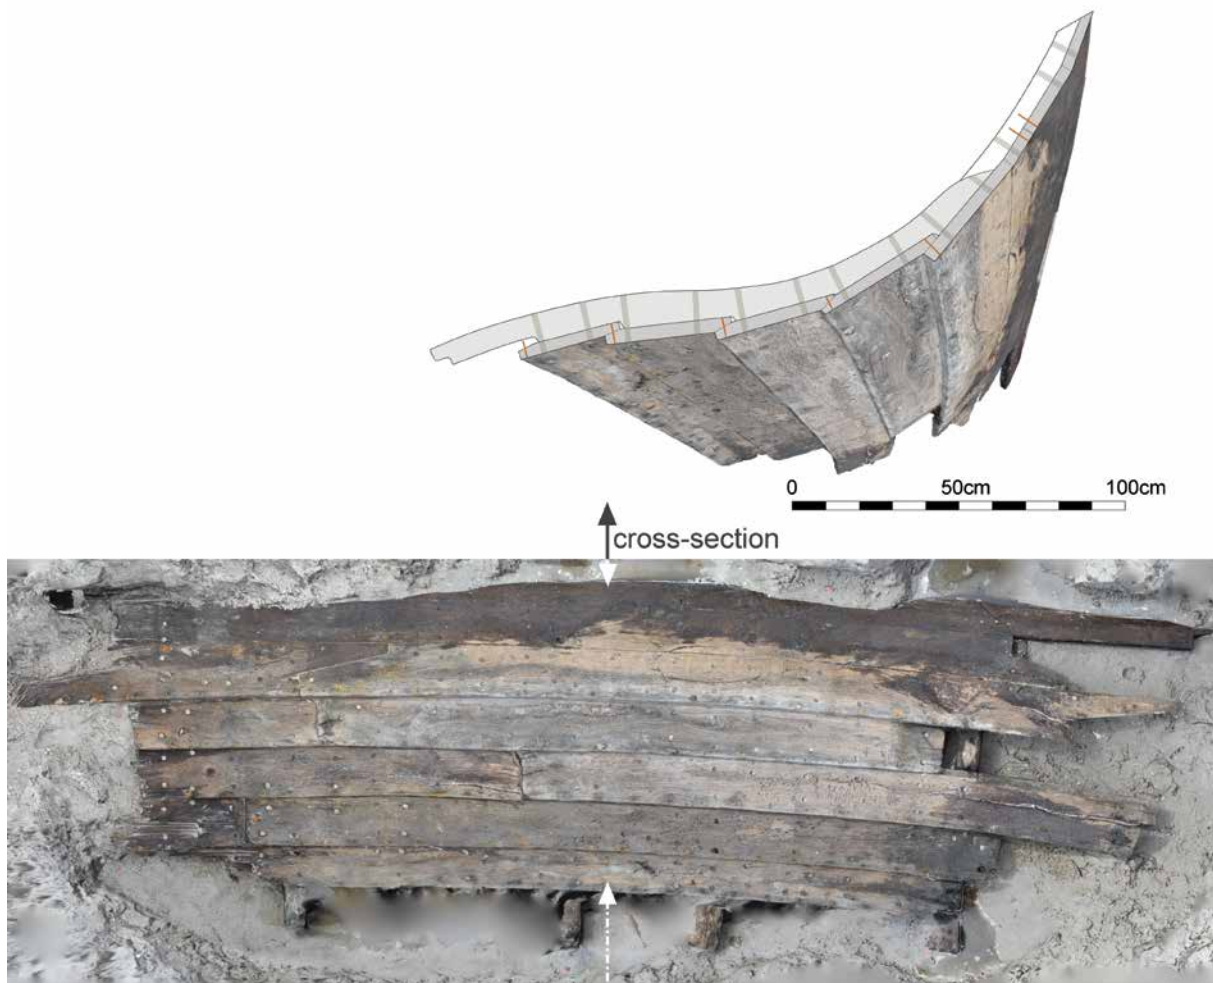
Fig. 3 The second wreck fragment (WF2) as recorded in May 2017. The orthogonal projection and cross-section view was generated as SfM-model with Agisoft Metashape on the basis of over 200 photos. The framing and fasteners were schematically added (graph: D. Zwick).

Two oblong graving pieces in the carvel planking of the second fragment were observed, which are not necessarily later repairs, but could have been inserted over a knot for watertightness.
