Documenting a 20th century wooden vessel at risk: the AGIOS SPYRIDON project

Constantinos Nicolaou – Stella Demesticha – Kostas Damianidis – Marina Faka – Massimiliano Secci – Irene Katsouri – Georgios Tzavaras – Dante Abate

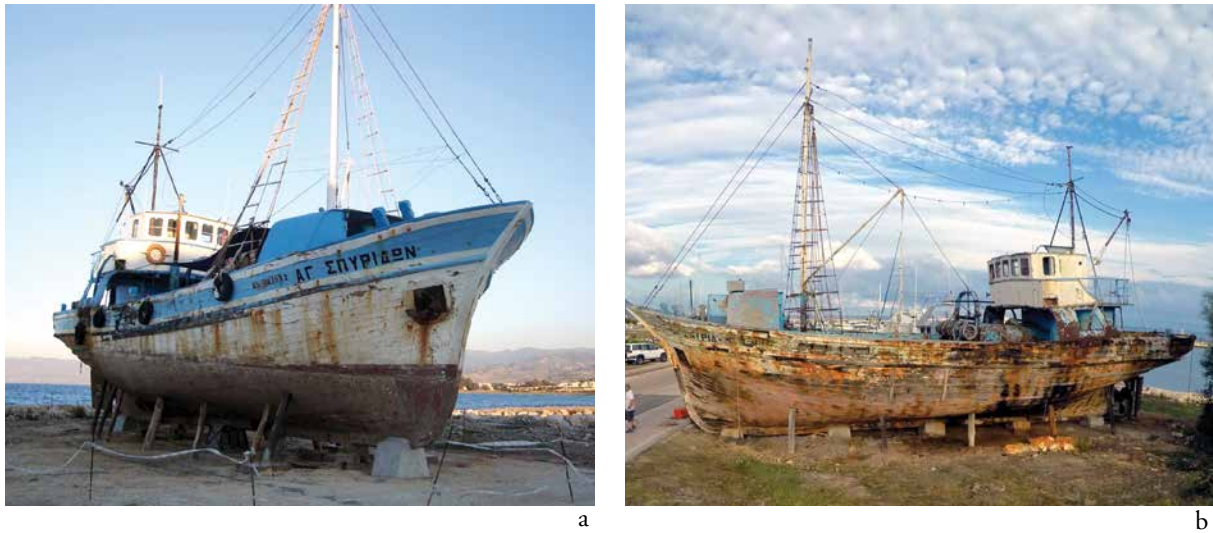
Fig. 1 The Agios Spyridon on dry land: (a) in 2006 (photo: K. Damianidis) and (b) prior to the project's commencement in 2019 (photo: © University of Cyprus, MARELab)

In 2005, after its retirement, the Cypriot Department of Fisheries allowed the Municipality of Polis Chrysochous to preserve and protect *Agios Spyridon* as a monument of vernacular maritime heritage. It was dry docked outside the marina at Latsi, Polis Chrysochous, on the northwest coast of Cyprus. The boat remained fully rigged, sitting on concrete blocks and supported on its sides with beams, without protection from the elements. As a result, the deterioration of the entire structure was a matter of time (Fig. 1). In 2018 the local municipality council concluded that the vessel had turned into a hazard and should be destroyed. The Maritime Archaeological Research Laboratory (MARELab) of the University of Cyprus took action at this point and put significant effort to raise funding for the vessel's protection. The efforts bore no fruit and a controlled destruction program was deemed the next best option. Thus, the *Agios Spyridon* project commenced in November 2019, and was funded by the Honor Frost Foundation, the Municipality of Polis Chrysochous and the Cypriot Department of Fisheries and Marine Research. It was conducted in collaboration with the Cyprus Institute, the company Blue Lines Shipbuilders, one of the oldest traditional shipwrights' families of Cyprus (NC 3), and a team of Greek specialists in wooden boat recording, led by Dr Kostas Damianidis. This paper discusses the approach that was adopted for the comprehensive documentation and the controlled destruction of the vessel.

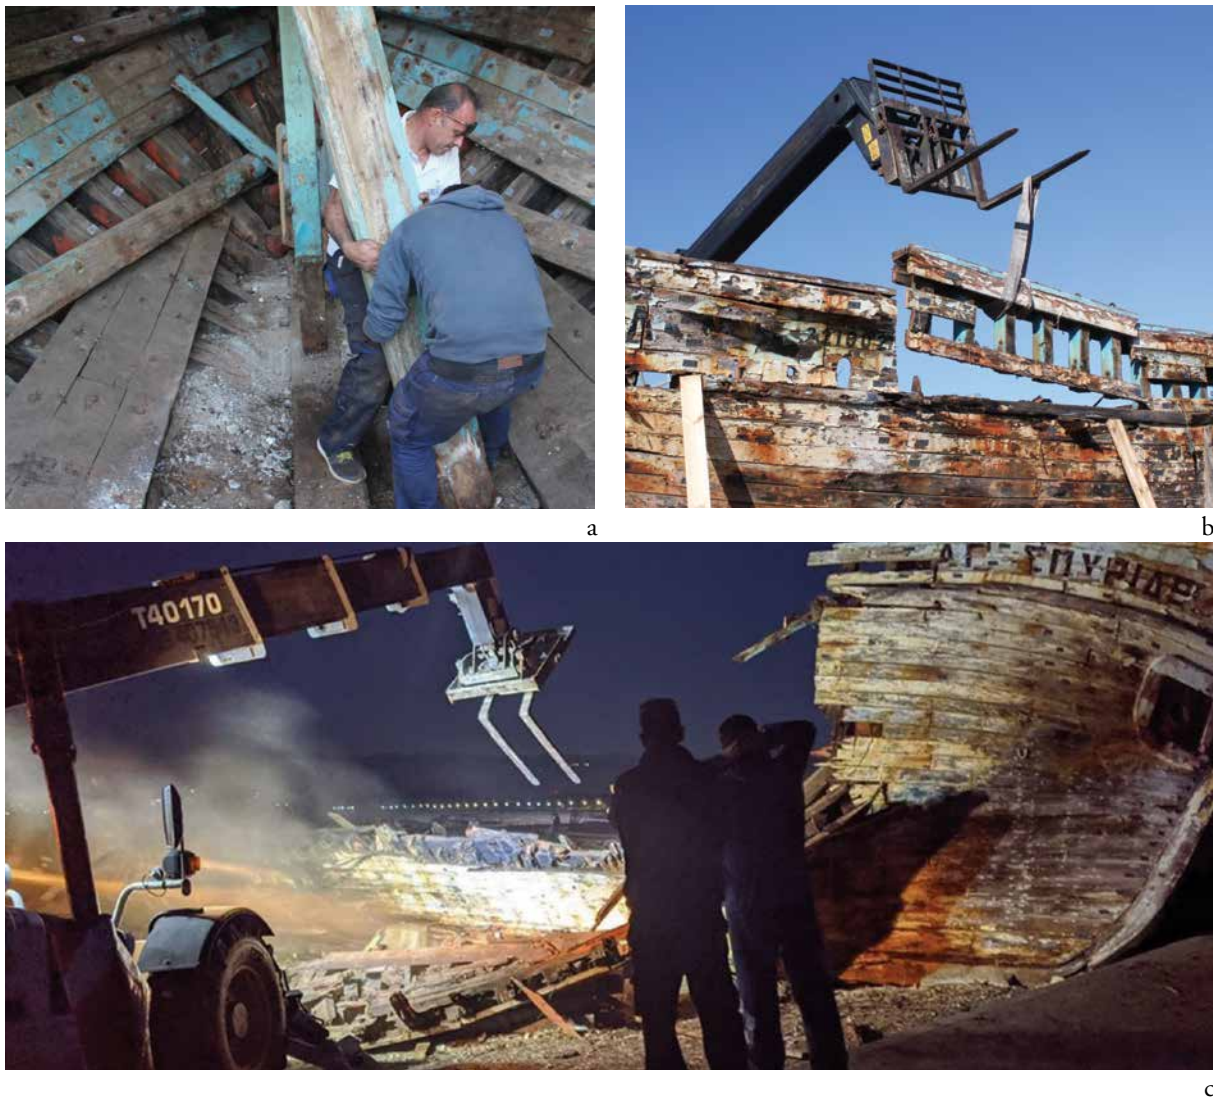
Fig. 2 Main phases of Agios Spyridon's controlled destruction a) Structural timbers being carefully disassembled. Cutting (b) and breaking (c) parts of the vessel using mechanical means and a telescopic handler (photo: © University of Cyprus, MARELab)

One of the main concerns was the selection of the technical methods and tools that should be used for the dismantling, considering the limited time available and the destructing character of the project. Three methods were used (Fig. 2): (i) careful dismantling of mechanical and fishing equipment, as well as parts of the vessel, with the use of hand tools, or electric cutting wheels for rusted bolts and joints; (ii) cutting and removing wooden parts of the vessel with the use of chain saws, and (iii) breaking large parts of the vessel with the use of a telescopic handler, by either pushing or pulling. This method was mainly used during the last phase of destruction, when the remaining parts of the vessel were considered already as disposal material.

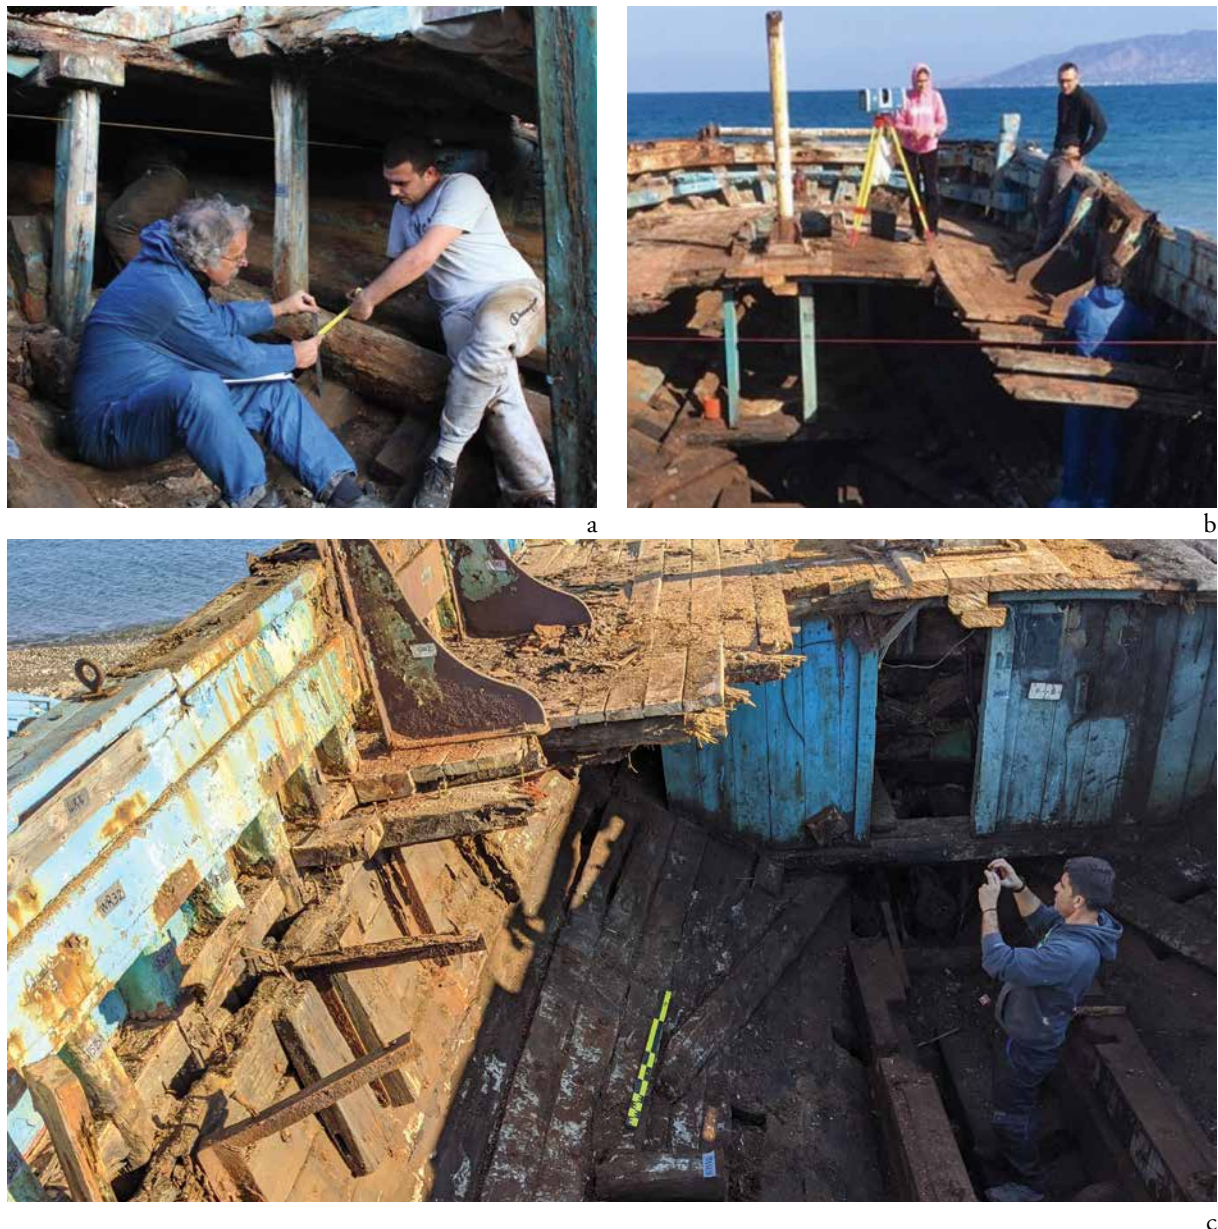
Fig. 3 The different methods of recording Agios Spyridon: a) Conventional measurements, b) Laser Scanning, and c) Photogrammetry

Throughout the destruction process, the hull together with the mechanical and fishing equipment were photogrammetrically recorded, as they were gradually exposed. Alongside the photogrammetric documentation of the interior sections and details, many measurements were taken with conventional methods. Before the final destruction, the hull was also recorded with laser scanning (Fig. 3).

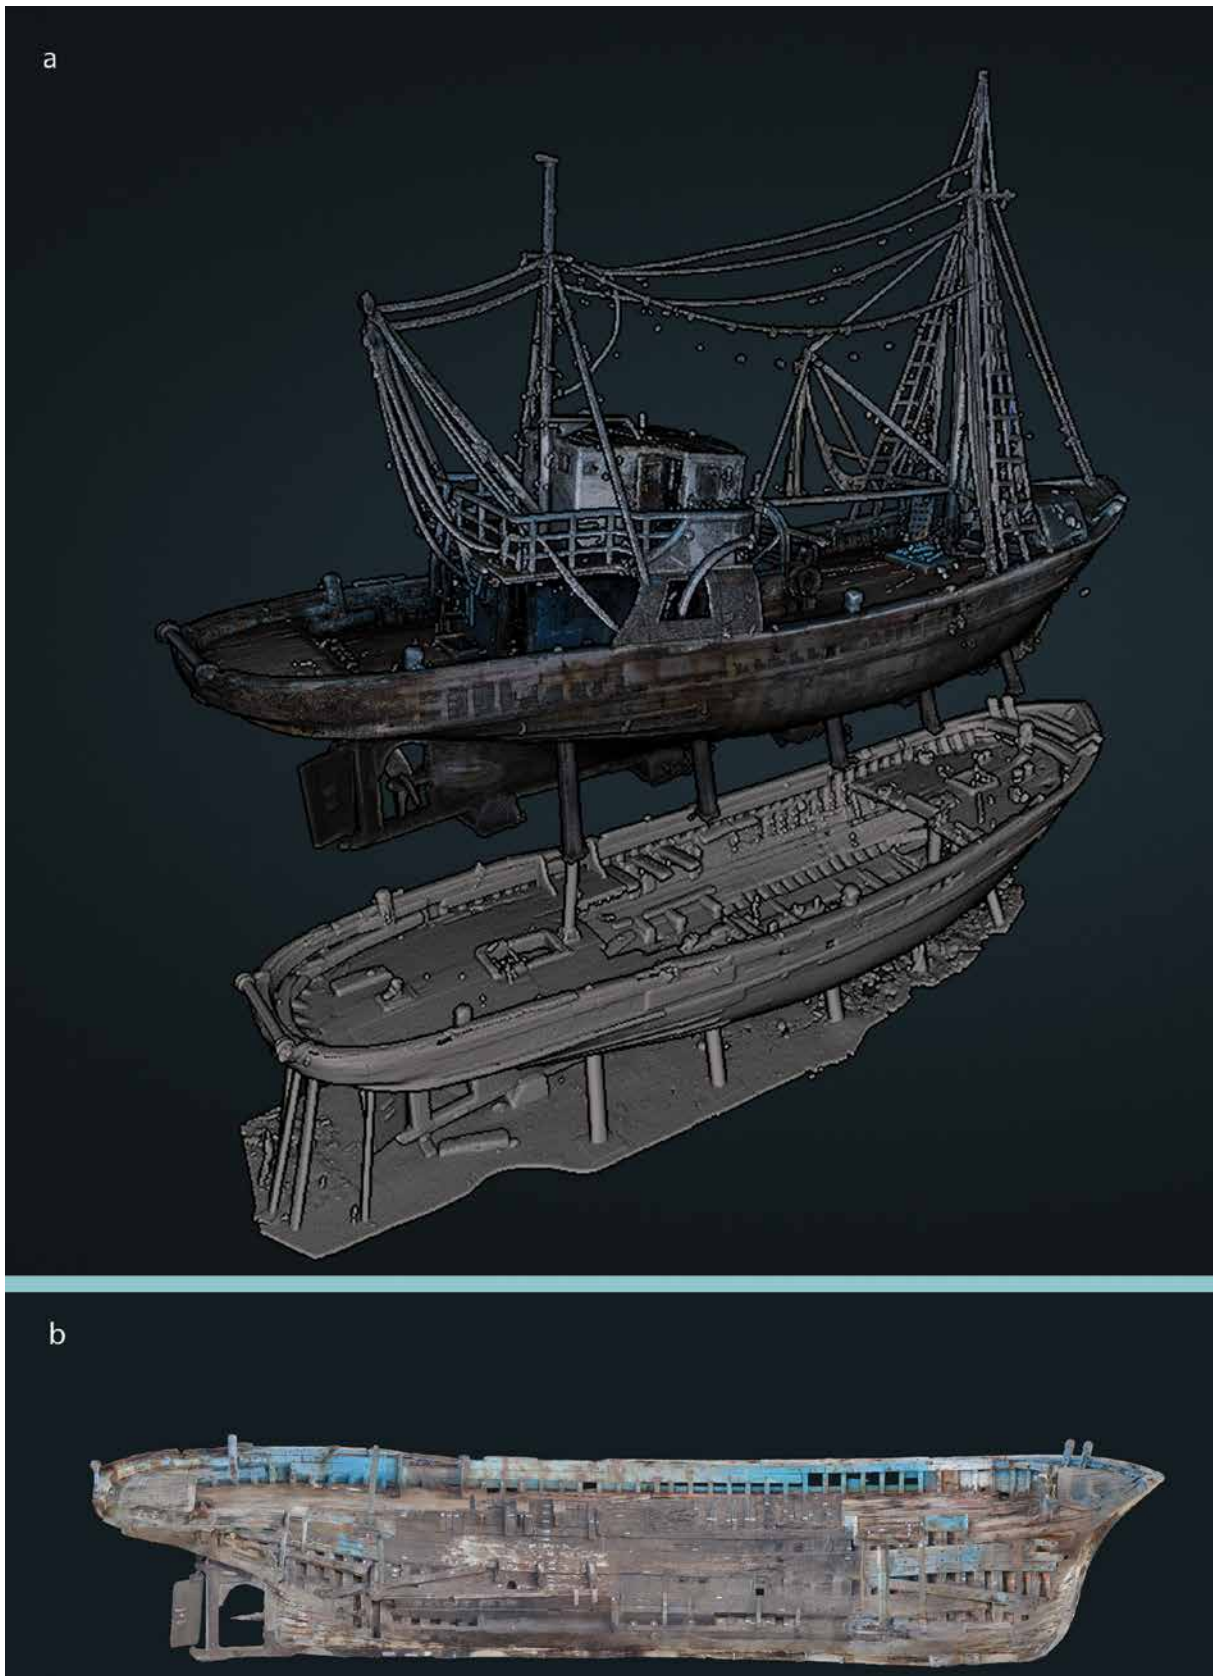
Fig. 4 The digital documentation of Agios Spyridon a) The TLS 3D models (© Cyprus Institute); b) A longitudinal section of the 3D model created from a combination of the TLS and photogrammetry point clouds (TLS © Cyprus Institute; Photogrammetry © University of Cyprus, MARELab)

The final 3D models of both seasons today available on the EpHEMERA database (Abate *et al.* 2017), were aligned in the same local reference system (Fig. 4) in order to: (i) perform a multitemporal comparison of the different epochs; (ii) analyse morphometric features of the lost structure, and (iii) extract architectural 2D drawings of the vessel.

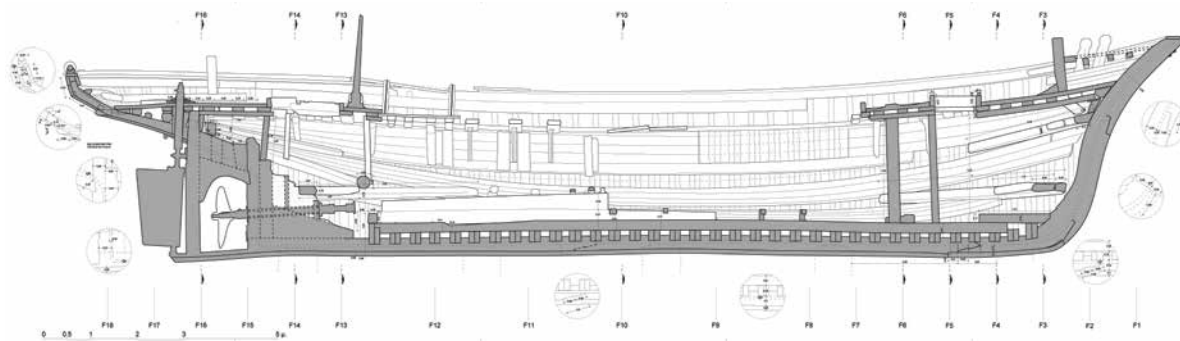
Fig. 5 Longitudinal construction section of the trawler *Agios Spyridon* (drawing: K. Damianidis, G. Tzavaras)

Agios Spyridon was one of the largest surviving wooden trawlers in Cyprus, and possibly in the eastern Mediterranean, and had preserved all fishing gear *in situ*, both on deck and in the interior. Its basic dimensions were recorded with accuracy during the project: overall length = 23.88 m; keel length = 18.8 m, maximum beam = 6.16 m; midship height = 3.26 m (Fig. 5).

The vessel had, 49 full frames from the stem to the stern post. They consisted mainly of nine pieces each, including the floor timbers, the futtocks and the top timbers. The cross section of the double frames was approximately 12 × 24 cm and the single 12 × 12 cm. The last full frame on the stern was above the vertical stern post. This is a strong structural element that supports almost all the cant frames that were placed radially behind it.

On most of the transversal sections the keel had a cross section about 17–18 cm wide × 23 cm high and the false keel 17–18 × 9 cm. The rabbet had a width of 5.5 cm. Clamps had a thickness of 11 cm and the keelson had cross sections of 28 × 21 cm amidships. The cross section of the deck beams was about 9 × 15–28 cm and the deck planking had a thickness of 4.5 cm.

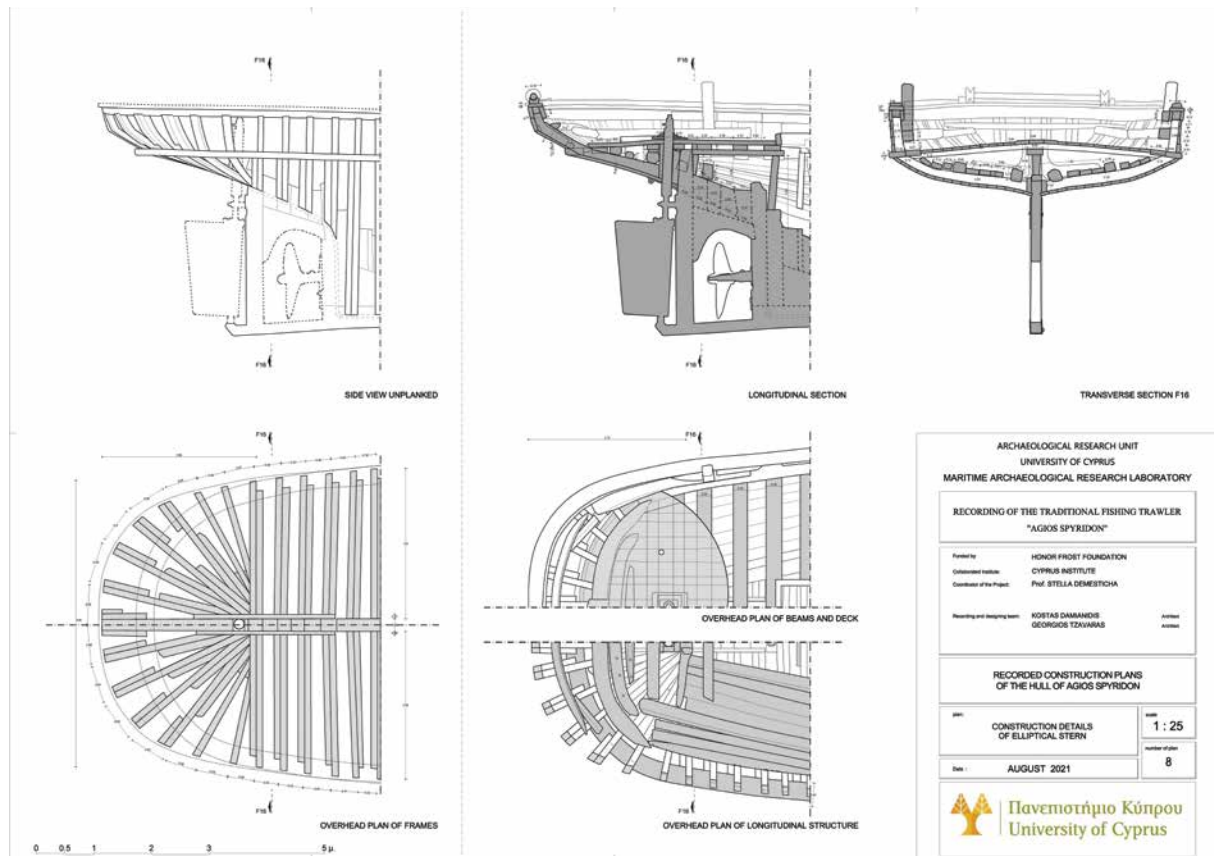
Fig. 6 Construction details of elliptical stern of the trawler Agios Spyridon (drawing: K. Damianidis, G. Tzavaras)

The elliptical stern of the vessel rested on the heavy axial structure of the lower part of the stern. The stern post consisted of two vertical pieces that stood upon the rear end of the keel. Aft of this stern post the axial structure extended with five vertical pieces; only the rear one was resting on an extension of the keel (9 × 18 cm) and the false keel (9 × 18 cm). Between the stern post and this vertical rear piece there was the opening for the placement of the propeller. Above the propeller opening, a wooden knee was fixed, and on top of it rested the other vertical pieces. Aft of this lower axial structure, there was the rudder hole and the metal rudder, were supported by two metal stays (bearings) and fastened on the axial structure. The aftermost complete frame of the skeleton together with 12 cant frames and the upper extension of the stern post comprised the skeleton of the elliptical stern. All of them were resting on the lower axial structure of the stern that is described above. The cant frames were placed radially around a centre that was located at the top of the rear pieces of the axial structure of the lower stern. They were placed at almost equal intervals, which at their top averaged 65 cm (46–69 cm). The cant frames were connected together with several curved pieces horizontally placed in a way that provided support to the structure of the aft deck and gunwale (Fig. 6).
