# Potkamenica Cove shipwreck, island of Šolta, Croatia

Maja Kaleb

**Abstract:** The remains of a shipwreck located in the Potkamenica Cove on the island of Šolta were researched, documented and protected *in situ* in 2020, one decade after its discovery. The shipwreck is gravely devastated due to uncontrolled anchoring, but parts of the keel and one side of the ship with its belonging elements, planks and futtocks are partially preserved. The ship was built using the *shell-first* technique using the distinctive assembly method of tenon-and-mortise joinery. The sinking of the ship was dated in the 4<sup>th</sup> century by using the 14C AMS method and by the comparative analysis of movable archaeological material.

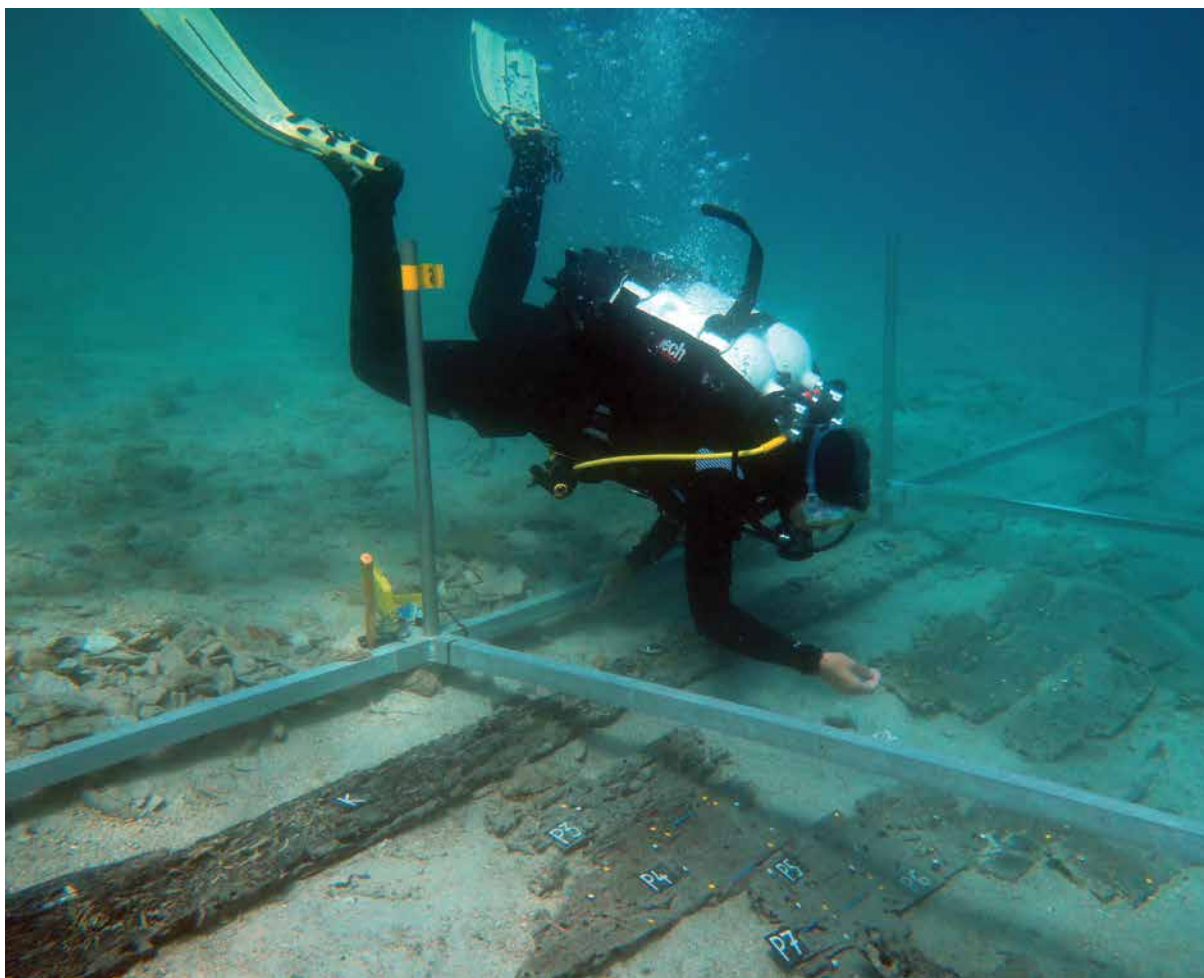
Fig. 2 Labeling of ship's structure before documenting (photo: R. Surić)

The very meagre quantity of sediment – sand and rubble – meant that the surface of the ship's structure was very quickly revealed and identified. In situ labelling of the ship's elements was initiated upon the clearing of almost the entire area of the excavated trenches. The horizontal and transverse elements of the ship were labelled (Fig. 2) with white marker on rectangular PVC labels<sup>1</sup>. The keel was designated with the letter K, with alphanumeric designators used to label the planks (P) and the frames and futtocks (F)<sup>2</sup>. Joint elements were labelled with white and yellow markers. White was used to designate the treenails used to join frames with the outside planking, and yellow to designate the pegs used to lock mortise-and-tenon joints. Butt scarfs between planks were marked with blue wire. Once all the elements were labelled, the ship's structure was photographed in detail for the production of a 3D model. A total of 500 photographic images were made, then reviewed and processed for use in the Agisoft Metashape software. The produced result is a photogrammetric 3D model and a digital orthophoto mosaic of the site (Fig. 3). Along with the digital material we also insisted on the production of technical, i.e., hand-drawn documentation. A separate plan view was drawn for each trench, later merged as a complete field drawing of the wreck. The produced drawing of the remains of the wooden structure greatly facilitated the planning of the further course of excavation work. Three profile drawings of the preserved remains of the ship were also produced ahead of the placement of markings on the ship's structure.

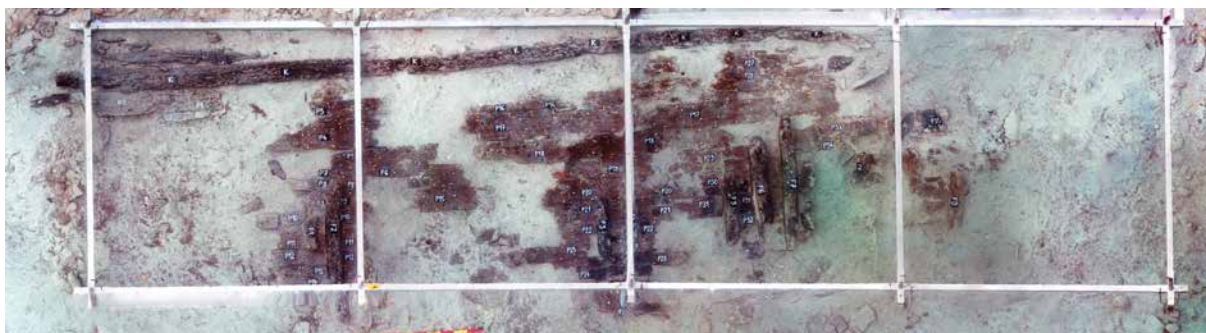
Fig. 3 Orthophoto model of ship's remains (author: R. Surić)

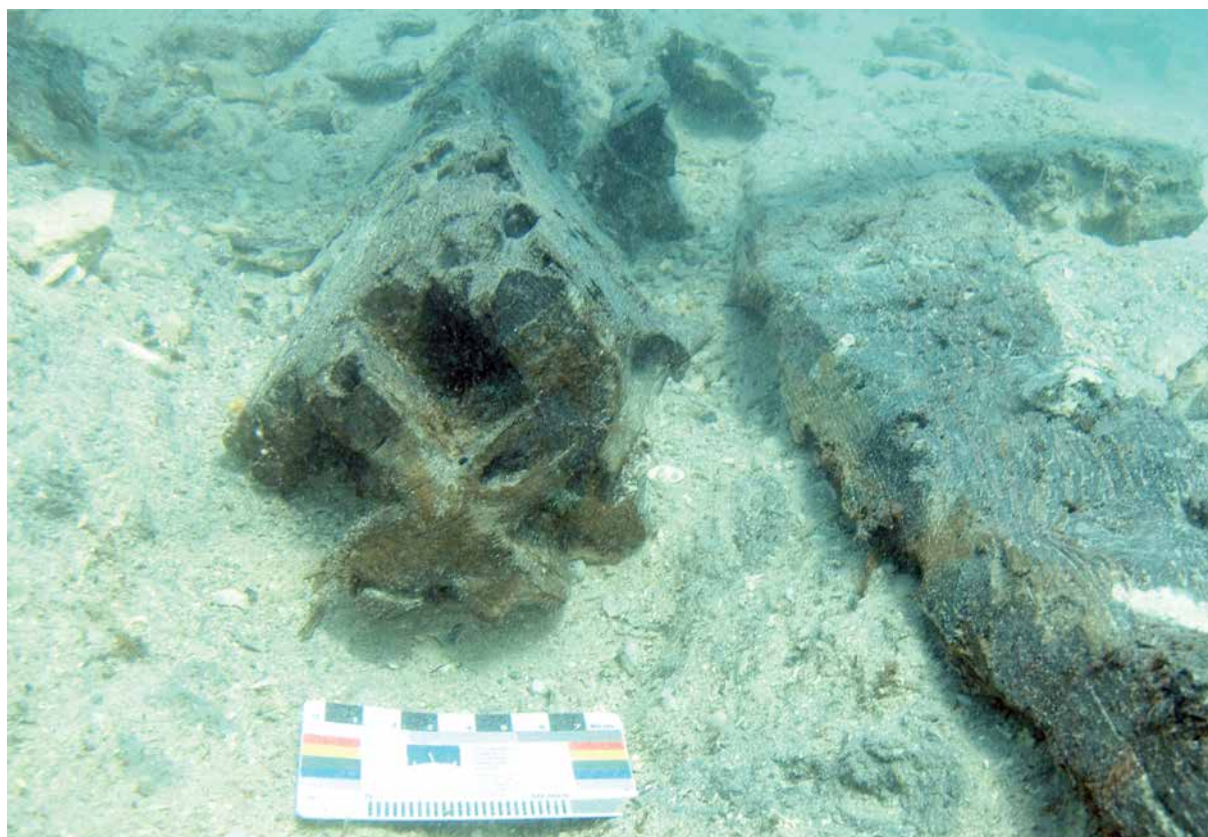
Fig. 5 Keel scarf of Potkamenica shipwreck (photo: M. Kaleb)

The ship wrecked in the waters of Potkamenica cove was built using shell-first construction technique. The outside planking, consisting of planks laid edge to edge (carvel work) with mortise and tenon joints, was built after the keel and posts had been set. The ship's keel, made of oak (*Quercus sp.*), is preserved to a length of 5.9 m. The maximum preserved keel height (moulded dimension) is 18 cm, and the width (sided dimension) is 17 cm. The section is rectangular, with no visible rounding of the edges. The keel was not found in situ, rather overturned to the south with its topside lying on the garboard strake. Although it is likely that the garboard planks were joined to the keel by a system of mortise and tenon joints, as seen in the example of the Marausa wreck (Tiboni, Tusa 2016: 242) and the Monaco A wreck (Pomey, Kahanov, Reith 2012: 247), there are few material remains that might confirm this. At one end of the preserved part of the keel we see a scarf (Fig. 5), a joint used to connect two timbers or planks (Radić Rossi 2015: 445), e.g., two parts

of the keel, or the keel to the stem and/or the sternpost (Markovina, Ukalović 2010: 111). We know of a number of scarf variants (Markovina, Ukalović 2010: 111; Bernardi 1964: Figs. 15, 16, 17; Steffy 1994: 292–293), but the scarf joint most similar to the one at Potkamenica is seen on the Monaco A wreck in France (Pomey *et al.* 2012: 246, Fig. 14), with a three-part hook scarf locked with a large bolt.
