Clinker & carvel. A mid-16th century wreck find from Terschelling, the Netherlands

Alice Overmeer – Thijs Coenen – Heidi E. Vink

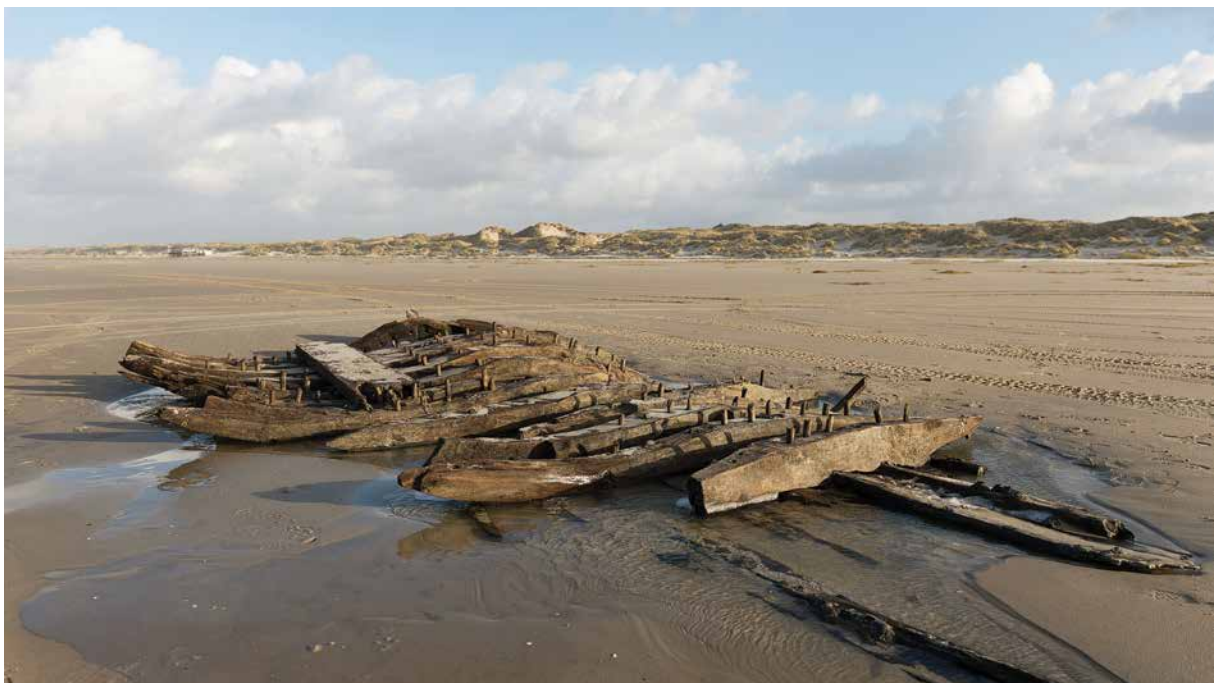
Fig. 2 The shipwreck on the day of the discovery, on the North Sea beach of Terschelling (photo: S. Kok, ROSE photography, Terschelling/Omrop Fryslân)

Beachcombing has been a tradition in the Dutch coastal communities for centuries, especially on the Dutch Wadden islands. After every northwesterly storm, locals roam the beaches for washed up goods and driftwood, to use as building materials or for decorating their houses and gardens. Often single ship timbers are discovered, but sometimes more substantial wreck parts emerge on the shore. After a storm in February 2022, a large hull fragment from a wooden ship was discovered on the North Sea shore of Terschelling, between two kilometre markers on the beach, *Paal* (Post) 9 and 10 (Fig. 1, Fig. 2).

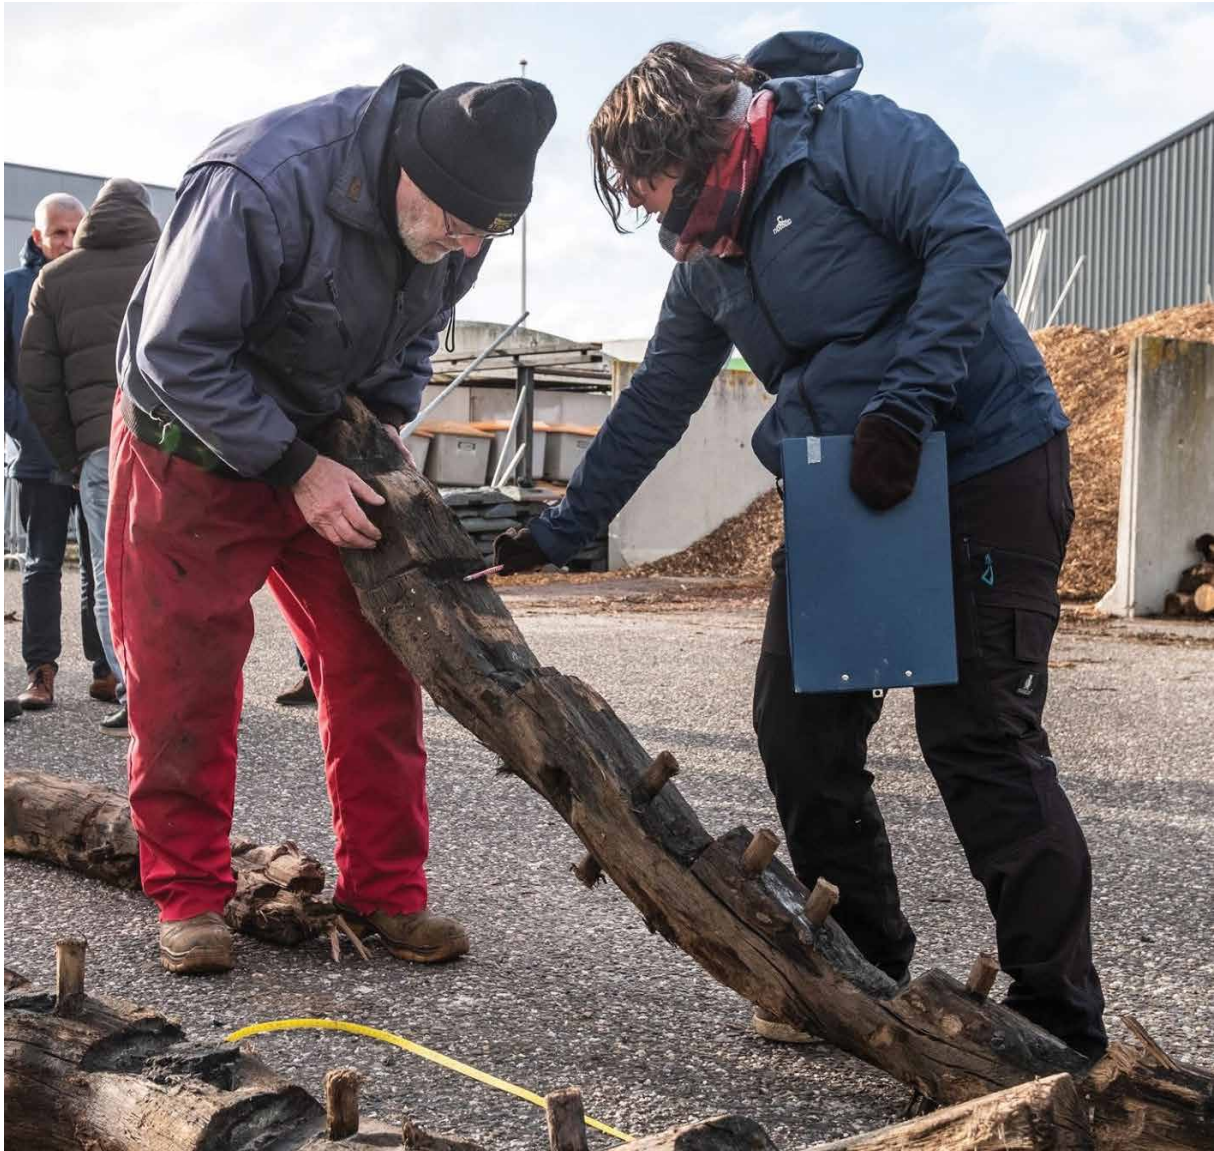
Fig. 3 Manual documentation of the remaining wreck parts (photo: L. Conijn, Laura Conijn Fotografie, Terschelling)

A single day was available for recording all the wreck parts. Therefore, the focus was on obtaining information on the size, building details, and preservation of the timbers. The primary method of documentation was 3D-photogrammetry. In addition, the wreck parts were manually documented through measuring, sketching, and describing the parts (Fig. 3).
