ARHEOLOŠKO ISTRAŽIVANJE NA LOKALITETU JEZERA – CRIKVINA NA SJEVERNOM VELEBITU

Archaeological excavations at
the site of Jezera – Crikvina in
northern Velebit

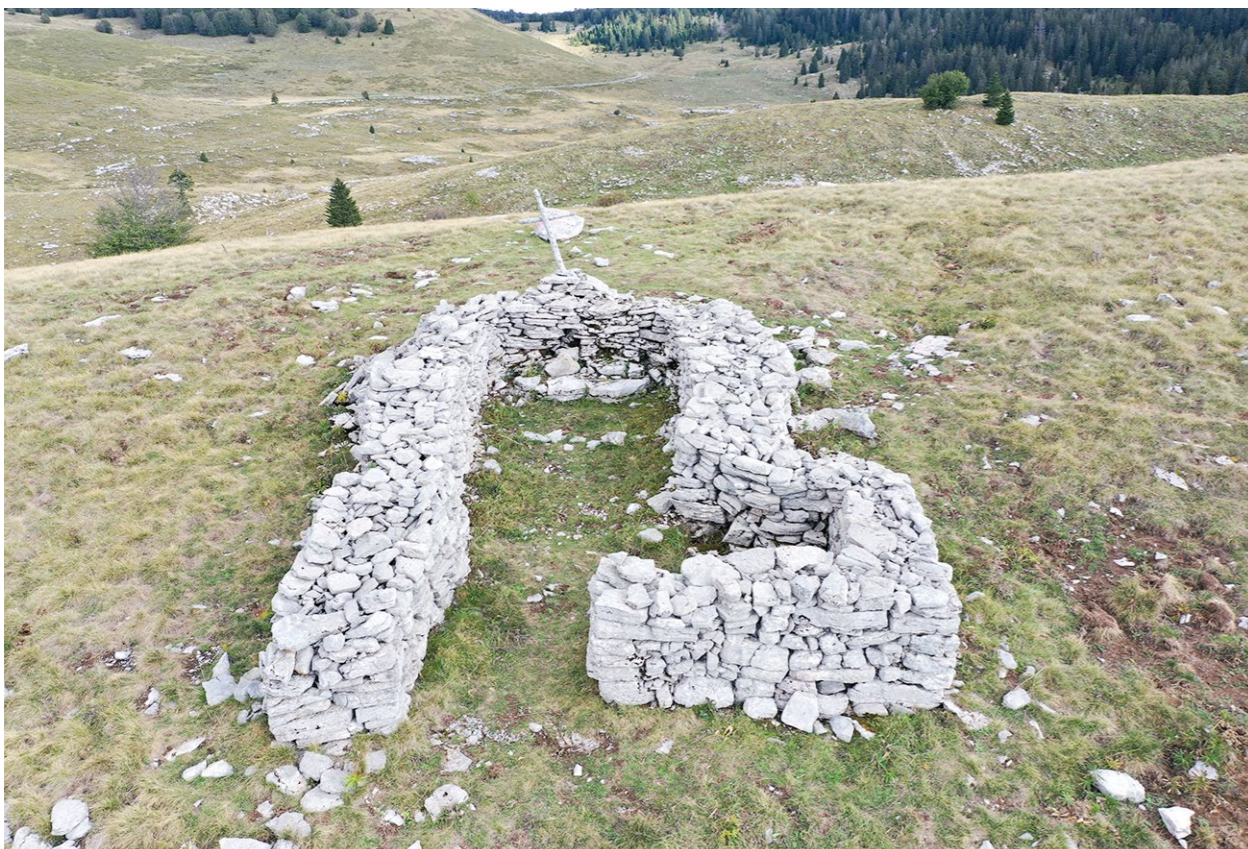
... Lokalizet Crikvina na Jezerima (foto: V. Glavaš)
 ... The site of Crikvina in Jezerima (photo: V. Glavaš)

The site is located at 1470 masl, on the Jezera glacial plateau, former high-mountain pasture of the residents of Primorje and Krasno. According to oral tradition, "Greeks" once lived in Jezera, and the dry stone wall structure of Crikvina is associated with the remains of their church (Glavičić 1968: 282; Pleterski 2009: 30). The building, measuring 10.4 x 7.5 m, was built of platy limestone using the dry stone wall technique. The building

consists of the main area and an extension on the southwestern side to the right of the entrance. Inside the building, bedrock was used for the altar.

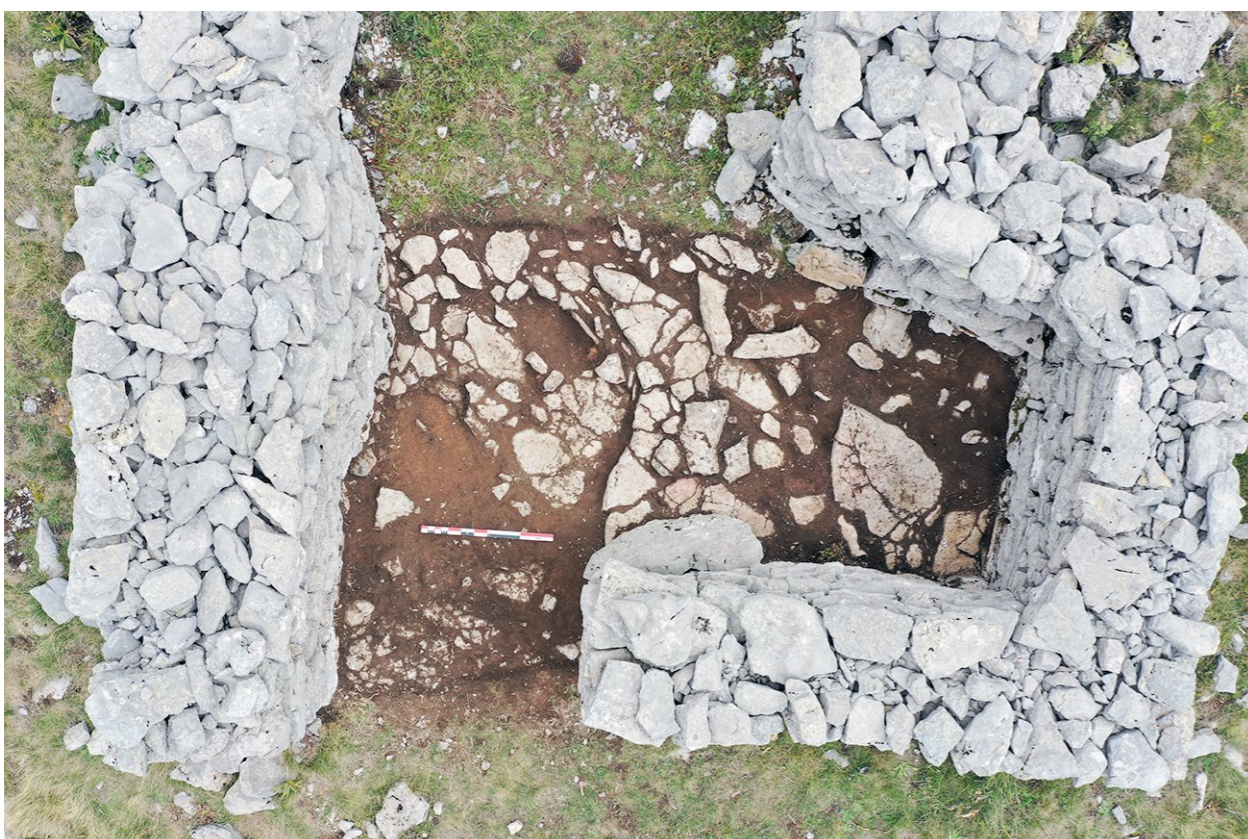
... Ostatci popločanja SJ3A (foto: V. Glavaš)
 ... Remains of the paving SU3A (photo: V. Glavaš)

I u ovoj istraživačkoj kampanji potvrđeno je postojanje popločanja objekta (SJ3A) koje je ustanovljeno i u ranijim istraživanjima. Popločanje se rasprostire po središnjem dijelu objekta, a potpuno

This research campaign attested the existence of the paving of the building (SU3A), which was

also found in the earlier excavations. The paving spreads over the central part of the building, and is completely absent at the entrance. In many places, bedrock was used instead of slabs.
