# ISTRAŽIVANJE I VAĐENJE OSTATAKA DVAJU SREDNJOVJEKOVNIH BRODOVA U RABU

Research and extraction  
of the remains of two medieval  
ships in Rab

**Irena RADIĆ ROSSI**  
irenaradicrossi@gmail.com

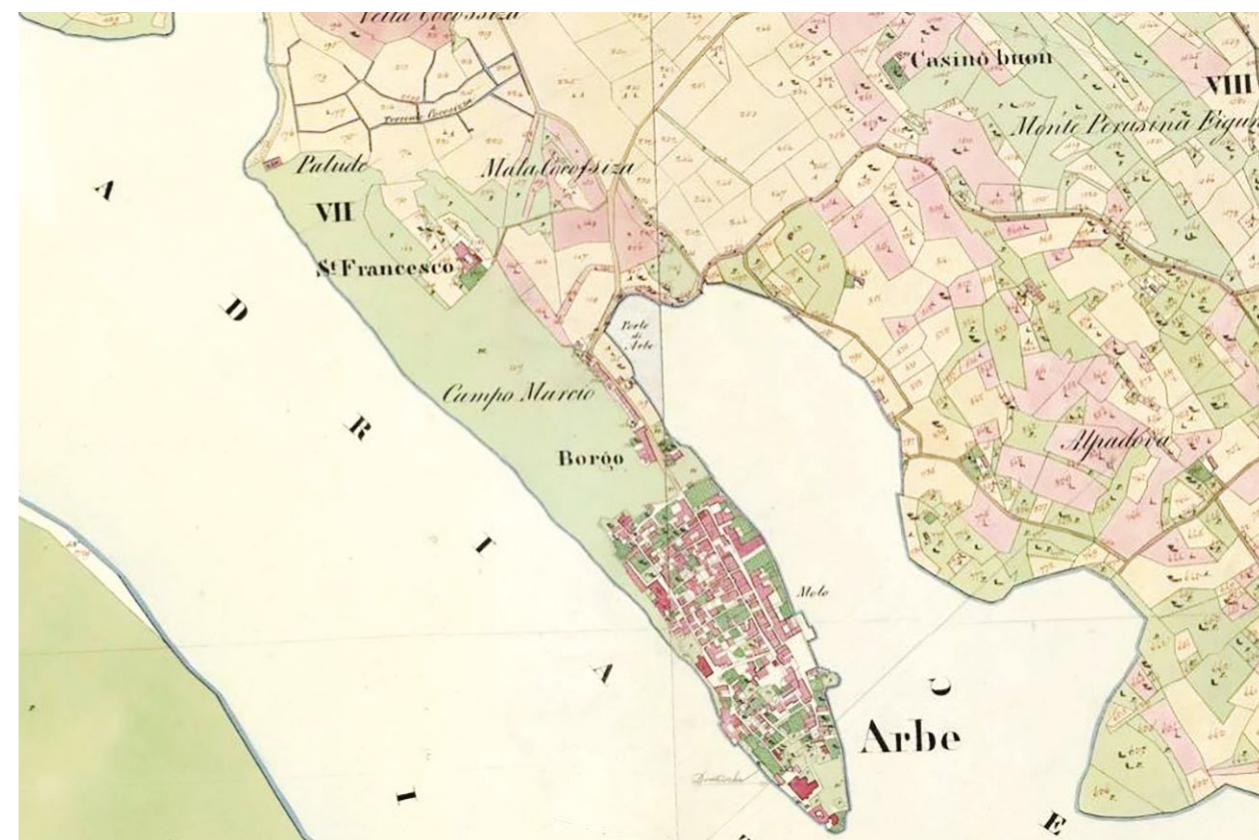
Izvadak iz austrougarskog katastarskog plana iz 1828. godine, s označenom lukom na sjeveroistočnom kraju (<https://maps.arcanum.com/en/map/cadastral>)  
Segment of the Austro-Hungarian cadastral map from 1828, with the port marked at the north-eastern end (<https://maps.arcanum.com/en/map/cadastral>)

Na tom mjestu tijekom druge polovice 20. stoljeća izgrađen je hotel Istra, koji je nedavno srušen kako bi se na njegovu mjestu izgradio hotel Mareta. Riječ je o prostoru nekadašnje rapske luke koja je još postojala tijekom prve polovice 19. stoljeća. Na karti Habsburške Monarhije, izrađenoj tijekom vojnog snimanja 1869. – 1887., vidi se već izgrađena obala, a prostor nekadašnje luke potpuno je zatrpan (<https://maps.arcanum.com/en/map/thirdsurvey25000/>).

In the second half of the 20th century, Hotel Istra was built on that site, but it was recently demolished to make way for Hotel Mareta. It is the area of the former port of Rab, which still existed during the first half of the 19th century. On the map of the Habsburg Monarchy, made during a military survey in 1869 - 1887, one can see the coast already built, and the area of the former port completely buried (<https://maps.arcanum.com/en/map/thirdsurvey25000/>).

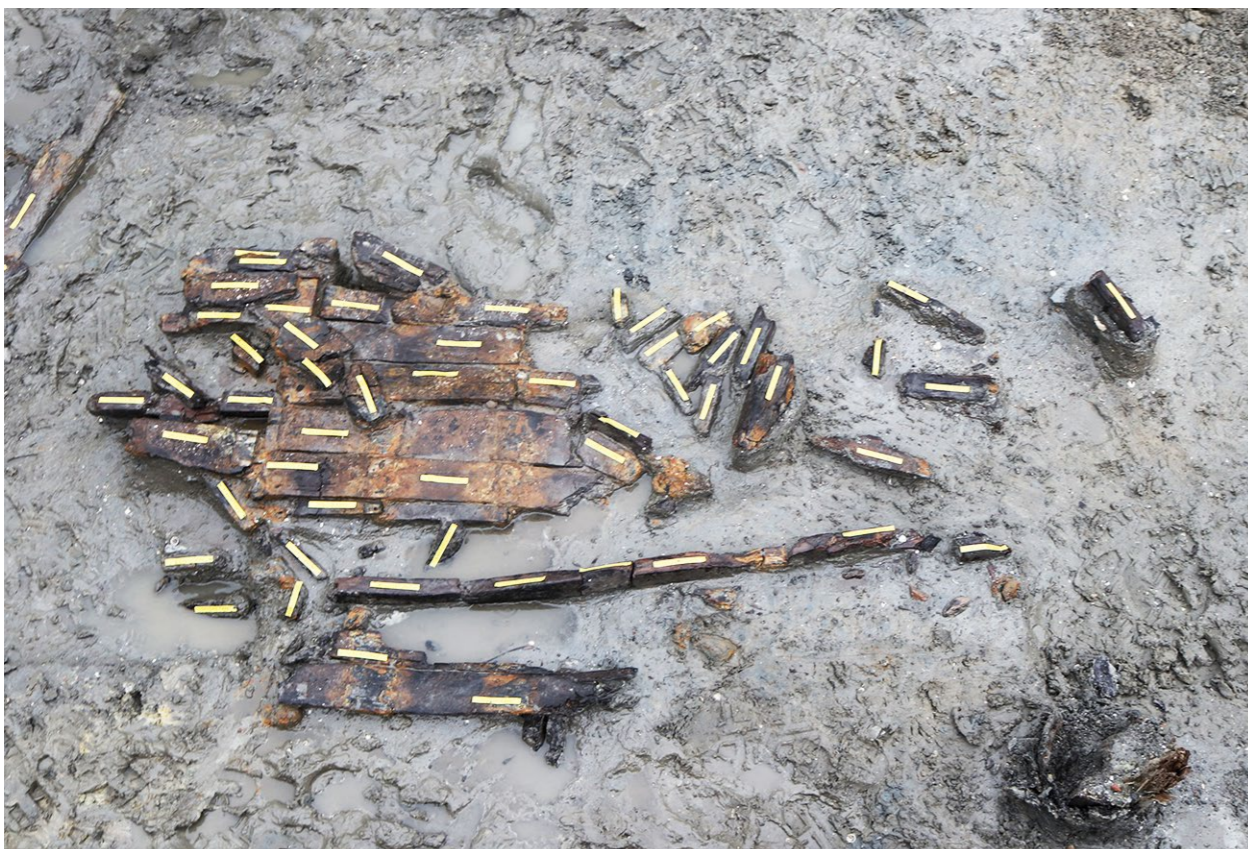
Ostatci broda Rab 2 (foto: A. Mitrović)  
Remains of ship Rab 2 (photo: A. Mitrović)

RAB.2\_2022\_T01 – RAB.2\_2022\_T035,<sup>1</sup> nakon čega je konstrukcija zaštićena geotekstilom u očekivanju dokumentiranja i vađenja. Ono što se na osnovi oskudnih ostataka moglo primijetiti činjenica je da je brod vjerojatno izgrađen bez središnje kobilice koja je zamijenjena kobilicom platicom, a nakon izrade brodske oplata s donje su strane pričvršćene dvije bočne grede koje su služile za stabilizaciju broda na plitkim pješčanim obalama otoka Raba.

brought to an end successfully. The research began with the removal of the surface layer of earth, simultaneously in the area of both ships. During the first week, ship Rab 2 was completely cleaned. The preserved wooden elements are marked with the marks RAB.2\_2022\_T01 – RAB.2\_2022\_T035<sup>1</sup>, after which the structure is protected with geotextile pending documentation and extraction. What could be noticed on the basis of the scarce remains is the fact that the ship was probably built without a central keel, which was replaced by a keel plank, and after the construction of the ship's planking, two side beams were attached to the bottom, which served to stabilize the ship on the shallow sandy shores of the island of Rab.

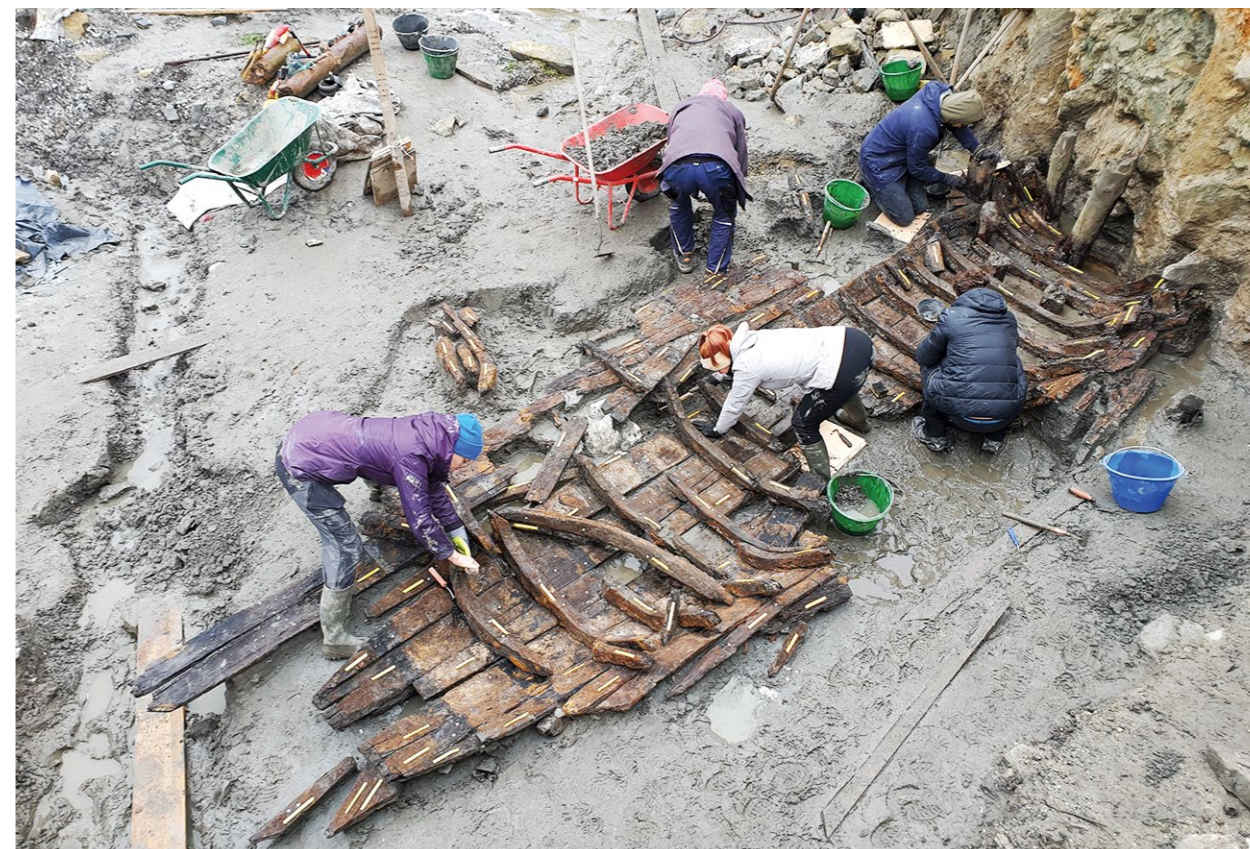
Čišćenje broda Rab 1 (foto: I. Radić Rossi)  
Cleaning of ship Rab 1 (photo: I. Radić Rossi)

južne strane, oko sredine broda, nalazi se veliko oštećenje uzrokovano djelovanjem bagera. Čitava je konstrukcija izrađena pomoću rebrenica i rebrenih nastavaka koji su u stražnjem dijelu broda pričvršćeni uz dijelove rebrenica prema krmu, a u njegovu prednjem dijelu uz dijelove rebrenica prema provi. I u slučaju broda Rab 1 utvrđeno je kako je pri njegovoj izgradnji centralna kobilica zamijenjena kobiličnom daskom, a dvije bočne gredice poslužile su za stabilizaciju brodske konstrukcije.

discovery of several groups of olive pits right next to the ship's structure, which are most illustrative of the use of the ship in the daily life of the medieval inhabitants of Rab. The structure has been preserved from the stern to the nineteenth frame towards the bow, where, unfortunately, it was interrupted by a concrete fill that supports a concrete fence beam. Extensive damage caused by the action of the excavator was recorded around the middle of the ship on its southern side. The entire structure is made by using floor timbers and futtocks that are attached to the parts of the floor timbers towards the stern in the rear part of the ship, and to the parts of the floor timbers towards the bow in its front part. In the case of ship Rab 1 as well, it was established that during its construction, the central keel was replaced by a keel plank, and the two side beams were used to stabilize the ship's structure.

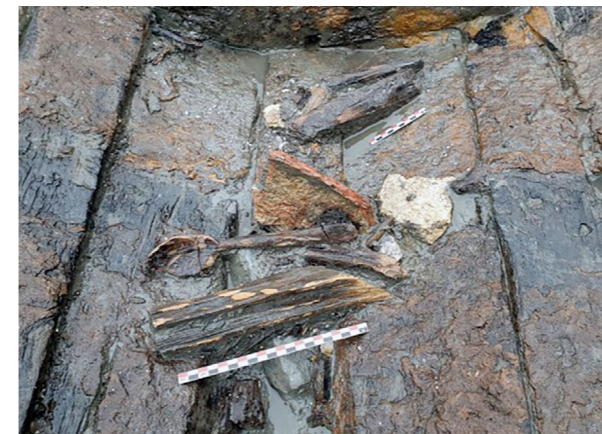
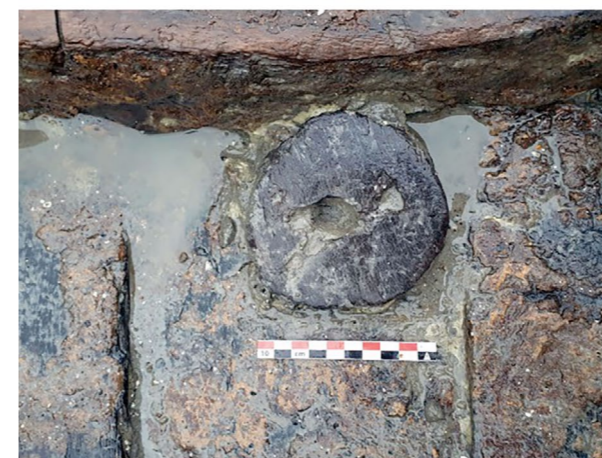
a) Drvena žlica pronađena u blizini rebra RAB.1-2022-F 01; b) Drveni kolotur pronađen u blizini rebrenog nastavka RAB.1-2022-Fu 02 S (foto: I. Radić Rossi)  
 a) Wooden spoon found near frame RAB.1-2022-F 01; b) Wooden pulley found near futtock RAB.1-2022-Fu 02 S (photo: I. Radić Rossi)

Tijekom čišćenja konstrukcije broda Rab 1 u kremenom je dijelu pronađena jedna dobro očuvana drvena žlica, a dio manje žlice pronađen je i u skupini granja iza oštećene krme. Nešto dalje prema pramcu pronađen je i drveni kolotur promjera desetak centimetara. Osim toga, vrijedi istaknuti i pronalazak nekoliko skupina koštica maslina tik uz brodsku konstrukciju, koje najrječitije svjedoče o korištenju broda u svakodnevnom životu srednjovjekovnih stanovnika Raba. Konstrukcija je očuvana od krme do devetnaestog rebra prema provi, gdje je, nažalost, prekinuta betonskom ispunom koja podržava betonsku ogradnu gredu. S njezine

During the cleaning of the structure of ship Rab 1, one well-preserved wooden spoon was found in the stern part, and part of a smaller spoon was also found in a cluster of branches behind the damaged stern. A little further towards the bow, a wooden pulley with a diameter of ten centimeters was also found. Furthermore, it is worth highlighting the
