# RANI NOVOVJEKOVNI BRODOLOM KOD RTA RATCA NA OTOKU KOLOČEPU

## Postmediaeval shipwreck off Cape Ratac at the island of Koločep

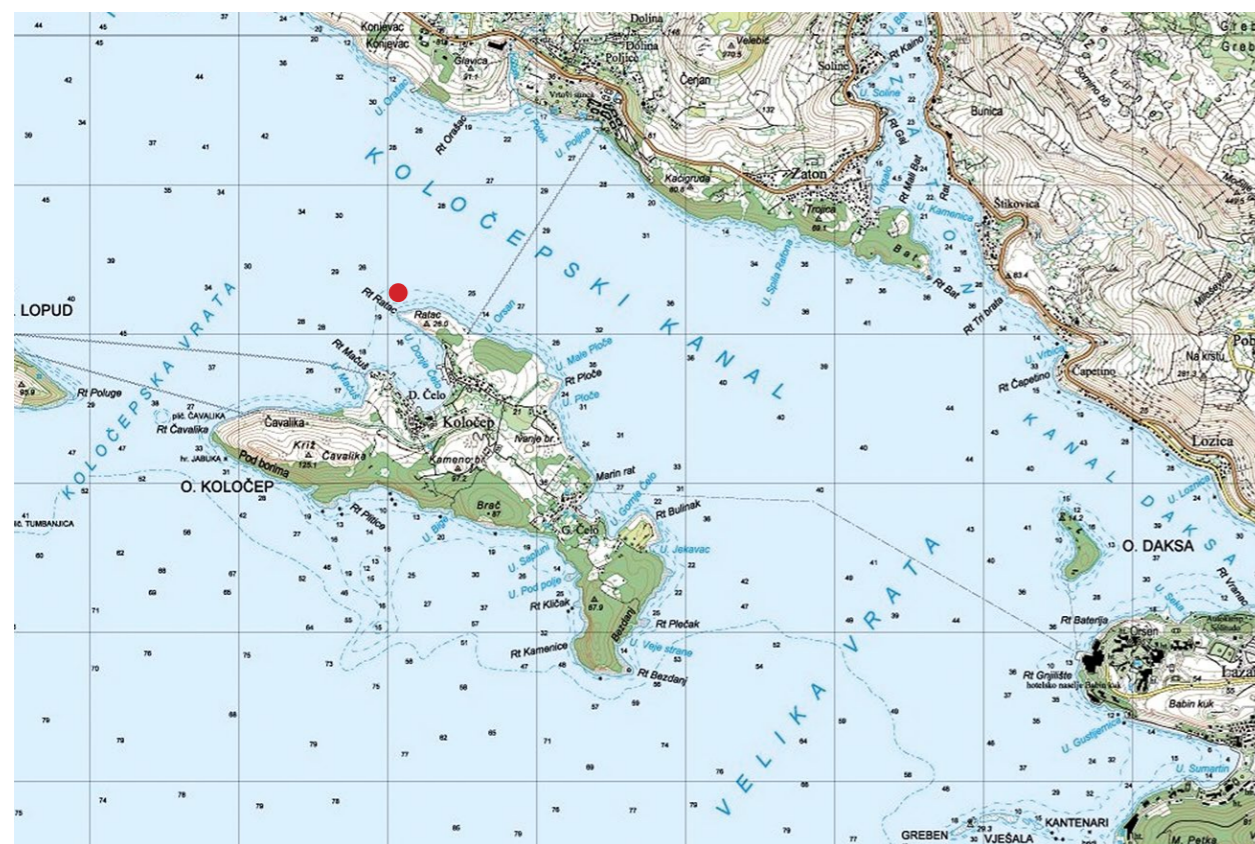
..... Položaj nalazišta kod rta Ratac na otoku Koločepu  
 ..... Location of the site off Cape Ratac at the island of Koločep

The wreck is located off Cape Ratac, approximately 150 meters from the tip of the cape toward the centre of the Koločep Channel. The seabed is partially rocky before transitioning into a sandy plain covered with seagrass. The remains of the wreck lie at a depth of about 20 to 22 meters, and the scattered surface finds cover an area of approximately 8 by 21 meters. One iron gun was recorded at the southern end of the site, while five others were found in its northern section. Across large areas between the guns are rows of rectangular window panes, coils of metal wire and sheet metal, fragments of glass and ceramic vessels, and clusters of corroded metal tools, suggesting they were once stored in wooden, crate-like containers. It is well-documented that the site has been heavily looted. During this destruction, at least one small bronze *petriere*-type cannon was recovered. Six similar guns, now exhibited in the Tower of St. Francis on the Dubrovnik Walls, were once purchased by the Society of Friends of Dubrovnik Antiquities. While it is suspected that they may also originate from this shipwreck, this cannot be confirmed at present.

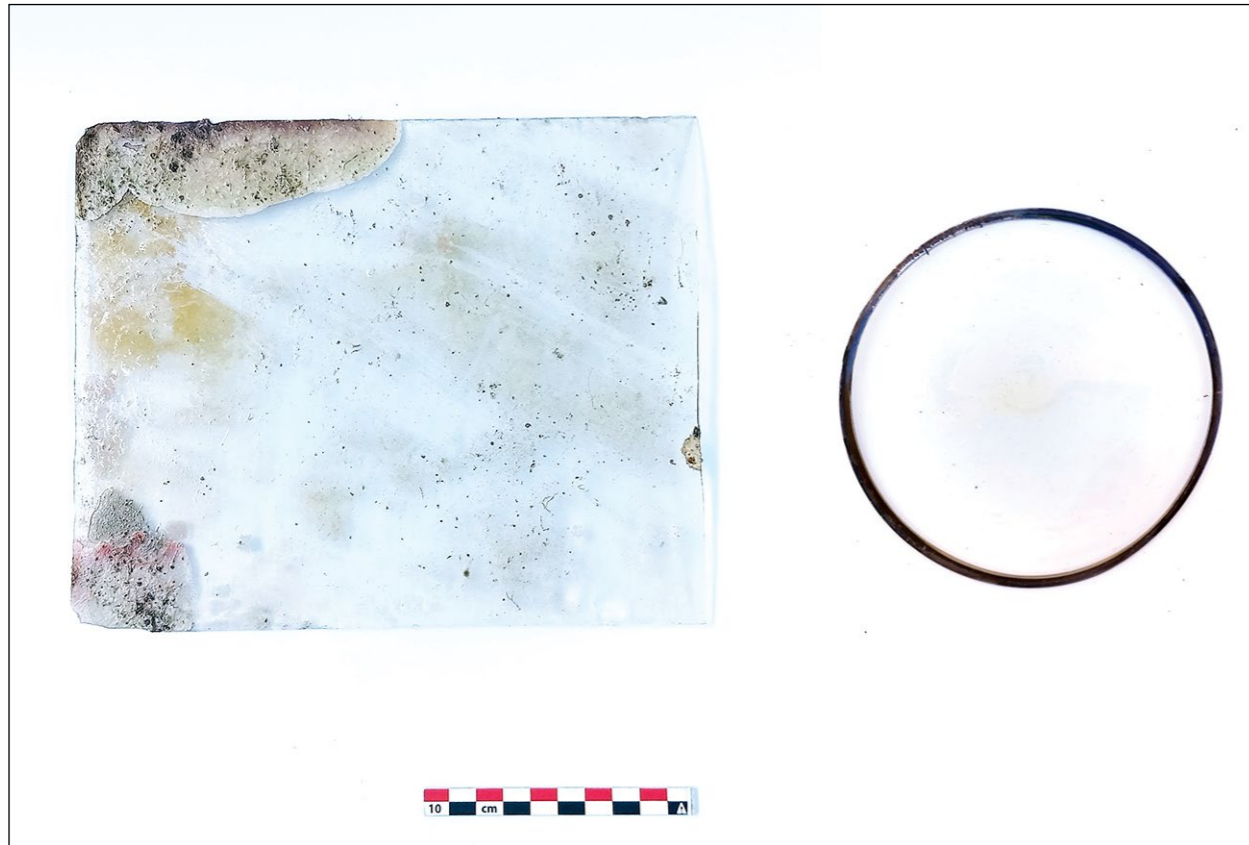
Četvrtasta i okrugla prozorska stakla iz broskog tereta (foto: A. Lucchini)  
Square and round window panes from ship's cargo (photo: A. Lucchini)

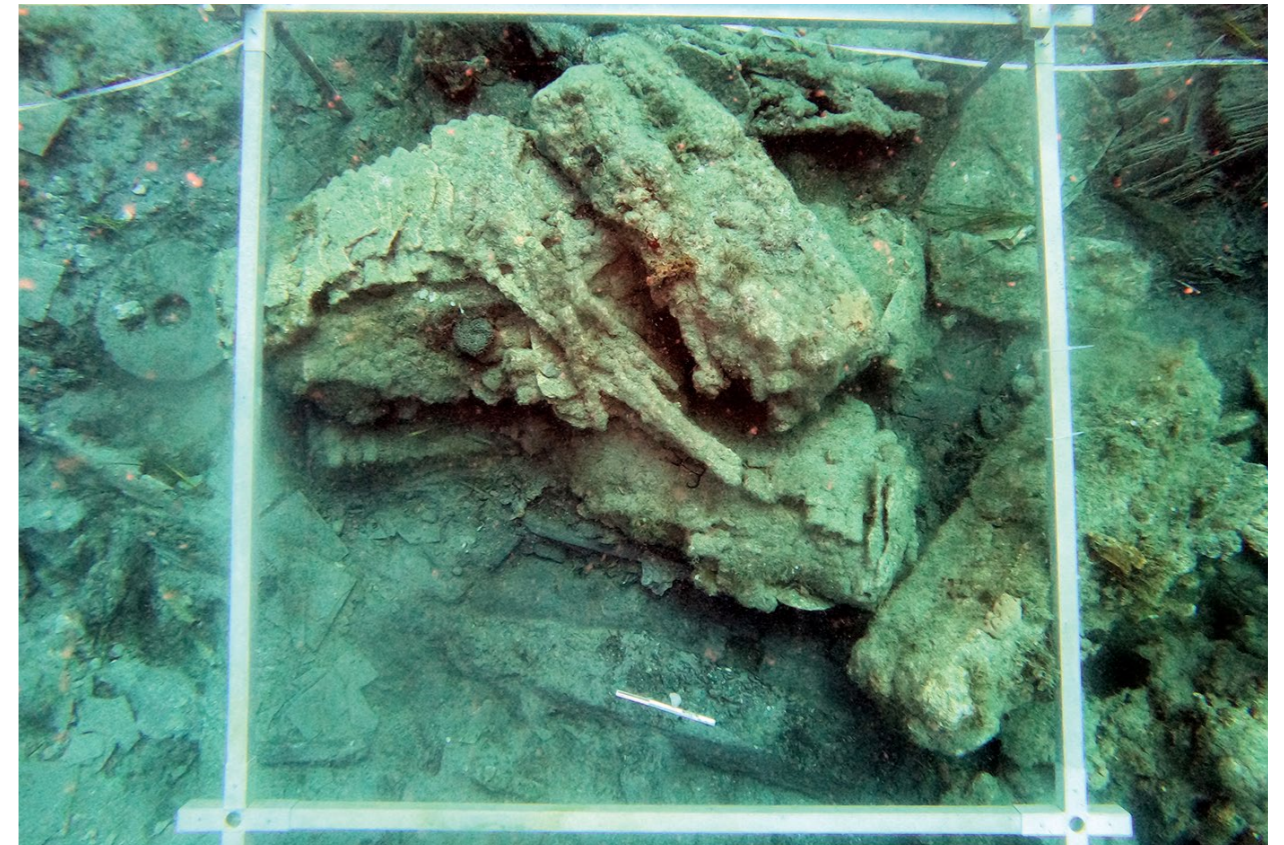
Situacija u kvadratu D7; korodirani ostaci sadržaja sanduka nad pretpostavljenom temeljnicom jarbola (foto: I. Radić Rossi)  
Situation in square D7; corroded remains of the contents of the crate above the presumed mast step (photo: I. Radić Rossi)

window panes. Relatively well-preserved parts of the ship's structure were discovered in squares D7, E7, D8 and E8. For now, it seems that the mast step has been preserved, from which, the ship's frames and planking extend in a westward direction. A smaller part of the frames has also been preserved in eastward direction, but on that side the ship's structure has been destroyed. Across the entire surface of the site, partially preserved ceramic and glass vessels were found within the surface layer. In the central section, as previously mentioned, several clusters of corroded objects were identified. Their shapes suggest they were originally stored in wooden containers, which have since decayed. Additionally, round coils of sheet metal or a similar material were also discovered in this area. In the northern part of the site, a larger concentration of thicker sheet metal plates and wire was observed,

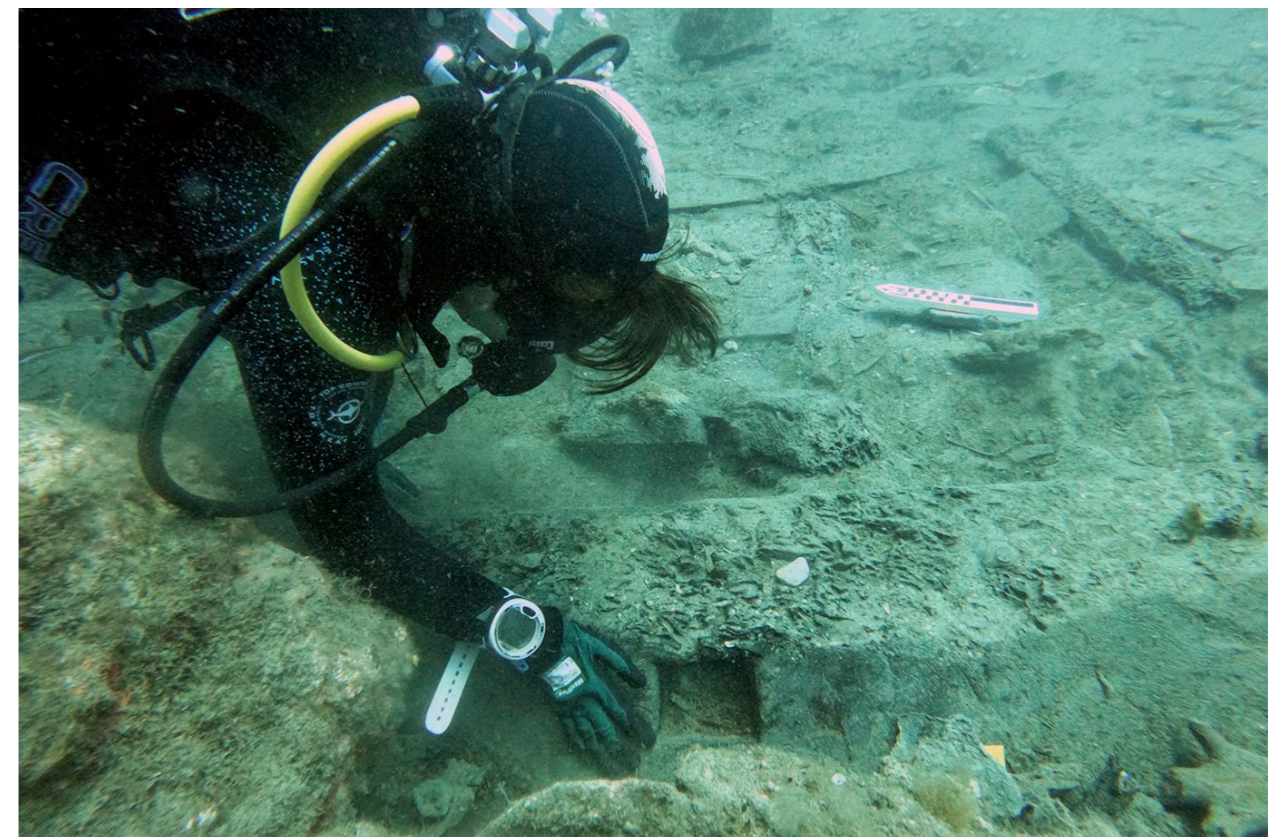
Dio masivne temeljnice jarbola pod korodiranim ostacima sadržaja sanduka (foto: P. Bojakowski)  
Part of the massive mast step under the corroded remains of the contents of the crate (photo: P. Bojakowski)

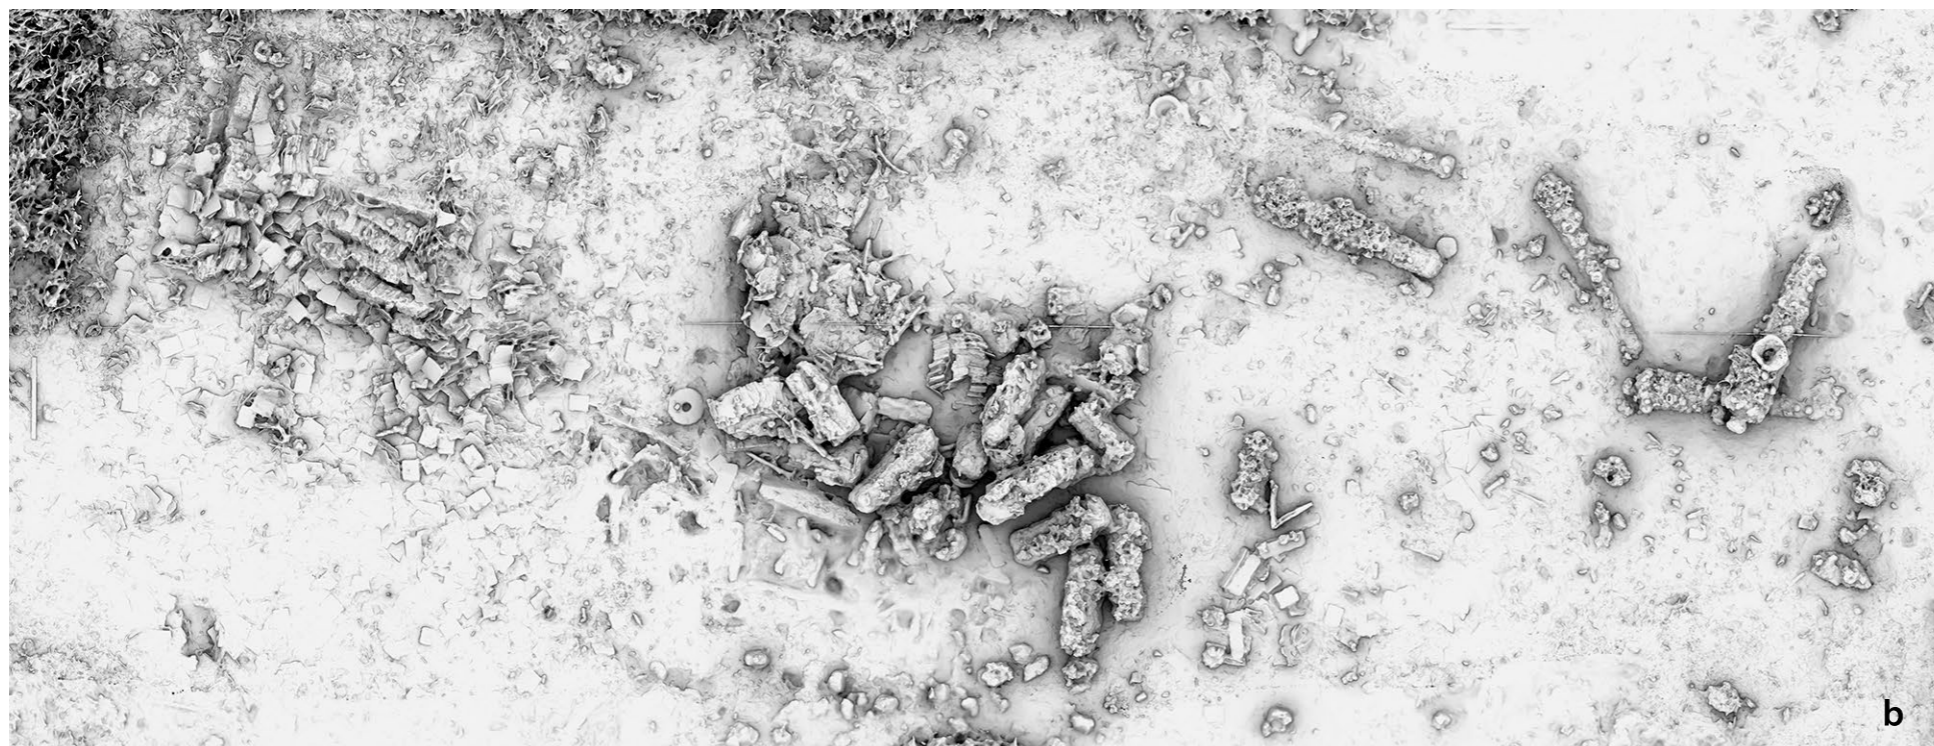
a) Ortomozaik iz virtualnog 3D modela nalazišta; c) CB verzija ortomozaika (video: I. Radić Rossi; model: K. Yamafune)  
a) Orthomosaic from the virtual 3D model of the site; c) BW version of the orthomosaic (video: I. Radić Rossi; model: K. Yamafune)

Po završetku istraživanja čitavo je nalazište fotogrametrijski snimljeno za potrebe izrade virtualnog 3D modela te pokriveno geotekstilom kako bi se usporilo propadanje nalaza od organskih materijala i pokušalo zaustaviti daljnju devastaciju. Iako nije riječ o nekoj učinkovitoj zaštiti od pljačke, dosadašnje iskustvo s nalazištima kojima se posvećuje odgovarajuća pozornost pokazalo je kako se devastacija smanjuje ili gotovo u potpunosti nestaje u slučaju da se o nalazištu vodi odgovarajuća briga.

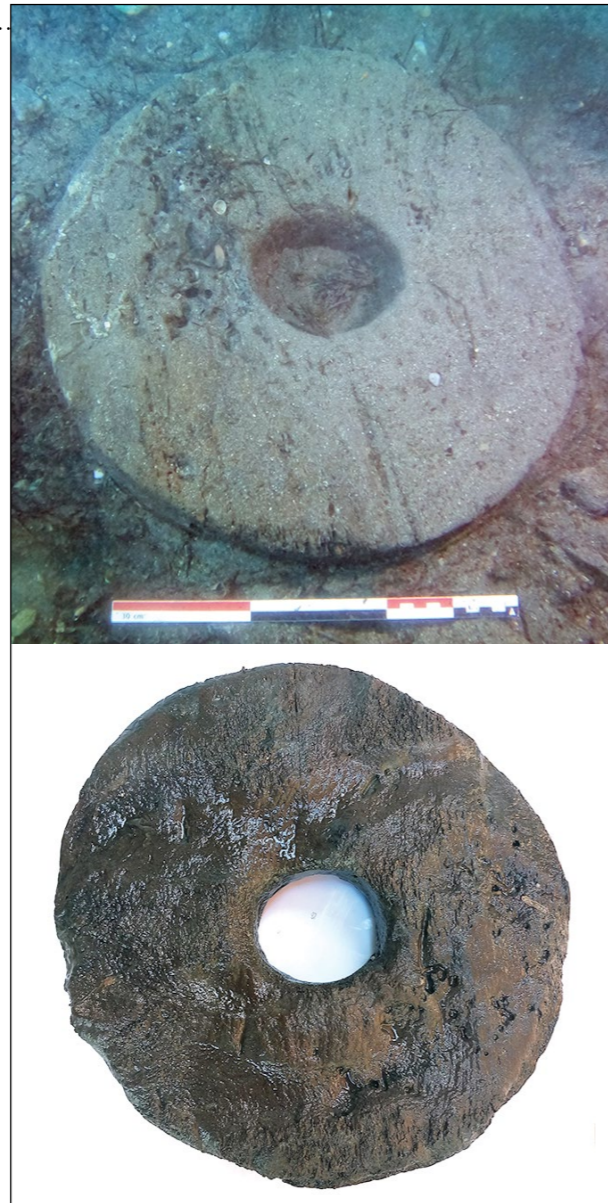
a) Drveni kotač na morskom dnu (foto: I. Radić Rossi);  
 b) Drveni kotač izvađen iz mora; promjer  
 oko 45 cm (foto: A. Lucchini)  
 a) Wooden wheel on the seabed (photo: I. Radić Rossi);  
 b) Wooden wheel recovered from the sea;  
 diameter about 45 cm (photo: A. Lucchini)

rijala. U sjevernom dijelu nalazišta uočena je veća količina debljih limenih ploča i žice, a pojavljuju se također četvrtasta prozorska stakla raznih veličina. U kvadratu D12 pronađen je potpuno očuvan manji drveni kolot (promjer 26 cm), vjerojatno kolotura, a u kvadratu D6 pronađen je jedan potpuno očuvan veliki drveni kotač promjera oko 45 cm, koji možda pripada postolju topa.
