A mid-16th century carvel-built ship from Mukran, Jasmund-Peninsula, island of Rügen, Germany

Mike Belasus – Jens Auer – Konstantinos Alexiou

Abstract: The 16th century ‘Mukran wreck’ is one of the earliest carvel-built ships found in Germany. Naval armament found in the vicinity of the site and traces of fire within the remains may relate the wreck to a hostile encounter between a joined squadron of Danish vessels and ships from the Hanseatic town of Lübeck with Swedish ships in 1565 during the Nordic Seven Years’ War (1563–1570). In 2016 and 2017 a detailed investigation and recording of the wreck was carried out. The wreck represents an important source for the understanding of the development of carvel shipbuilding in northern Europe.

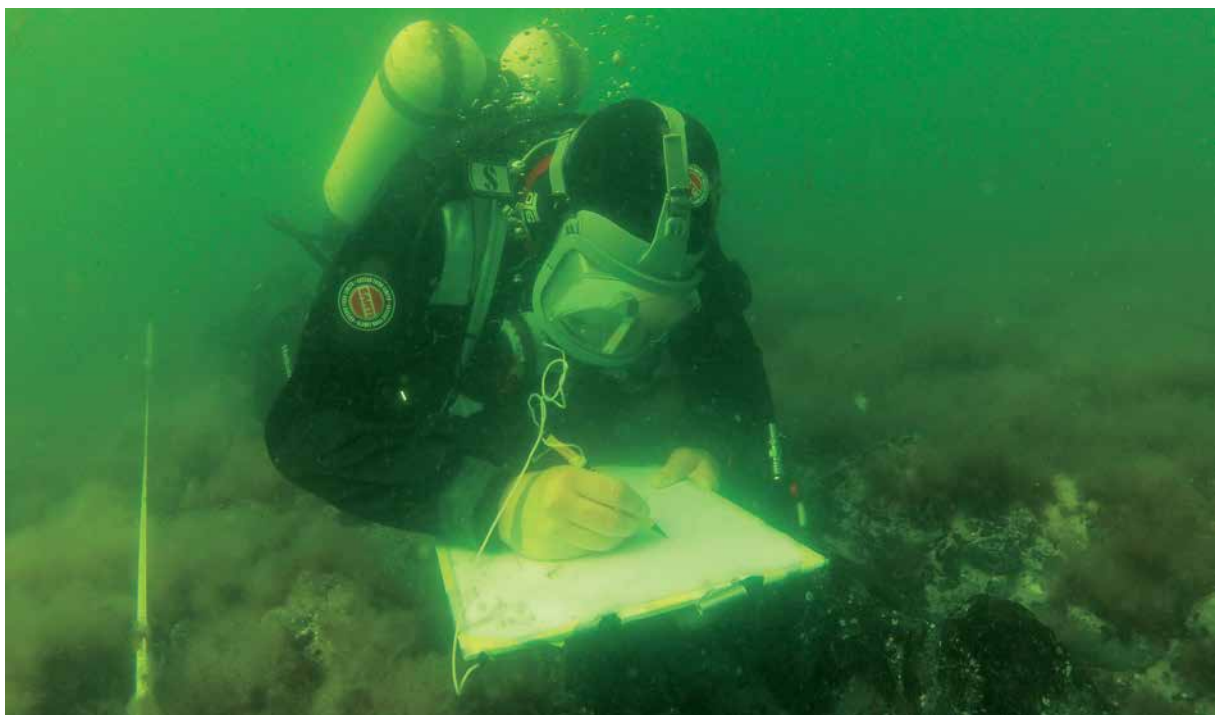
Fig. 2 Diver on the exposed wreck in about 3 m of water (photo: SDU MAP)

In the shallow water of the exposed East coast of the island, the lower part of the hull survived with almost no sedimentation cover (Fig. 2). The bottom of the ship is preserved over a length of 17.6 m and a width of 6.4 m in 3 m of water. It lies in approximate East-West orientation with the bow pointing to the West. While the keel still exists over its full length, only the lower remains of the stem and stern post assemblies are preserved *in situ*. The floor timbers still cover the lower part of the turn of the bilge, with remains of ceiling planking on both sides of the heavily eroded keelson, which is covered by a mix of ballast and local stones. Eight strakes of the outer planking are preserved on both sides of the keel. Framing timbers survive at 21 frame-stations, but are mostly eroded or missing in the more exposed aft part of the vessel (Fig. 3). Most of the surviving components are made from oak. Exceptions are some of the filler planks between the stringer-like ceiling planks, which are made from pine (*pinus spec.*) and fir (*abies spec.*). Selected samples of trenails also confirm the use of pine, fir and willow (*salix spec.*).

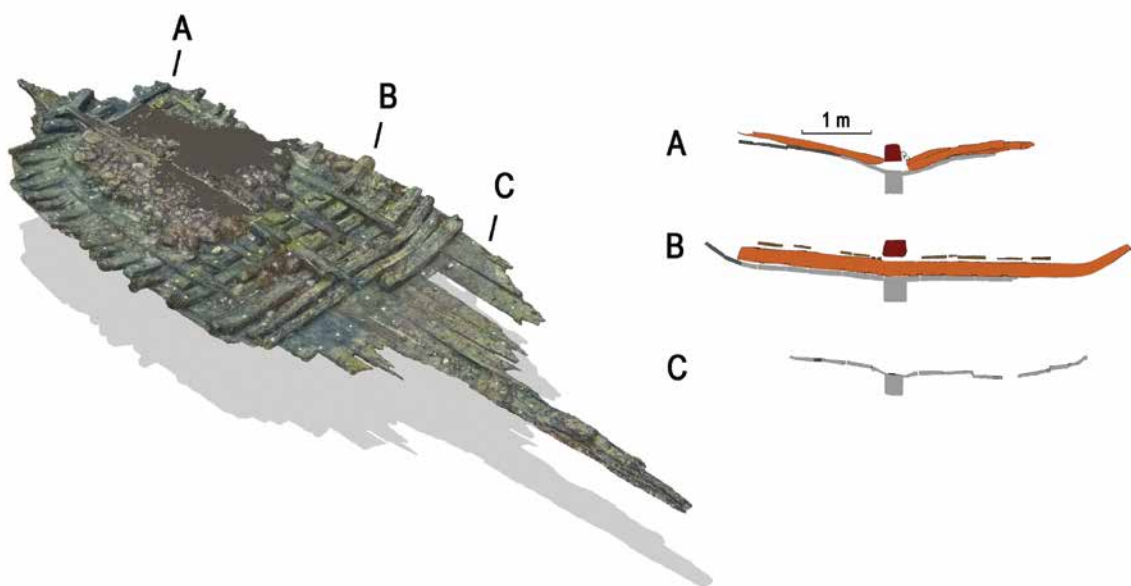
Fig. 4 Perspective view of the photogrammetric model of the wreck with cross-sections on three positions (graphic: M. Belasus, NIhK; model: R. de Hoop, RCE; cross sections by SDU MAP)

The hull has a flat bottom with no bilge or detectable deadrise in its central section (Fig. 4). The considerable width just before the stem post remains suggests a wide and bluff bow construction. The surviving part of the lower stem post assembly suggests a curved shape in its lower section.

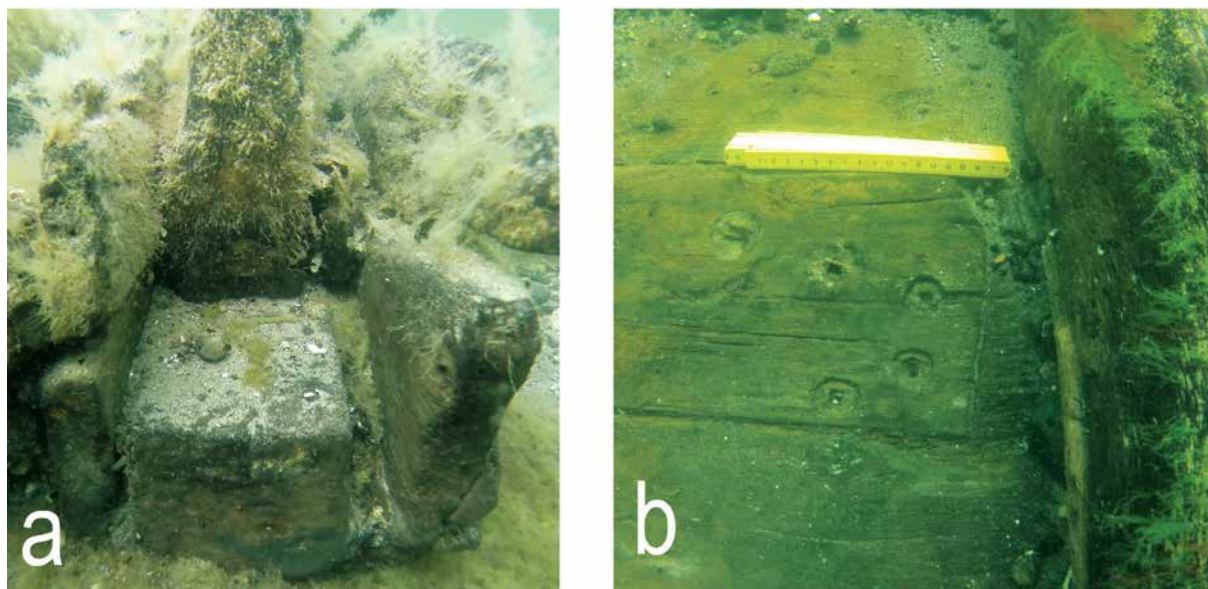
Fig. 5 a) Stern post assembly showing the gap of the missing post; b) Impressions of iron nail heads at the garboard scarf (photos: SDU MAP)

The garboards have no direct connection to the keel apart from the area covered by the sternpost construction, and probing the seam towards the keel with a thin blade gave no indication of any kind of rebate. The garboards are fastened to the frames at a 90° angle towards the keel in the ship's central section, resulting in no visible deadrise. They are twisted by 90° towards the stern. Here, the garboards are bent from horizontal to vertical within a distance of 3.0-3.5 m to cover the keel and stern post components. Each garboard strake is made up of at least two planks. The distribution of impressions of round nail heads at the scarf indicates a flat diagonal stop-scarf, which was connected by double-clenched or riveted iron nails (Fig. 5b).

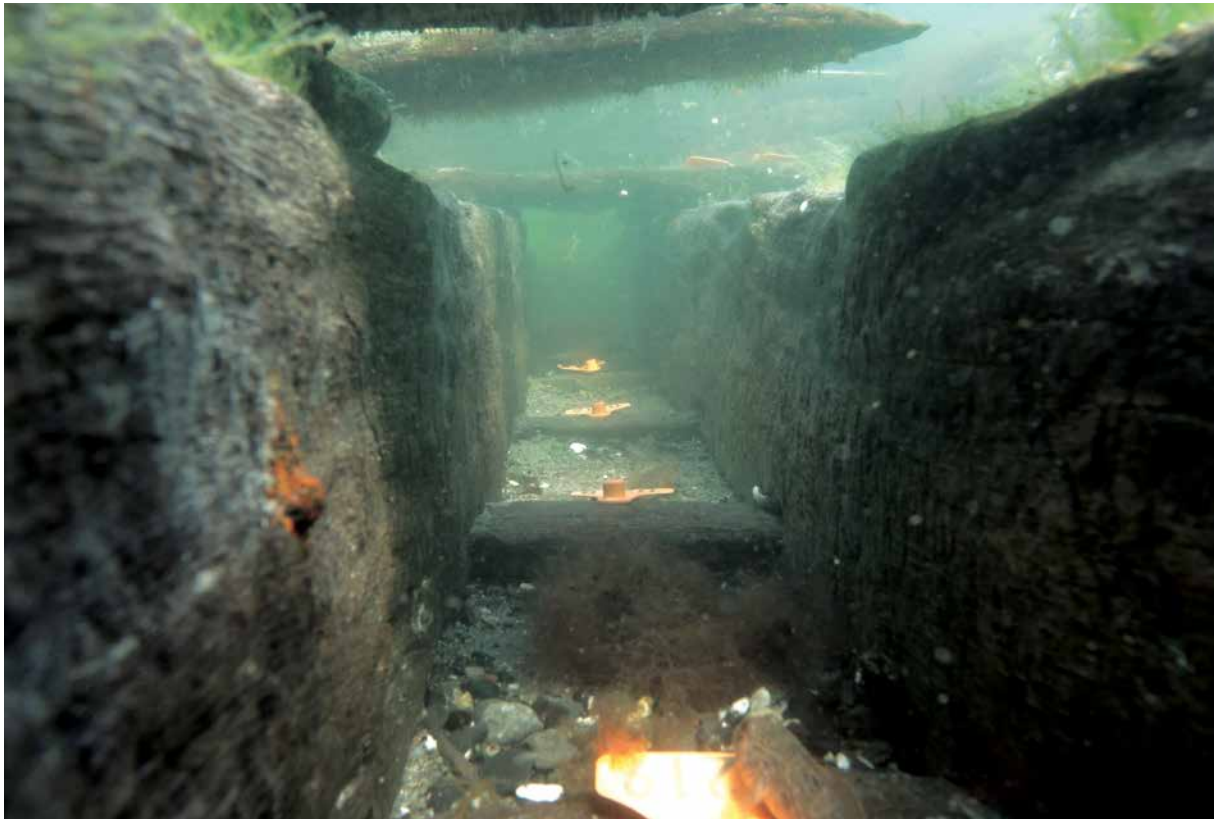
Fig. 6 Lath over seams between the frames (photo: SDU MAP)

The caulking process seems to be supported or accompanied by the installation of short laths, which are placed on the inside of the hull between the frames over the seams. They are fitted into shallow recesses on the lower edge of the frames (Fig. 6). The recesses were either square or consisted of a roughly axe-bevelled edge. The function of these laths might have been to prevent the caulking material from being pressed out of the seams on the inside during the caulking process. However, considering their rather loose fit, their function as a possible precaution to enable quick repairs of leaking seams while at sea may also be considered. The lath-feature is among others also present in the wrecks of the *Mars* and *Elefanten*, which also sank in the Nordic Seven Years War (Adams 2013: 87 ff.) and seems to be a common technique in Northern shipbuilding of the time. Two samples of caulking material have been recovered from the wreck and are currently being analysed. They appear to be highly fragmented plant fibres.
