Recording, analysis, and interpretation of the hull remains of *Santo Hieronimo* (1576), a vessel from the merchant fleet of the Maritime Republic of Ragusa

Jose L. Casabán – Irena Radić Rossi

Keywords: shipwreck, *Santo Hieronimo*, Maritime Republic of Ragusa, wooden hull, lead sheathing

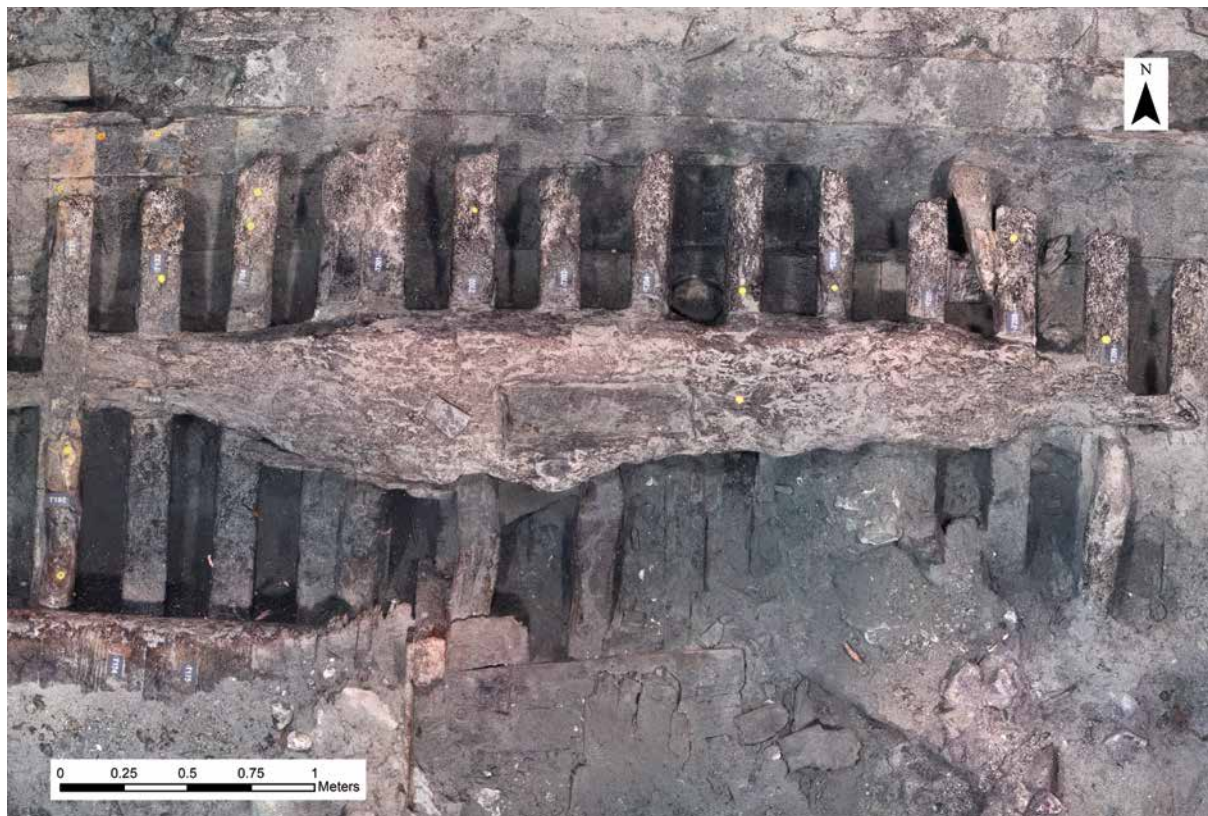
Fig. 4 Mast step, master frame, and presumed pump well (orthomosaic: J. L. Casabán)

The double-floor timber situated amidships beneath the forward end of the mast step was identified in 2021 as the ship's master frame. As with the rest of the floor timbers, its starboard side is broken just before the turn of the bilge, while its port side appears to continue underneath the limber boards of the ship's ceiling (Fig. 4). The floor timbers of the master frame are 17.4 cm and 16.7 cm sided, and 21 cm molded, with a combined width of 34.1 cm and a room and space between the first floor timbers before and aft of the master frame of 51.9 cm and 52.2 cm respectively.

The mast step extends over nine floor timbers, from the first floor timber before the master frame to the seventh aft (Fig. 4). It measures 3.21 m in length, 63 cm in width, and has a preserved height of 21 cm, with its center just after the master frame. On its upper surface, it has a rectangular mortise for the heel of the mainmast located between the first and fourth floor timbers aft of the master frame. The mortise is 73.2 cm long, 23 cm wide, and 15 cm deep. The upper surface of the mast step surface is damaged, especially from the mortise to the aft end, and a portion of its port side is also missing. The damage was probably caused by the weight of the ballast mound that was visible on the site's surface and located directly above the mast step.

The starboard side of the mast step presents four notches cut on its upper edge to insert the buttresses that laterally reinforce the mast step, although only three are completely visible (Fig. 4). The preserved edges of the notches are 17.5 cm long, 4 cm wide, and have an approximate depth of 5 cm, with a 44–50 cm center-to-center spacing. The traces of two more notches, and two preserved buttresses, 15 cm sided and a visible length of 81 cm, have been identified aft of the master frame, directly opposite the notches documented on the starboard side of the mast step.

Finally, the remains of a wooden structure, currently under excavation, situated amidships south of the mast step, have been tentatively interpreted as the western side of the ship's pump well (Figs 3, 4). A horizontal wooden plank 2 cm thick and 30 cm wide would form the partially visible side of the western wall of the pump well. The inner side of the plank is attached to a vertical, although slightly tilted outwards, post with a 20 × 13 cm section situated aft of the master frame floor timber. The pump well is not preserved north of the vertical post, and, at this stage of the excavation, it is unclear if the southern and eastern walls survived since the weight of the ballast mound severely damaged this hull area.

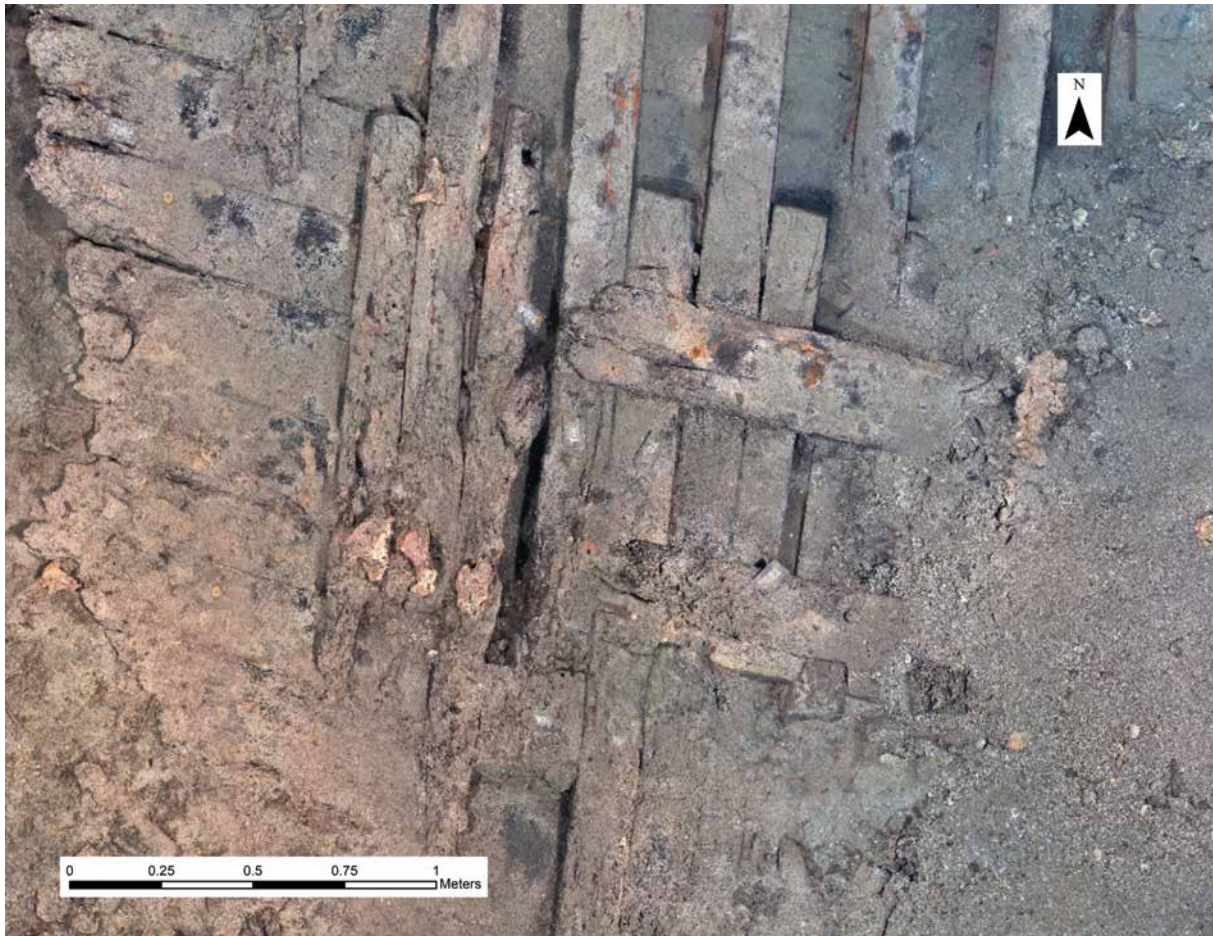
Fig. 6 Shelf clamp and second stringer on the port side of the bow (orthomosaic: J. L. Casabán)

the hull is still under excavation, the stringer presents a thickness of 10.8 cm and a width of 28 cm. A series of poorly preserved planks are situated immediately to the south of this stringer, although it has not been possible to determine yet if they correspond to the limber boards of the ship's ceiling. A second stringer is also visible on the port area of the bow, located on top of the joint scarf of the first and second futtocks (Fig. 6). This stringer is 27.2 cm sided and 10 cm molded, and its forward end is not preserved.

Finally, a timber situated above the second stringer at the bow was interpreted as a shelf clamp supporting the lower deck's beams (Fig. 6). The clamp is 27 cm sided and has a minimum molded dimension of 9.5 cm. Its upper edge presents a series of dovetail mortises where the 13 cm molded head of the beams are still inserted, with a center-to-center spacing of 39 cm.
