Villeneuve-d'Ornon (Gironde, France): A wreck from the early Middle Ages

Laurent Grimbert – Marc Guyon – Eric Rieth

Abstract: The Villeneuve-d'Ornon wreck was discovered in 2013 south of Bordeaux, near the Garonne River. Its scientific interest led the DRAC Nouvelle Aquitaine to prescribe a preventive excavation, which was begun by Inrap in 2019. Initial observations indicate a robust boat, keel-built, adapted to transporting goods in coastal areas and riverine environments. Several radiocarbon dates provide a chronology between the second half of the 6th and the end of the 7th century. As the dismantling of the wreck could not be completed in 2019, a second operation is under way until September 2022.

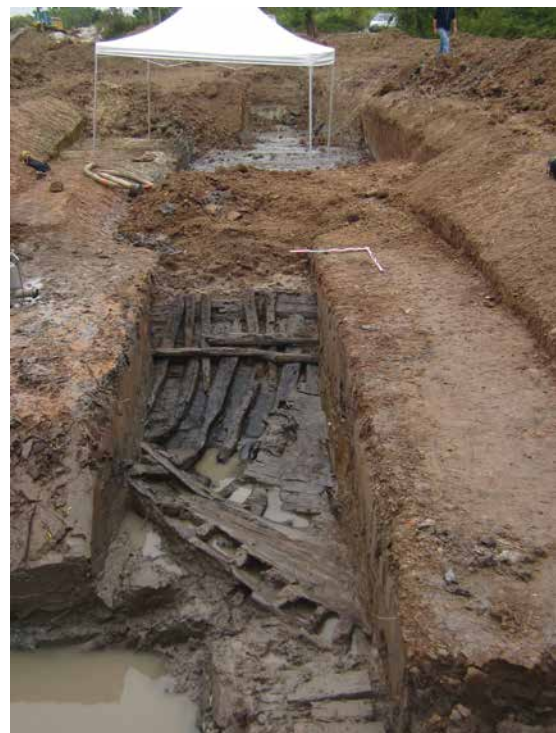
Fig. 2 Discovery of the wreck in 2013
(photo: Ch. Dunikowski, Inrap)

The Villeneuve-d'Ornon wreck (Gironde, France, Fig. 1) was discovered in 2013 during an Inrap archaeological survey, in connection with a major real estate project on the banks of the Garonne River, a little upstream from Bordeaux. An initial radiocarbon dating quickly revealed the age of this boat (7th–8th century), while observations showed its strong scientific potential (Fig. 2): good conservation of the wood, presence of fittings, general quality of the construction.... All of these clues led the Ministry of Culture to prescribe a preventive archaeological excavation to clear the wreck and remove it. The initial intervention, carried out by Inrap, took place from August to November 2019.

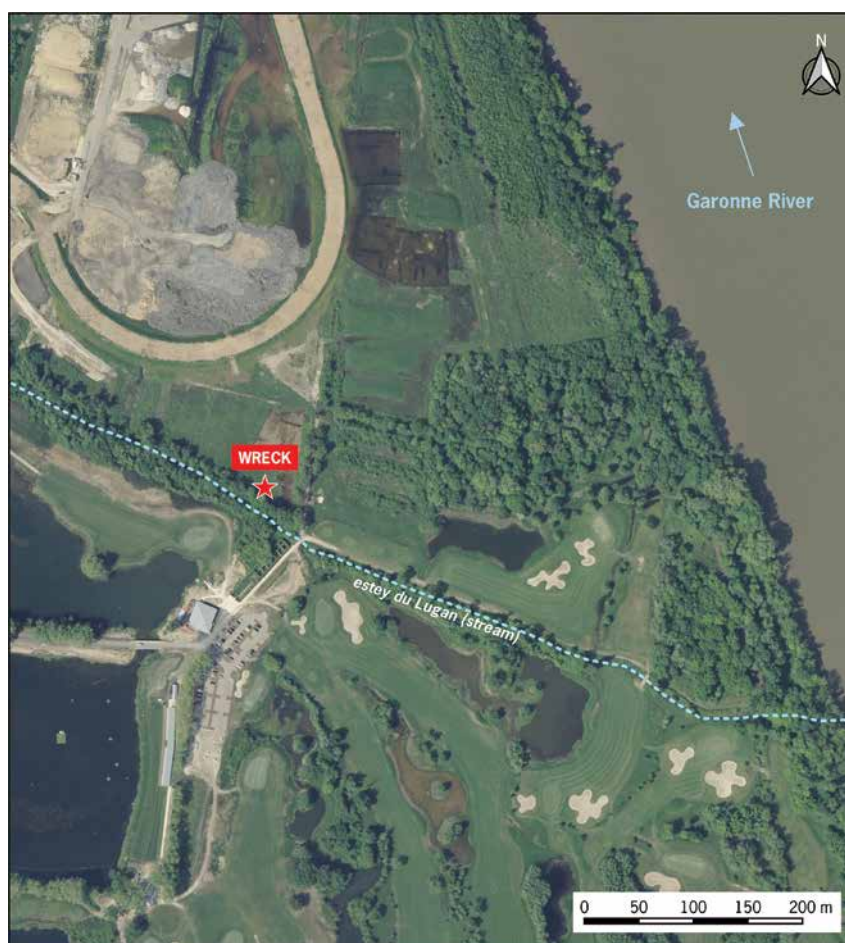
Fig. 3 Aerial view of the wreck area (author: L. Grimbert, Inrap, Google)

The wreck is buried in the old, clogged bed of the Lugan *estey*, a lateral tributary of the Garonne on the left bank, whose current bed, very reduced compared to its ancient width¹, is located some 10 m south of the position of the wreck (Fig. 3). The old northern bank of this tributary, observed during the 2013 diagnostic phase, has a gentle slope on which the bow of the boat partially rests. The boat is sunken in a grey-blue clay sediment, which corresponds to its progressive silting up (flooding of the Garonne and daily input of sediment by the tides whose influence is felt up to here). The level at which the wreck appeared is very close to the current surface of the land, only 1.30 m deep. The proximity of the water table, outcropping in this particular sector, explains the very good preservation of the boat.

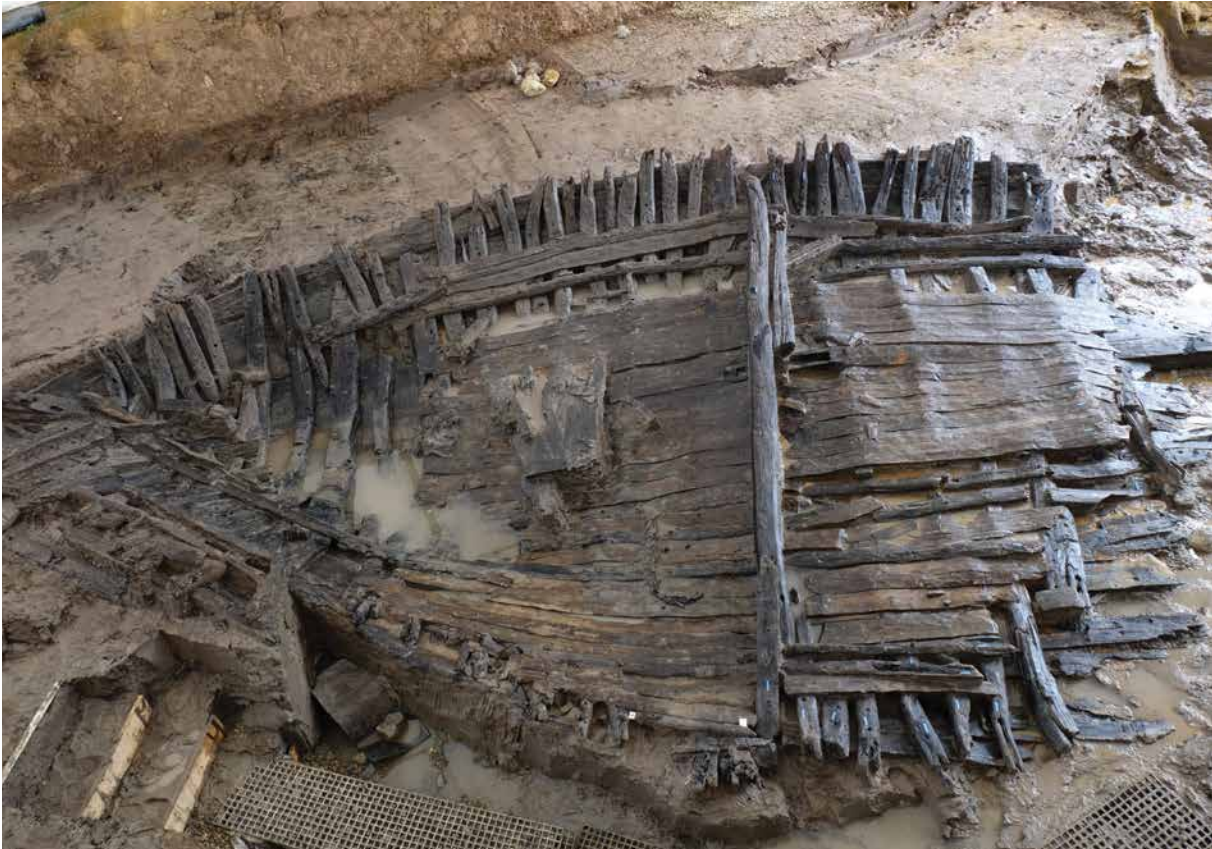
Fig. 4 General view of the wreck (photo: P. Ernaux, Inrap)

The 2019 excavation confirmed a remarkable state of preservation of the boat, preserved over a length of 11.20 m, a width of 5.90 m and a height of 1.60 m (Figs 4 and 5). Part of the stern is destroyed over a presumed length of 3 or 4 m, which would restore a boat of an initial length of about 15 m. The reasons for the absence of this part of the wreck have not been identified, but the presence of traces of cutting on the visible part of the keel proves that this is an old phenomenon (a choice to recover some of the elements before the wreck was completely buried?).

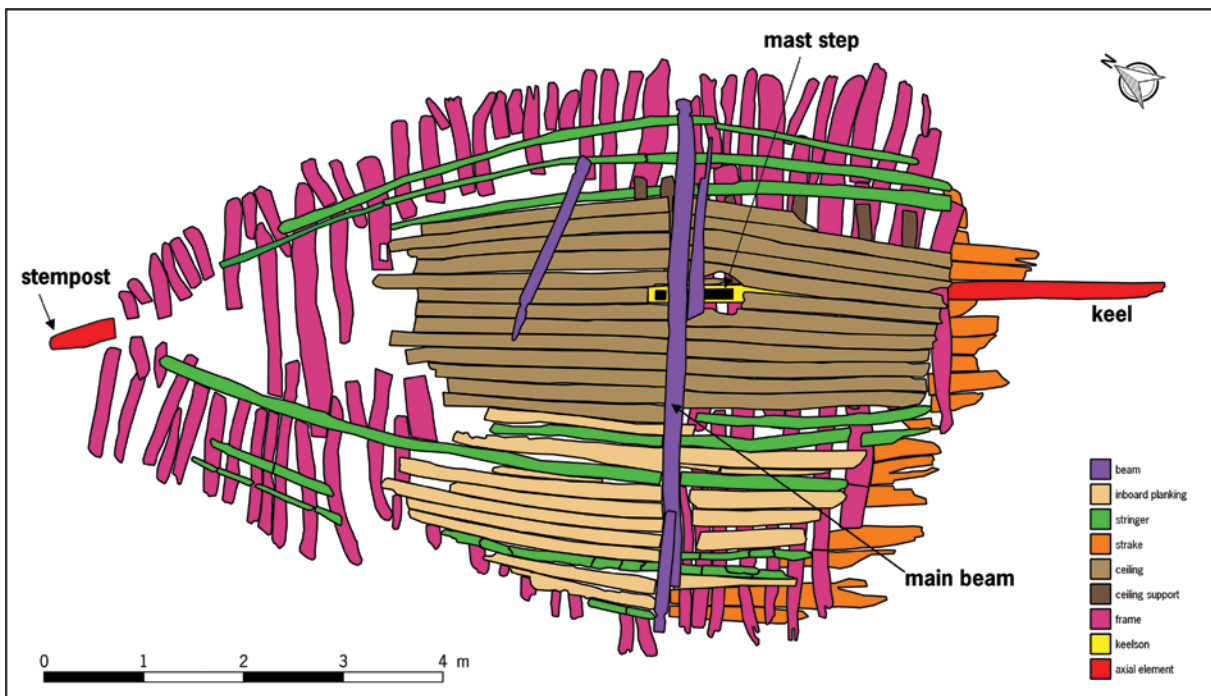
Fig. 5 Plan of the wreck's elements (drawing: L. Grimbert, Inrap)

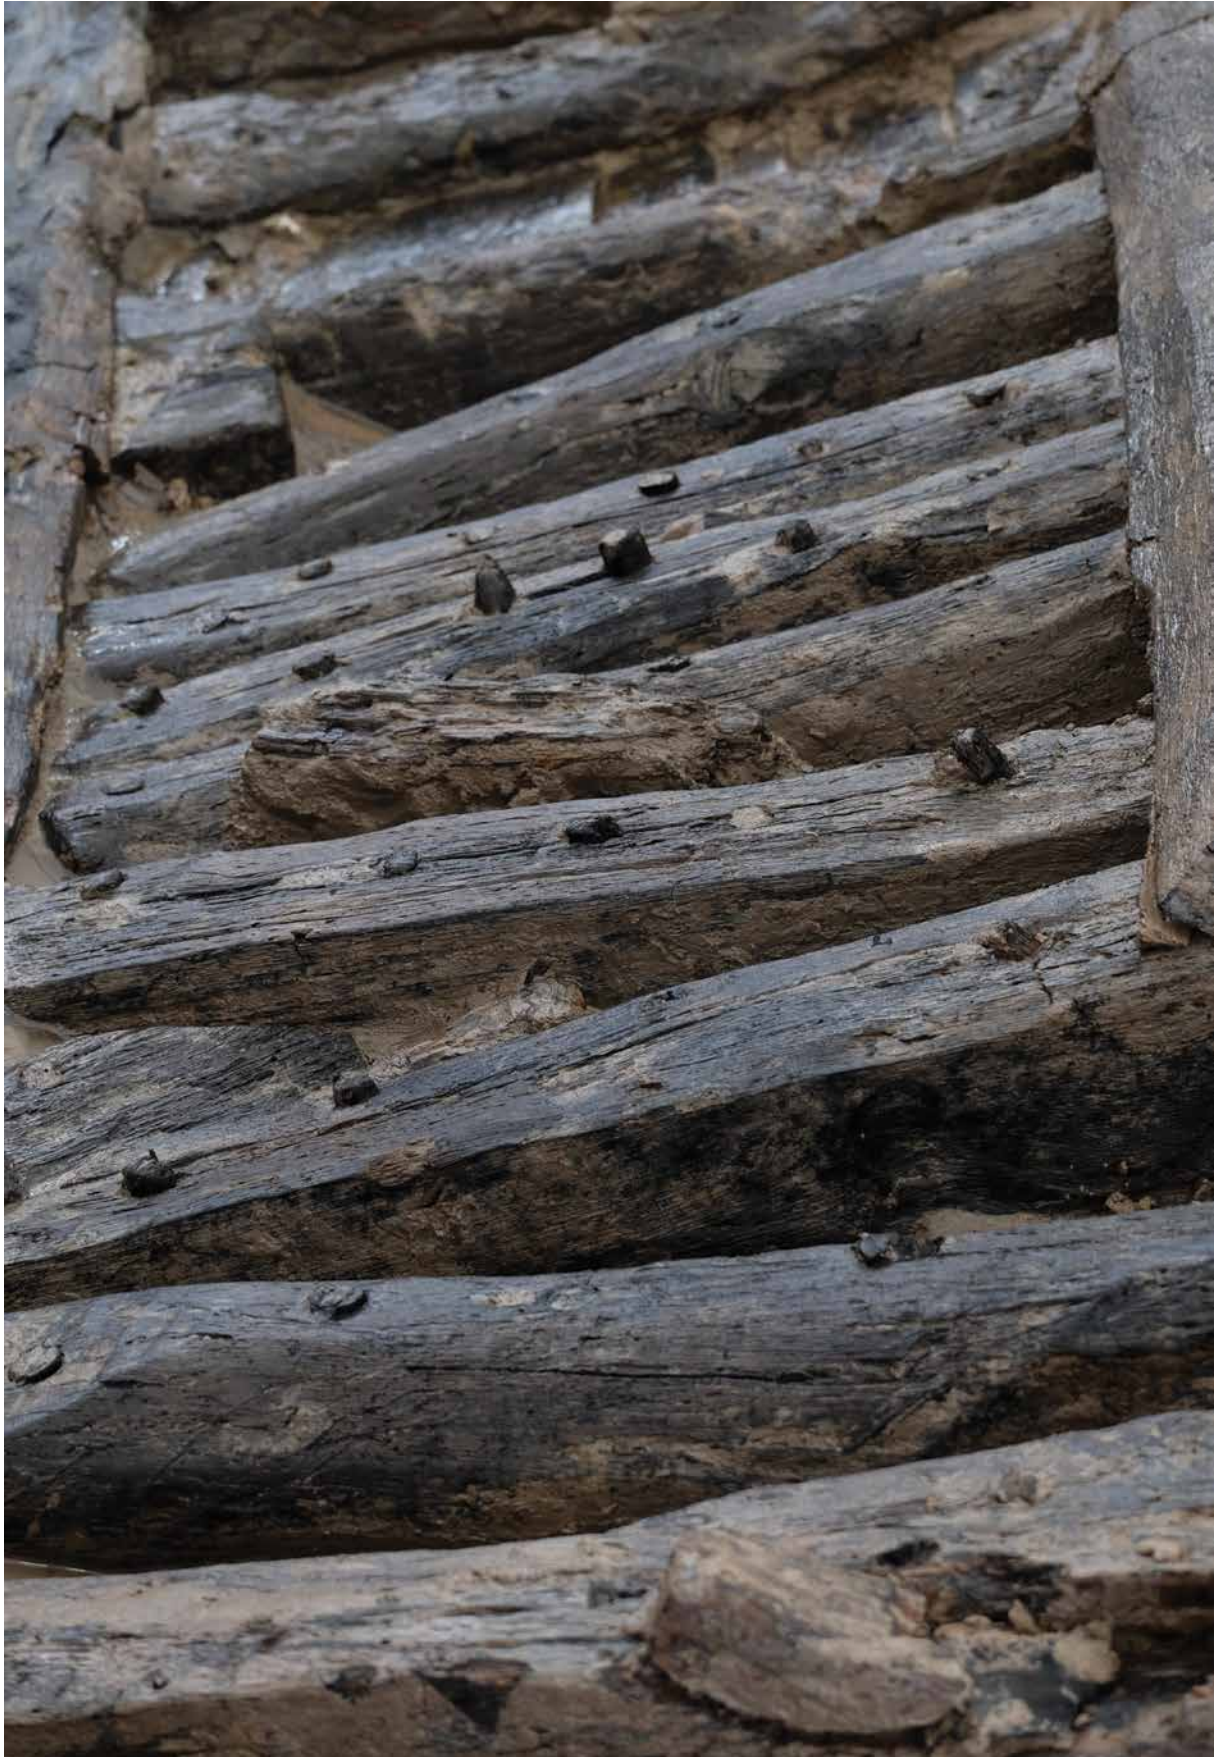
Fig. 6 Detail of the treenails in the starboard frame (photo: P. Ernaux, Inrap)

All the structural elements were observed in a precise manner (keel, planking, ceiling, mast step, beams, etc.) as well as the connections between the elements, mainly by treenails (Fig. 6), but numerous iron nails are also present, particularly at the connections of the important structural parts (stempost, keel, keelson, stringers). Nails were also used for the ceiling.
