ARHEOLOŠKI NADZOR U ULICI FRANKA LISICE

Archaeological supervision in Franka Lisice Street

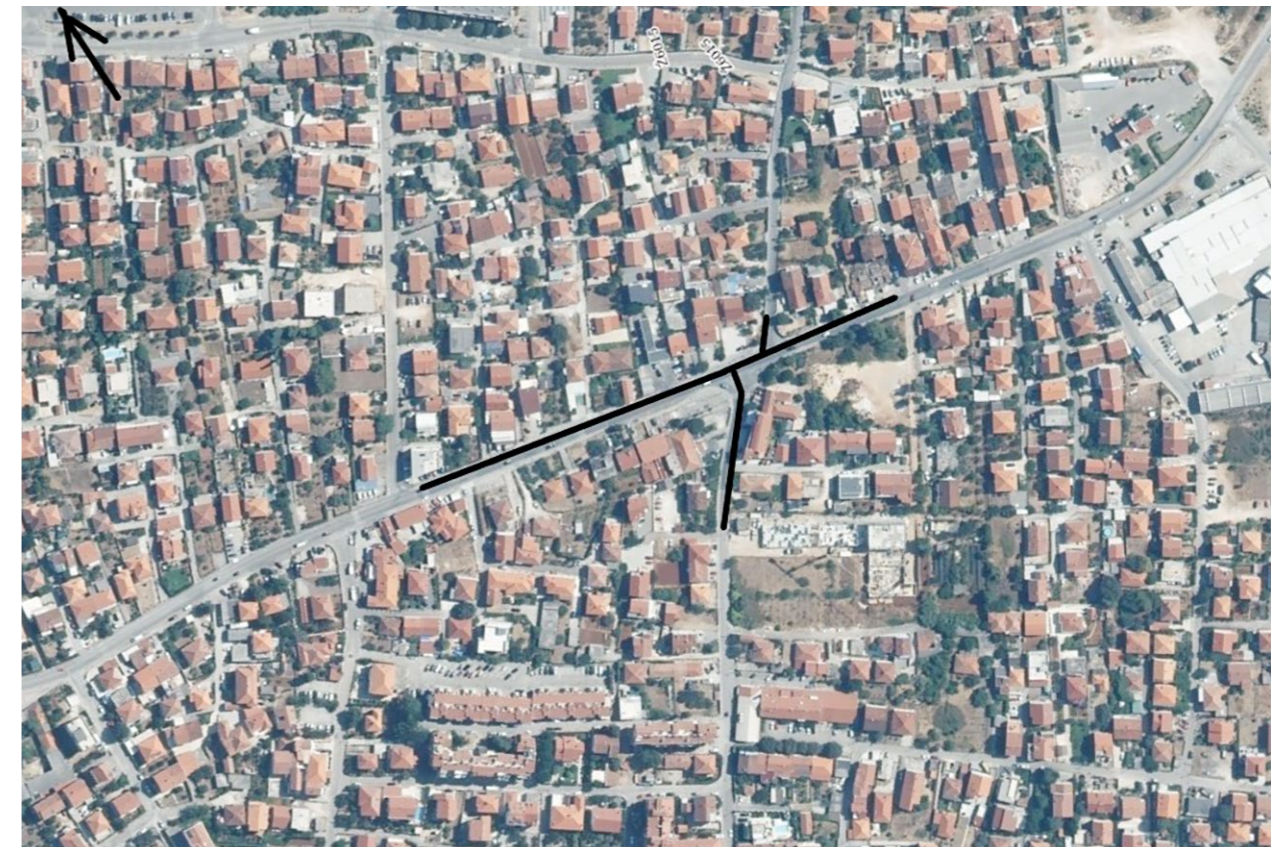
Karta područja s ucrtanim trasama iskopa (preuzeto s: geoportal.dgu.hr)
Map of the area with marked excavation areas (downloaded from: geoportal.dgu.hr)

Posljednih nekoliko godina brojne rekonstrukcije zadarskih prometnica i ostali infrastrukturni radovi popraćeni su arheološkim nadzorima, pa tako Odjel za arheologiju već godinama prati radove na izgradnji plinskog distribucijskog sustava grada Zadra, a od ožujka do listopada 2023. radovi su se odvijali u ulicama Put Kotlara i Franka Lisice. (karta)

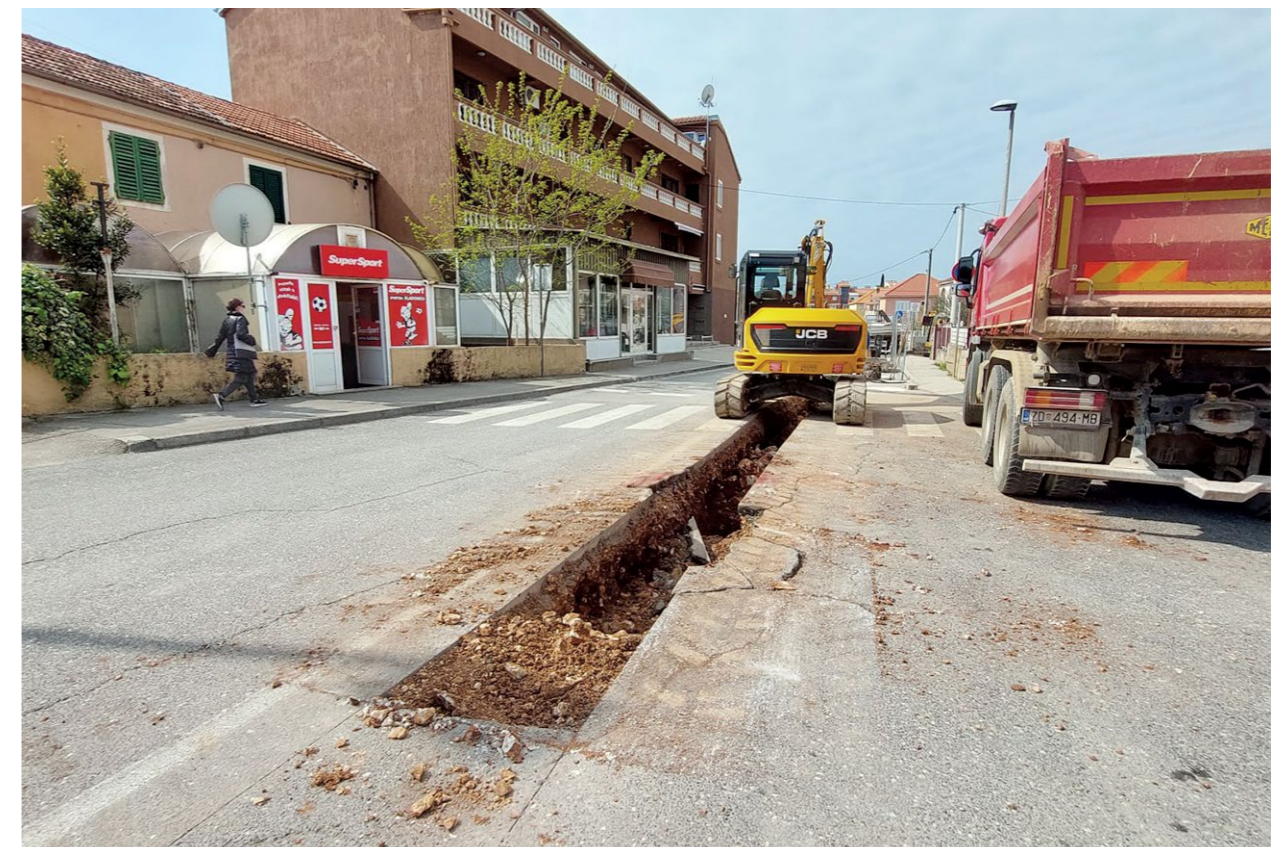
Pogled na kanal u ulici Put Kotlara (foto: L. Bogdanić)
View of the channel in Put Kotlara Street (photo: L. Bogdanić)

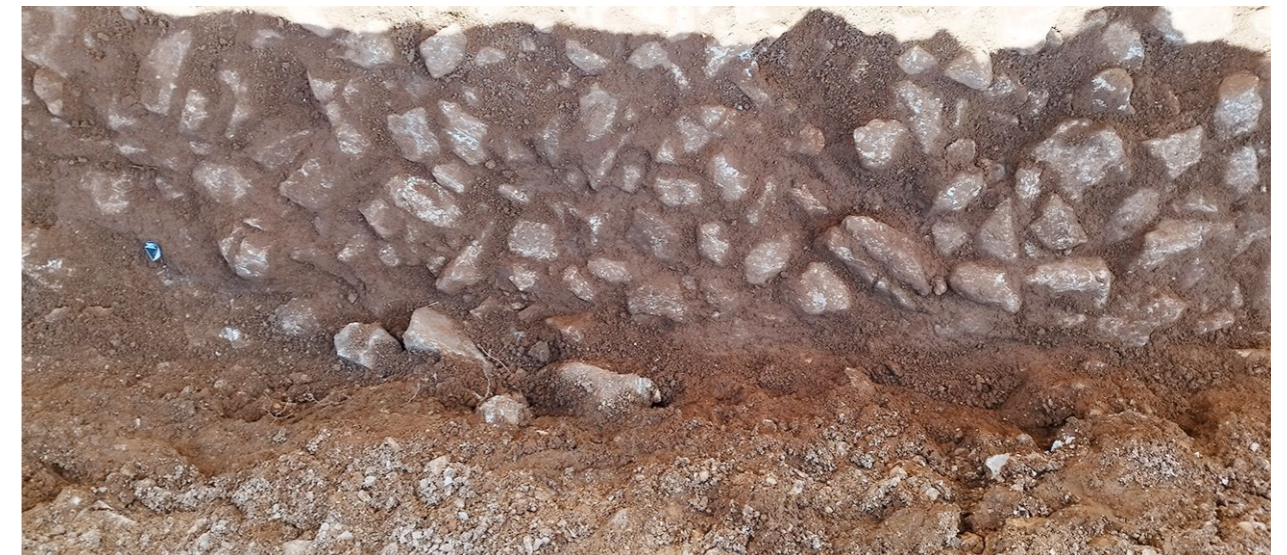
Detail of kaldrme u Ulici Franka Lisice (foto: F. Jurković Pešić)
Detail of the cobbled area in Franka Lisice Street (photo: F. Jurković Pešić)

Kamen živac je na cijelom potezu bio relativno visoko, pretežito na dubini od 50 do 80 cm, iznad je bio nasip od lomljenog kamena, a pri vrhu, ispod asfalta, recentna podloga ceste. U gornjem dijelu ulice, prema raskrižju s Ulicom F. Lisice, na dubini od 65 cm od površine asfalta otkriven je segment puta – kaldrme od sitnog nabijenog kamena, djelomično prekrivenog i povezanog pjeskovitom nabijenom zemljom. Mjestimično je vidljiva i živa stijena čija je površina uglačana i izlizana od korištenja. Ukupna dokumentirana dužina je 5 metara. Podloga je u većem dijelu masna crvenica sa sitnim kamenom, a mjestimično živa stijena. Nedostatak sitnih nalaza i uski kanal iskopa gdje nisu bili vidljivi rubni dijelovi strukture onemogućavaju preciznu dataciju. (Slika)

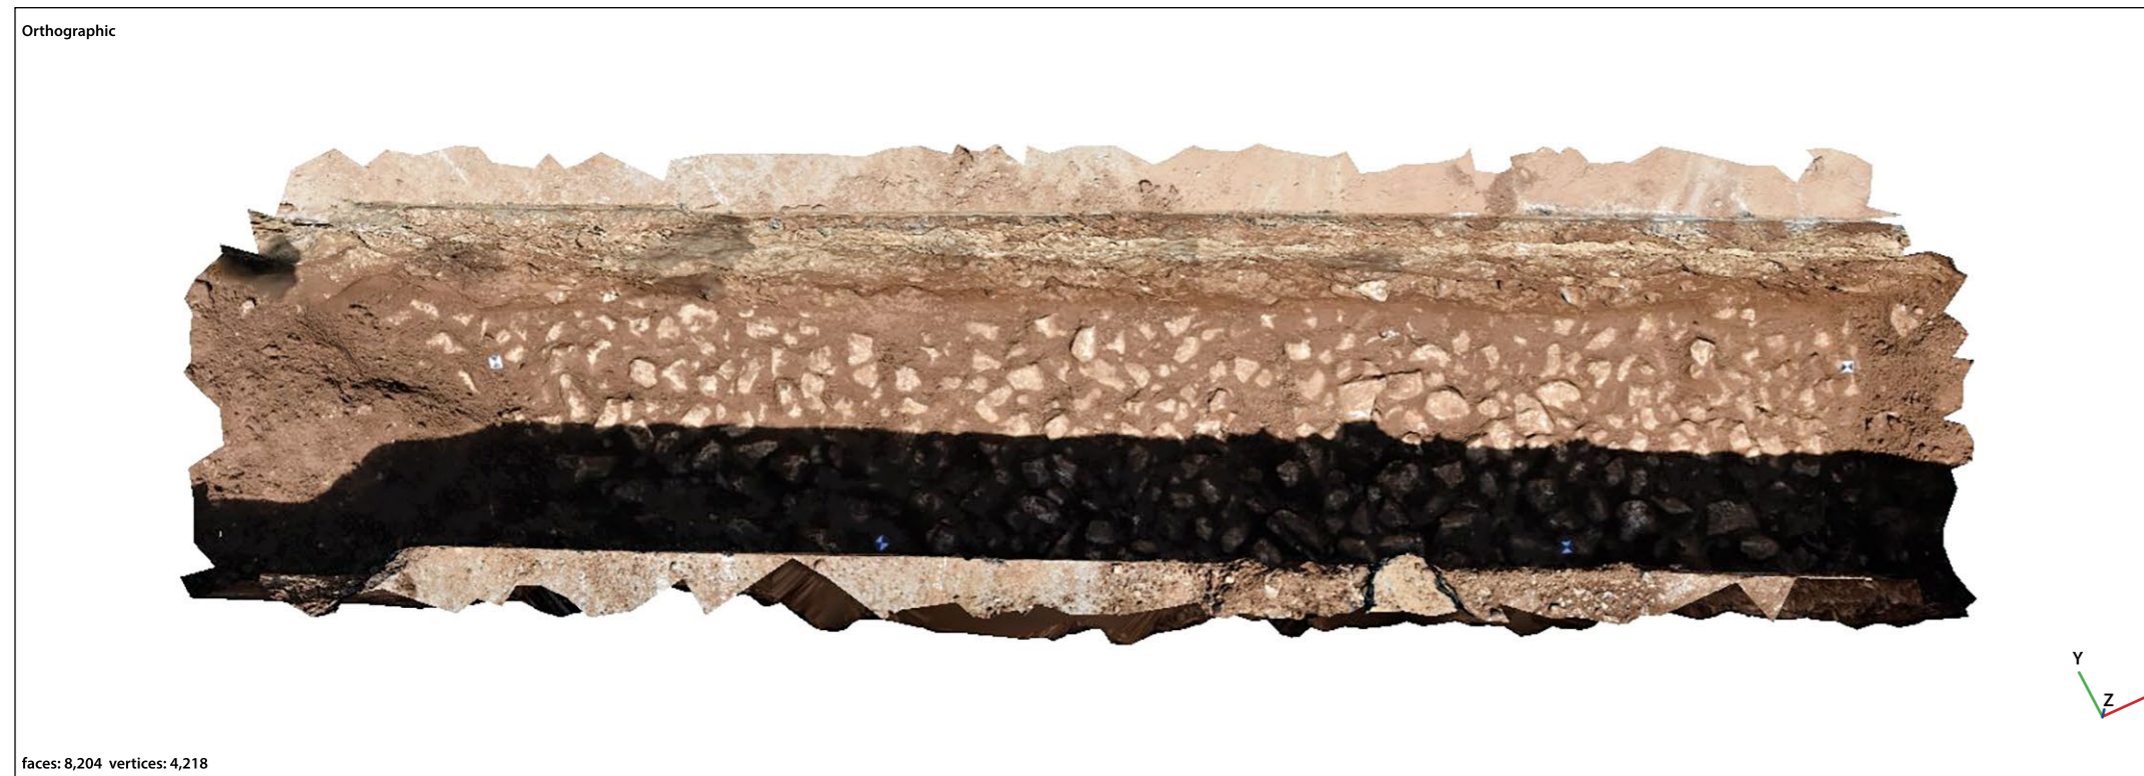
Kaldrma u Ulici Franka Lisice (izradila: M. Šimičić)
Cobbled area in Franka Lisice Street (made by: M. Šimičić)

od 100 do 130 cm. Zanimljivo je da to područje Ilakovac naziva velikom vrtačom koju akvedukt između pozicijskih točaka 22 i 20 zaobilazi s južne strane (Ilakovac 1982: 202). Upravo je ta niža konfiguracija terena omogućila da se do danas očuvaju i arheološki slojevi, pa je tako na prostoru pred crkvicom Sv. Duha na dubini od 105 cm otkriven segment puta. Kaldrma je od, čini se, neobrađenog kamena, prosječne veličine 10 x 10 cm, koji je s gornje strane istrošen od korištenja. Između kamena je sloj smeđe, relativno rahle zemlje. Vidljiva je u čitavoj širini kanala i očuvana u dužini od 3 metra, ali ni na ovoj

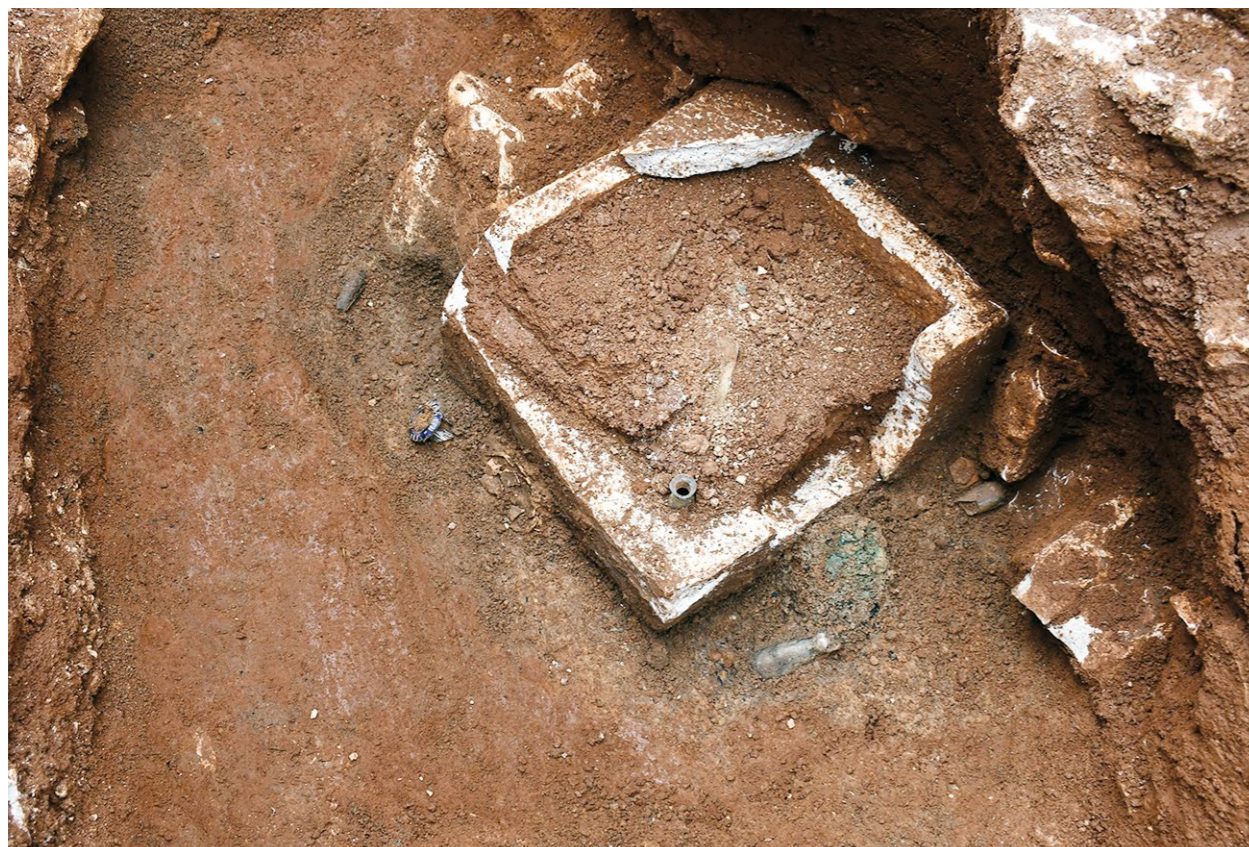
Grob 3 (foto: L. Bogdanić)
Grave 3 (photo: L. Bogdanić)

ical finds and items characteristic of the period of the 1st and early 2nd century, and grave 3 is particularly noteworthy, where 14 glass balsamaria were found inside the urn, three of which were burned and the remaining examples are complete and date to the 1st century (Eterović Borzić, Štefanac 2021: 72–83). One burial is in a ceramic urn that was previously partially destroyed during the construction of the drainage system located on the southern side of the channel. In one part a large quantity of tegula fragments and a possible part of the stone burial structure were discovered, but unfortunately, that grave was also destroyed earlier, probably by the electrical installations located on the other, northern side of the excavation for the gas pipeline.

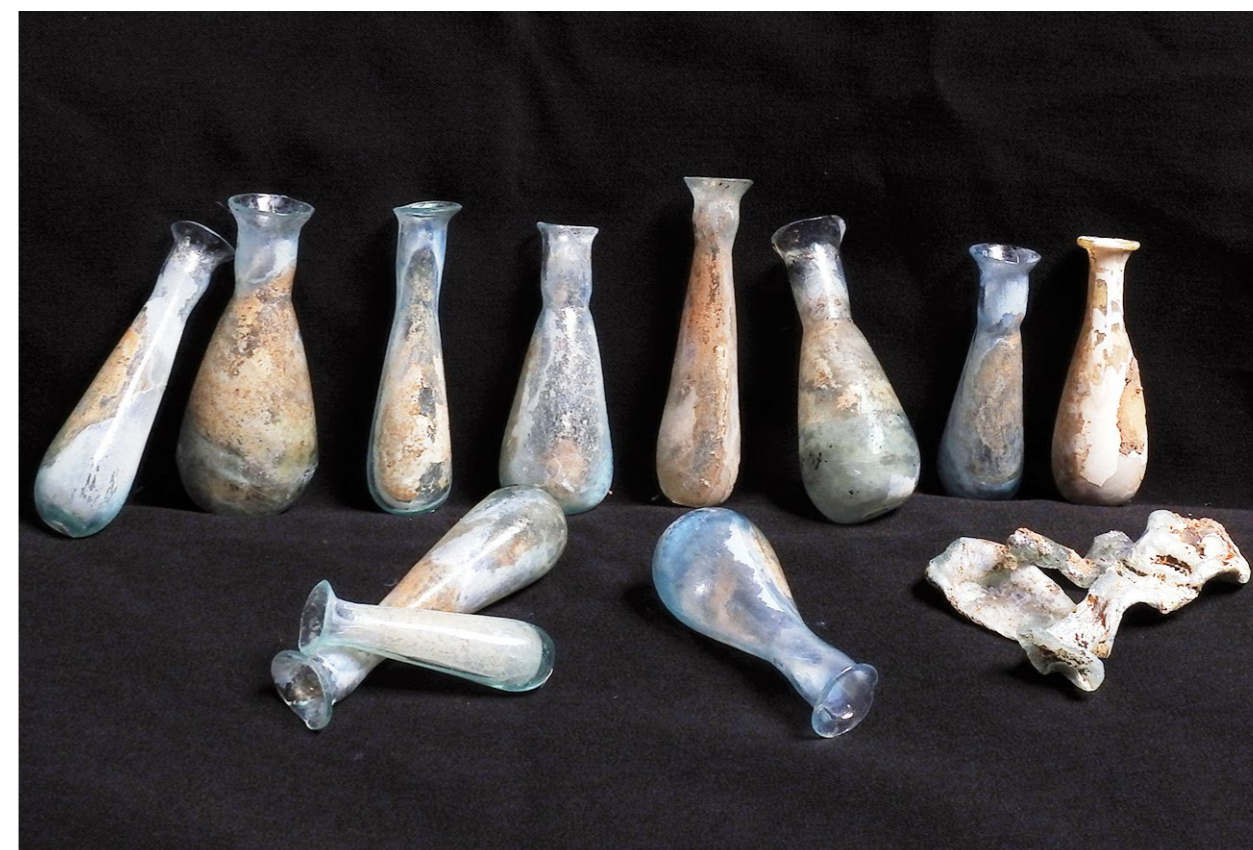
Stakleni balzamariji iz groba 3 (foto: F. Jurković Pešić)
Glass balsamaria from grave 3 (photo: F. Jurković Pešić)
