PROBNO ARHEOLOŠKO ISTRAŽIVANJE U PODRUMU OSNOVNE ŠKOLE SILVIJA STRAHIMIRA KRANJČEVIĆA U SENJU

Archaeological trial excavations in the basement of Silvije Strahimir Kranjčević Elementary School in Senj

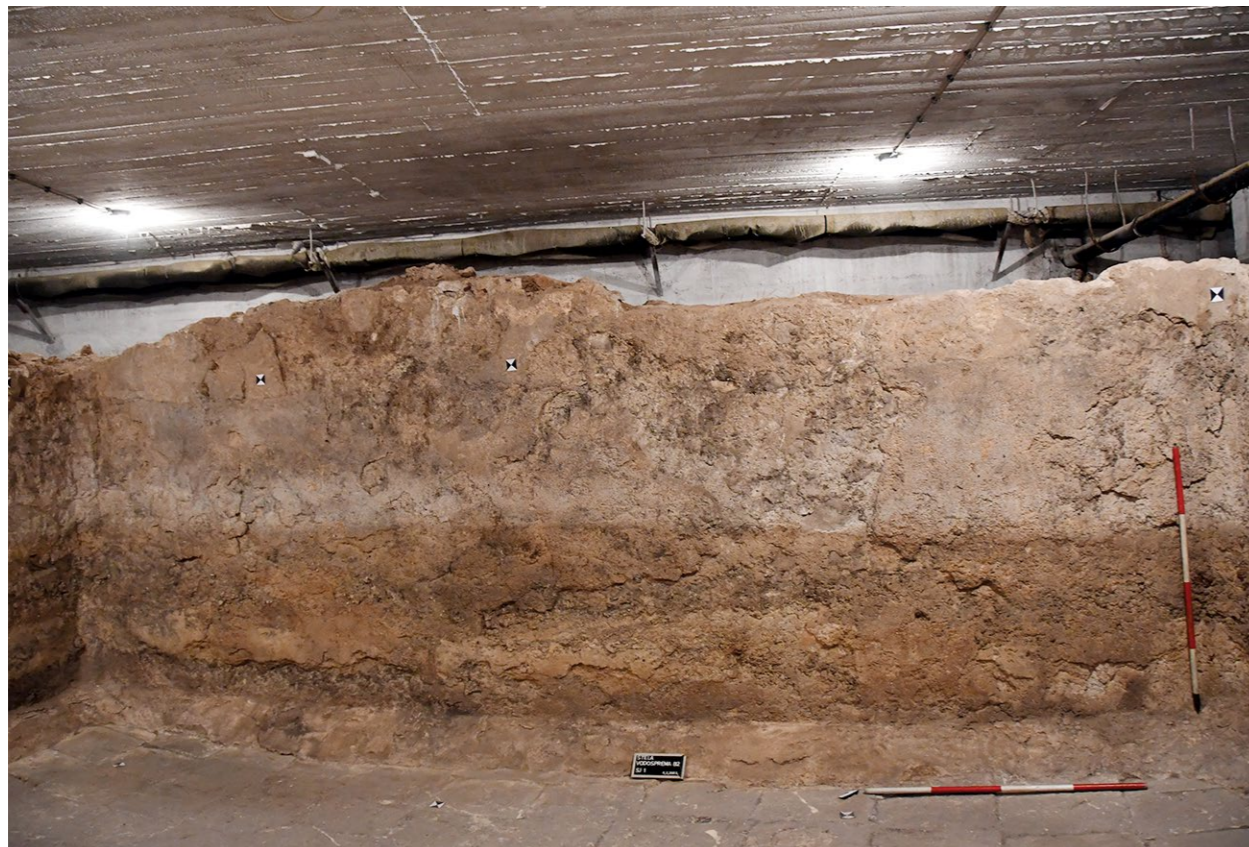
Sjeverozapadni zid vodospreme (foto: V. Glavaš)
Northwestern wall of the water reservoir (photo: V. Glavaš)

Zidovi vodospreme građeni su od neobrađenih i grubo obrađenih kamenih blokova, a mjestimično i od većih oblutaka međusobno povezanih vodonepropusnom žbukom svijetle crvenkastosmeđe boje. Primjetna je i tendencija vodoravnog uslojavanja kamena. Zidovi vodospreme debljine su oko 50-55cm, ukopani su u tlo, i to, kako se čini, u sterilni sloj. Građeni su kao podzidi, bez vanjskog lica. Na vrhu sjeverozapadnog i jugozapadnog zida vodospreme vidljivi su tragovi elevacije zidova vodospreme koji se vjerojatno nalazio na tadašnjoj hodnoj razini. Zidovi vodospreme međusobno su i s podom vodospreme povezani debljim slojem vodonepropusne žbuke.

The walls of the water reservoir were built from undressed and rough-hewn stone blocks, and in some places from larger pebbles connected with waterproof mortar of light reddish-brown color. The tendency of horizontal layering of the stone is also noticeable. The walls of the water reservoir are about 50-55 cm thick, they are dug in the ground, in a sterile layer as it seems. They were built as retaining walls, without an outer face. At the top of the northwestern and southwestern walls of the water reservoir, traces of the elevation of its walls are visible, which was probably at the walking level at the time. The walls of the reservoir are connected to each other and to the floor of the reservoir with a thicker layer of waterproof plaster.

The rest of the fill, which was not removed during the research in 1972, remained attached to the northwestern wall of the reservoir. During its removal, it was found that it consisted of the remains of the sediment and pieces of waterproof plaster of various sizes stuck together. Traces of molding are also visible on some fragments, which indicates that it is the ceiling of the cistern that collapsed and became the contents of its fill. The fill also contained some amorphous fragments, mostly ceramic building material, several fragments of amphorae, larger *tesserae* and fragments of wall plaster.

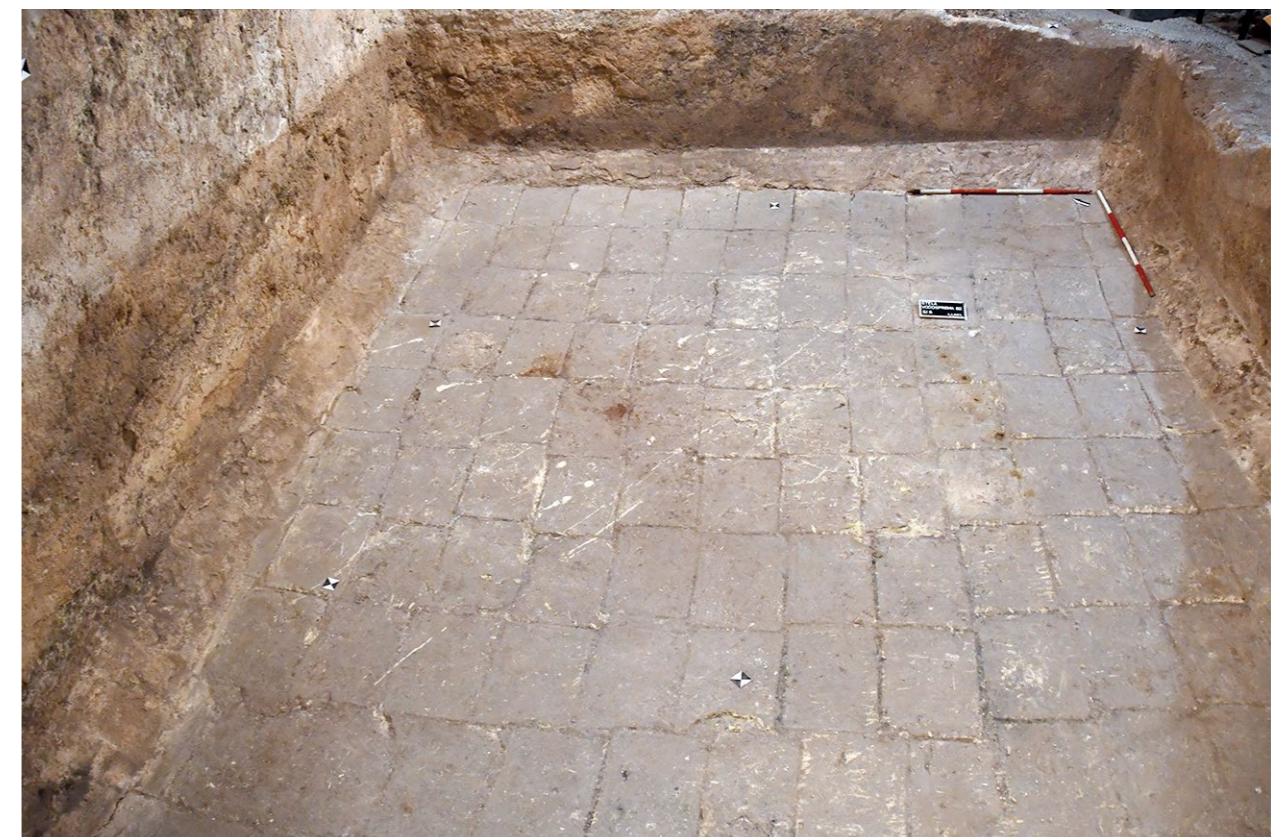
Popločanje vodospreme (foto: V. Glavaš)
Water reservoir paving (photo: V. Glavaš)

Dno vodospreme popločano je četvrtastim keramičkim pločama koje su međusobno povezane žbukom. Na mnogim pločama uočeni su životinjski tragovi (mačka, pas, srna?) te otisak cipele s potplatom s čavličima. Na svim zidovima uočljivi su tragovi finije i grube vodonepropusne žbuke. Gru-

The bottom of the reservoir is paved with square ceramic tiles that are connected with mortar. Animal tracks (cat, dog, doe?) and the imprint of a shoe sole studded with nails were observed on a number of tiles. Traces of fine and coarse water-

One of the goals of this research was to determine the chronological context of the construction of the water reservoir. For this reason, a part (1/3) of one tile of the cistern's floor was removed in order to see what the water reservoir lies on and to obtain data on the time of construction. It was found that the floor tiles of the water reservoir lie on a layer of solid waterproof plaster 17 cm thick. Below that layer, there was an earlier floor of the

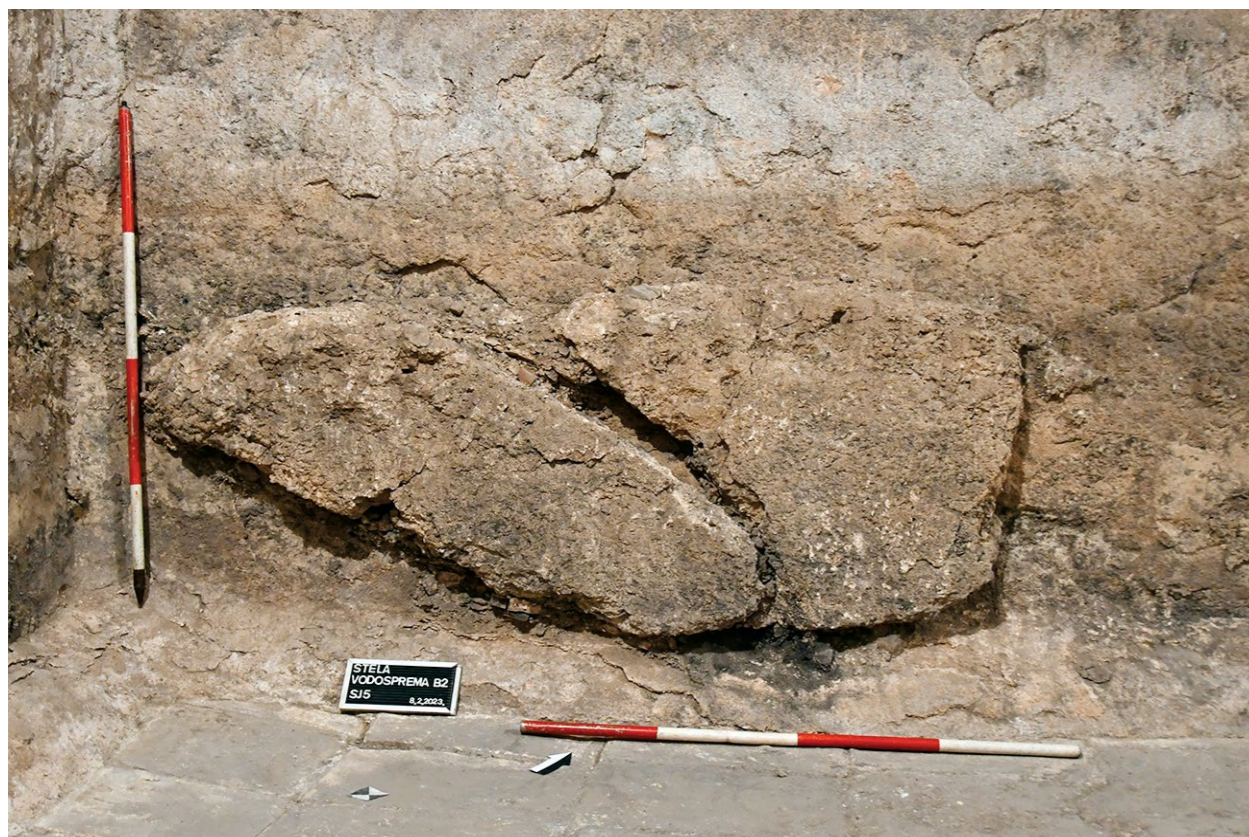
⋮ Ostatak zapune vodospreme (foto: V. Glavaš)
 ⋮ Remains of the water reservoir fill (photo: V. Glavaš)

Uz sjeverozapadni zid vodospreme ostao je pričvršćen i preostatak zapune koji nije uklonjen tijekom istraživanja 1972. godine. Tijekom njegova uklanjanja ustanovljeno je da je riječ o ostatku sedimenta i slijepljenih komada vodonepropusne žbuke raznih veličina. Na pojedinim ulomcima vidljivi su i tragovi profilacije što upućuje na to da je riječ o stropu cisterne koji je urušen i kao takav postao sadržaj njezine zapune. Zapuna je sadržavala i nešto amorfnih ulomaka većinom građevinske keramike, nekoliko ulomaka amfora, veće *tesserae* te fragmente zidne žbuke.
